Appendix A: Dubuque MPO Sites

Intersections

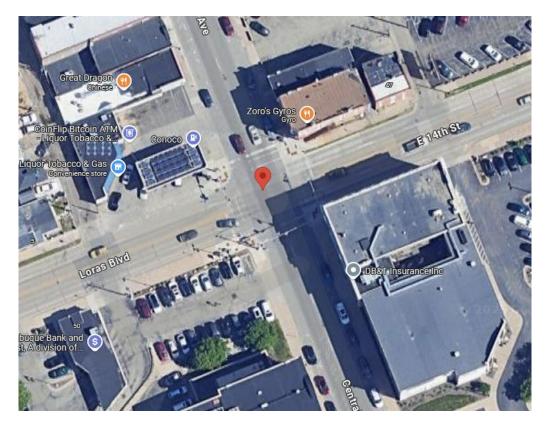
Figure 11: Intersection of Central Avenue and 14th Street (Image: Google Maps)

This site is a four-legged, undivided, low speed, signalized intersection (Google Map Link). It has a higher PCR level for KAB crashes, indicating the need for immediate attention and potential countermeasures. The surrounding area is predominantly commercial. The intersection has well-defined curbs, curb ramps and sidewalks. Overhead lighting is present at the intersection. The delineation and pavement are in good condition. Additionally, marked crosswalks and pedestrian signals are present, providing facilities for pedestrian safety.

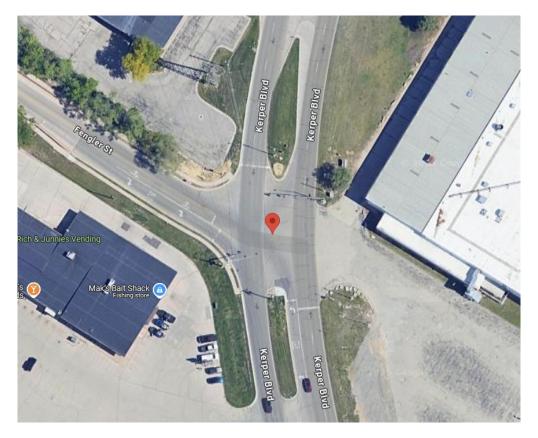
Figure 13: Intersection of Fengler Street and Kerper Boulevard (Image: Google Maps)

This site is a three-legged, divided, low speed, signalized intersection (<u>Google Map Link</u>). It has a higher PCR level for KAB crashes, indicating the need for immediate attention and potential countermeasures. The surrounding area is predominantly industrial. The intersection has well-defined curbs, however, curb ramps and sidewalks are only on minor roads. Overhead lighting is present at the intersection. The pavement is in good condition. There are no marked crosswalks present.

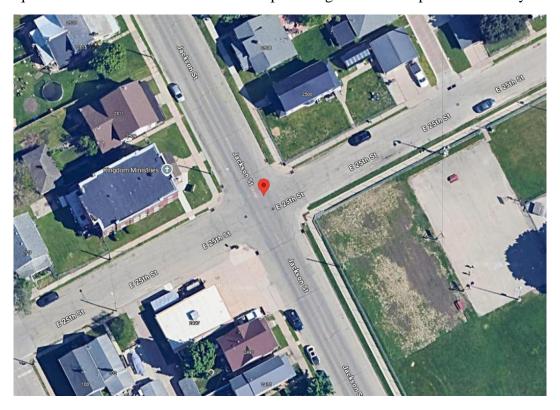
Figure 29: Intersection of East 25th Street and Jackson Street

This intersection in the city of Dubuque is a Four-legged, undivided, low speed, partial stop controlled intersection with a medium PCR level for KAB crashes, indicating the need for immediate attention and potential countermeasures (<u>Google Maps Link</u>). A park and playground are located in the southeast section of the intersection. The intersection features curbs, curb ramps, and sidewalks. The road delineation and pavement are in good condition, but the lighting is inadequate. There are no marked crosswalks providing facilities for pedestrian safety.

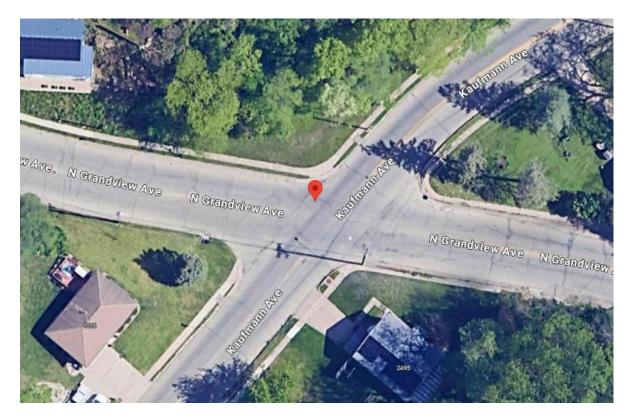
Figure 39: Intersection of Grandview Avenue and Kaufmann Avenue

This site has the medium PCR level for KAB crashes, indicating the need for immediate attention and potential countermeasures. It is a four-legged, undivided, low speed, partial stop-controlled intersection (Google Maps Link). The area is predominantly residential. The intersection has well-defined curbs, curb ramps and sidewalks. Overhead lighting is present. There are no marked crosswalks present.

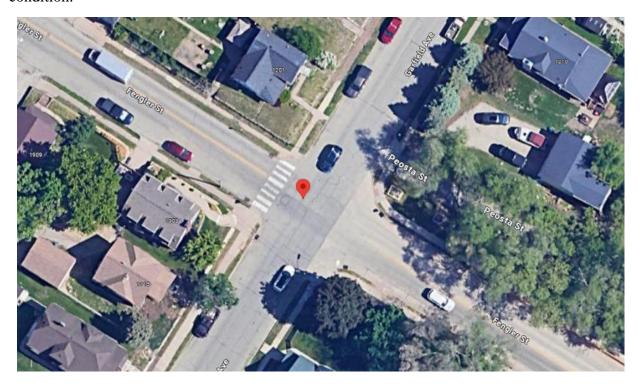
Figure 40: Intersection of Fengler Street and Garfield Avenue

This site has a medium PCR level for KAB crashes, indicating the need for immediate attention and potential countermeasures. It is a four-legged, undivided, low speed, all way stop controlled intersection located in a predominantly residential area (<u>Google Maps Link</u>). The intersection has well-defined curbs, curb ramps, sidewalks, and overhead lighting, and the pavement is in good condition.

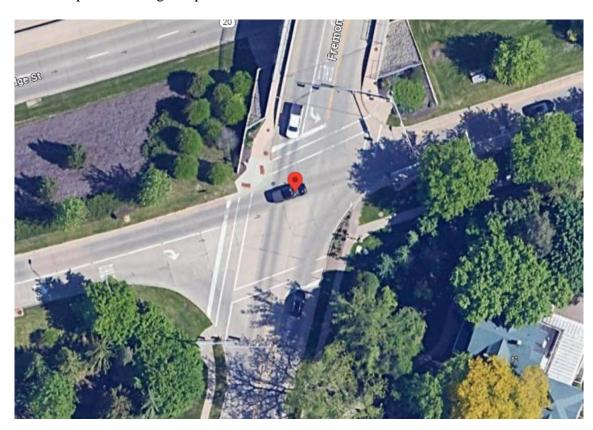
Figure 44: Intersection of Fremont Avenue and US 20 Ramp

This site has a medium PCR level for KAB crashes, indicating the need for immediate attention and potential countermeasures. It is a four-legged, undivided, low speed, signalized intersection, with the west and east legs serving as exit and entrance ramps to US 20, respectively (Google Maps Link). The intersection has well-defined curbs, curb ramps, and sidewalks. Overhead lighting is present and the pavement is in good condition. Additionally, there are marked crosswalks and pedestrian signals present.

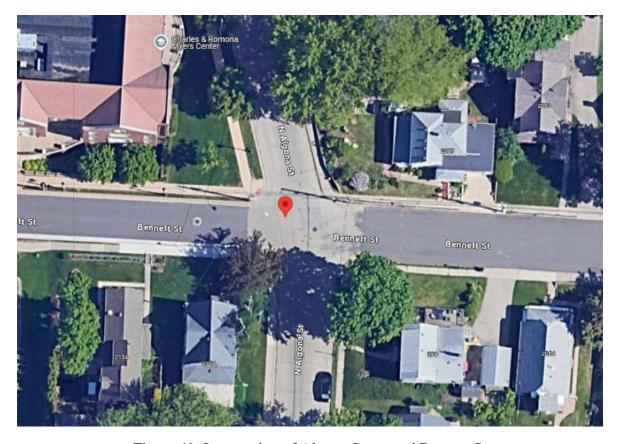
Figure 49: Intersection of Algona Street and Bennett Street

This site has a medium PCR level for KAB crashes, indicating the need for immediate attention and potential countermeasures. It is a four-legged, undivided, low speed, partial stop controlled intersection (Google Maps Link). The area is predominantly residential. The intersection features well-defined curbs, curb ramps, and sidewalks. Overhead lighting is present at the intersection and the pavement is in good condition. There are no marked crosswalks present.

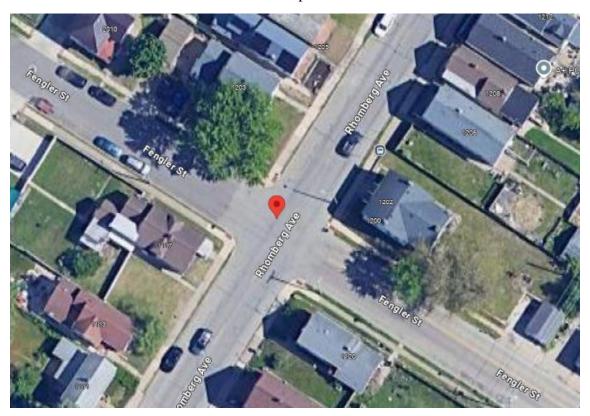
Figure 50: Intersection of Fengler Street and Rhomberg Avenue

This site has a medium PCR level for KAB crashes, indicating the need for immediate attention and potential countermeasures. It is a four-legged, undivided, low speed, partial stop controlled intersection located in a predominantly residential area (<u>Google Maps Link</u>). The intersection has well-defined curbs, curb ramps, and sidewalks, along with overhead lighting. The pavement is in good condition. There are no marked crosswalks present.

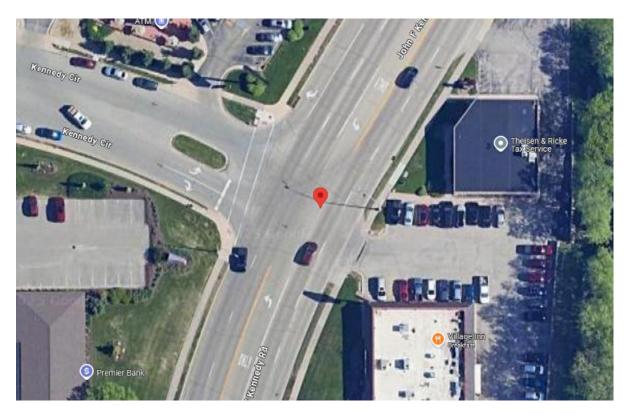
Figure 52: Intersection of Kennedy Road and Kennedy Circle

This site has a medium PCR level for KAB crashes, indicating the need for immediate attention and potential countermeasures. It is a four-legged, divided, low speed, partial stop controlled intersection located in a predominantly commercial area (<u>Google Maps Link</u>). The intersection has well-defined curbs, curb cuts, and sidewalks, along with overhead lighting. The pavement is in good condition. There are crosswalks present only on one side of the intersection.

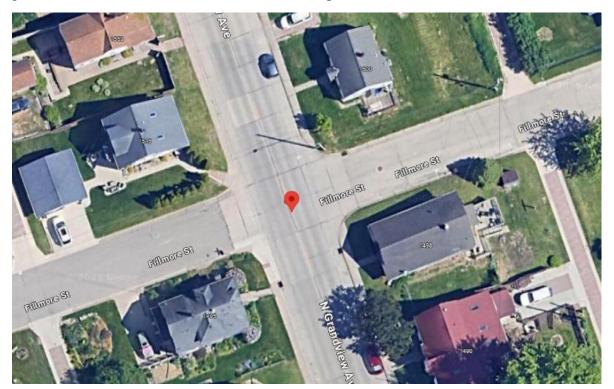
Figure 58: Intersection of Fillmore Street and Grandview Avenue

This site has a medium PCR level for KAB crashes, indicating the need for immediate attention and potential countermeasures. It is a four-legged, undivided, low speed, partial stop controlled intersection (Google Maps Link). The area is predominantly residential. The intersection has well-defined curbs, curb cuts, and sidewalks. Overhead lighting is present, and the pavement is in good condition. There are no marked crosswalks present.

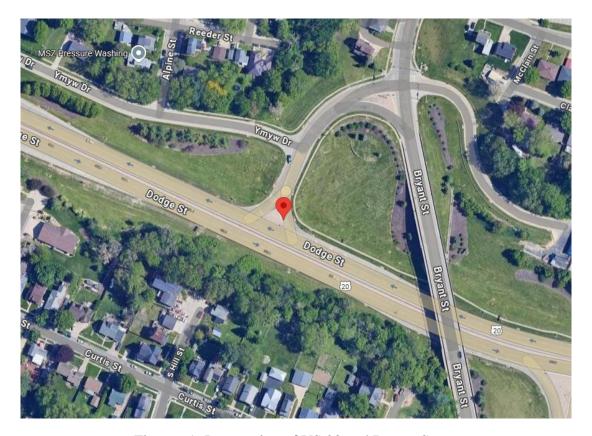
Figure 61: Intersection of US 20 and Bryant Street

This site is a three-legged, divided, moderate speed, partial stop controlled intersection (Google Maps Link). It has a high PCR level for KABCO crashes, indicating the need for immediate attention and potential countermeasures. The intersection is surrounded by residential areas. However, it lacks well-defined curbs and curb ramps as it is more of an interchange configuration, and only a partial sidewalk is present. Overhead lighting is present at the intersection, and the pavement is in good condition.

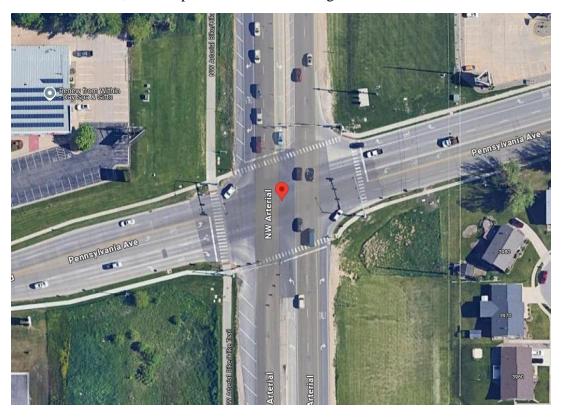
Figure 63: Intersection of Northwest Arterial and Pennsylvania Avenue

This site is a four-legged, divided, low speed, signalized intersection (<u>Google Maps Link</u>). It has a high PCR level for KABCO crashes, indicating the need for immediate attention and potential countermeasures. The area comprises a mix of different land uses. The intersection features well-defined curbs along the minor road, curb cuts, sidewalks, marked crosswalks, and pedestrian signals. It is illuminated, and the pavement condition is good.

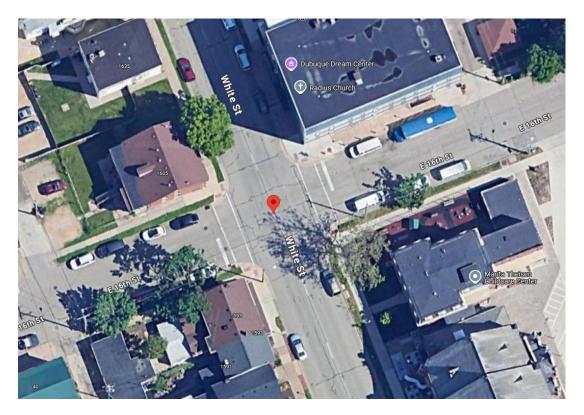
Figure 65: Intersection of East 16th Street and White Street

This site is a four-legged, undivided, low speed, partial stop controlled intersection (Google Maps Link). It has a low PCR level for KAB crashes but a high PCR level for KABCO crashes, indicating the need for attention and potential countermeasures. The area includes a mix of commercial and residential land uses. The intersection features well-defined curbs, curb ramps, sidewalks, and overhead lighting. The pavement is in good condition. While there are marked crosswalks on the minor road, the major road lacks them.

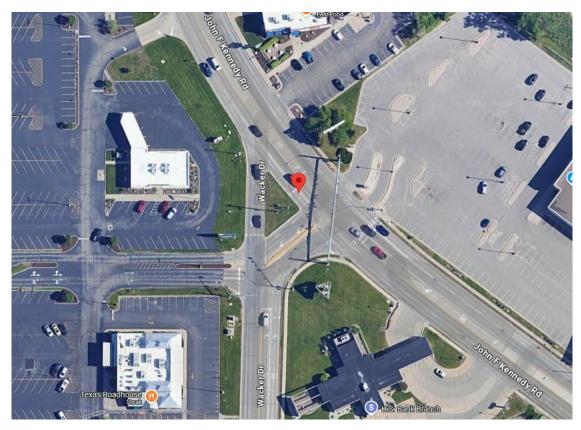
Figure 67: Intersection of Kennedy Road and Wacker Drive

This site is a four-legged, divided, low speed, signalized intersection (<u>Google Maps Link</u>). It has a high PCR level for KAB crashes, indicating the need for attention and potential countermeasures. The intersection is located in a predominantly commercial area and features well-defined curbs, curb ramps, sidewalks, and a marked crosswalk on one side of the intersection. The intersection is illuminated, and the pavement is in good condition.

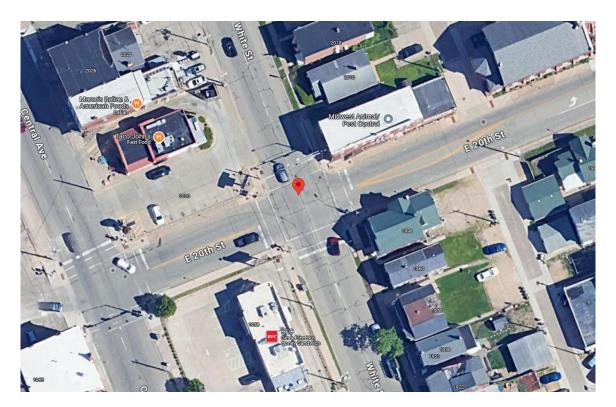
Figure 68: Intersection of East 20th Street and White Street

This site is a four-legged, undivided, low speed, signalized intersection (Google Maps Link). It has a high PCR level for KABCO crashes, indicating the need for attention and potential countermeasures. The intersection is located in a mixed-use area with both commercial and residential properties. It features well-defined curbs, curb ramps, sidewalks, and marked crosswalks on all approaches, enhancing pedestrian accessibility. Overhead lighting is present, and the pavement is in good condition.

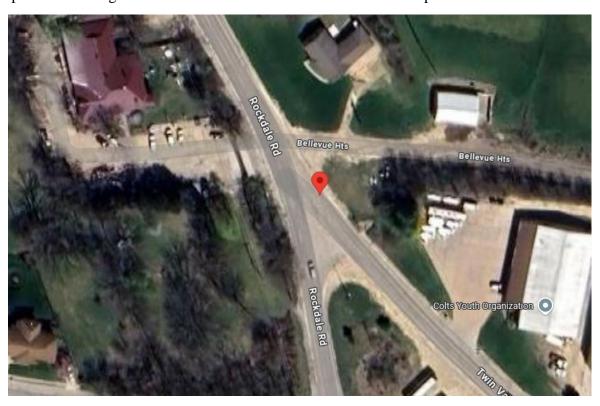
Figure 69: Intersection of Bellevue Road and Rockdale Road

This site is a three-legged, undivided, low speed, partial stop controlled intersection (Google Maps Link). It has a high PCR level for KABCO crashes, indicating the need for immediate attention and potential countermeasures. The area is predominantly a low-traffic area. The intersection lacks well-defined curbs, curb ramps, and sidewalks. However, it is illuminated, and the pavement is in good condition. There are no marked crosswalks present.

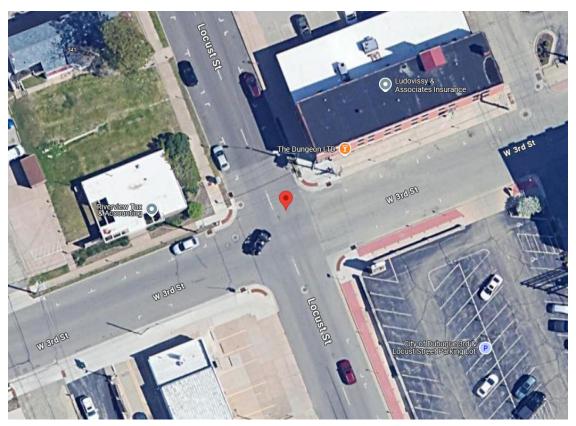
Figure 70: Intersection of Locust Street and West 3rd Street

This site is a four-legged, undivided, low speed, partial stop controlled intersection (Google Maps Link). It has a high PCR level for KABCO crashes, indicating the need for attention and potential countermeasures. The intersection is located in a predominantly commercial area and features well-defined curbs, curb ramps, and sidewalks. The intersection is illuminated, and the pavement is in good condition. There are no marked crosswalks at this location.

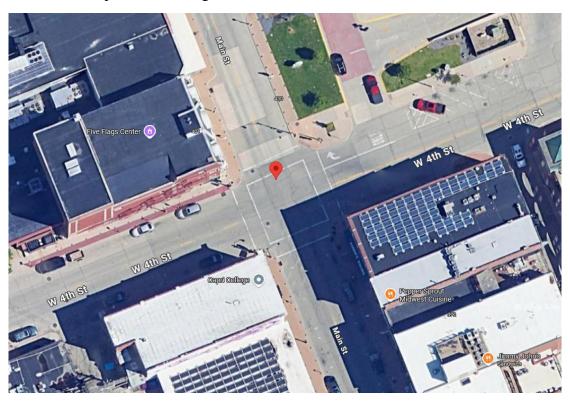
Figure 76: Intersection of Main Street and West 4th Street

This site is a four-legged, undivided, low speed, signalized intersection (<u>Google Maps Link</u>). It has a high PCR level for KABCO crashes, which warrants attention and potential countermeasures. The intersection is located in a predominantly commercial area and features well-defined curbs, curb ramps, sidewalks, marked crosswalks, and pedestrian signals. It is illuminated, and the pavement is in good condition.

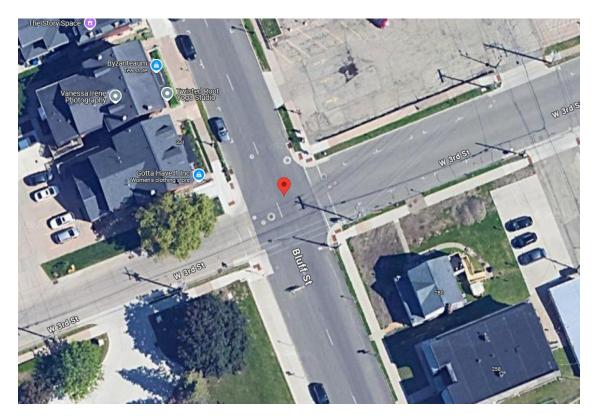
Figure 77: Intersection of Bluff Street and West 3rd Street

This site is a four-legged, undivided, low speed, partial stop controlled intersection (Google Maps Link). It has a high PCR level for KABCO crashes, indicating the need for attention and potential countermeasures. The intersection is located in a mixed-use area with both commercial and residential and features well-defined curbs, curb ramps, sidewalks, and overhead lighting. The pavement is in good condition. Marked crosswalks are available on the minor road, while the major road lacks pedestrian them.

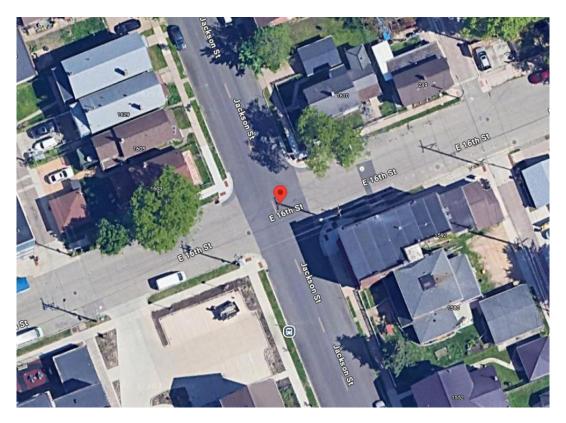
Figure 80: Intersection of East 16th Street and Jackson Street

This site is a four-legged, undivided, low speed, partial stop controlled intersection (Google Maps Link). It has a high PCR level for KABCO crashes, indicating the need for attention and potential countermeasures. The intersection is located in a predominantly residential area and has a childcare facility nearby. It features well-defined curbs, curb ramps, and sidewalks. Although overhead lighting is present and the pavement is in good condition, there are no marked crosswalks.

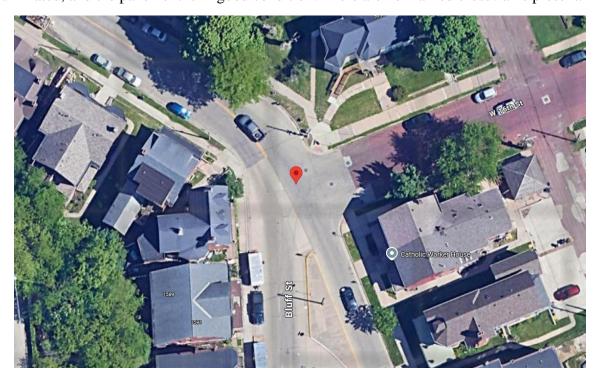
Figure 81: Intersection of Locust Street, Bluff Street and West 16th Street

This site is a four-legged, undivided, low speed, partial stop controlled intersection (Google Maps Link). It has a high PCR level for KABCO crashes, indicating the need for immediate attention and potential countermeasures. The intersection is located in a predominantly residential area and features well-defined curbs, curb ramps, and sidewalks. The intersection is illuminated, and the pavement is in good condition. There are no marked crosswalks present.

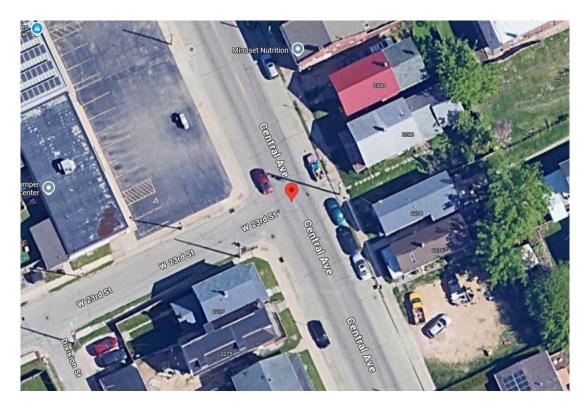
Figure 84: Intersection of Central Avenue and West 23rd Street

This site is a three-legged, undivided, low speed, partial stop controlled intersection (Google Maps Link). It has a high PCR level for KABCO crashes, indicating the need for immediate attention and potential countermeasures. The intersection is located in a mixed-use area containing both commercial and residential and features well-defined curbs, curb ramps, and sidewalks. Overhead lighting is present, and the pavement is in good condition. There are no marked crosswalks.

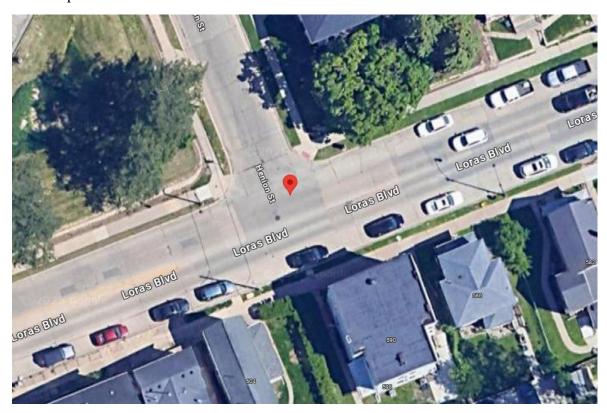
Figure 85: Intersection of Loras Boulevard and Henion Street

This site is a three-legged, undivided, low speed, partial stop controlled intersection (Google Maps Link). It has a high PCR level for KABCO crashes, indicating the need for attention and potential countermeasures. The intersection is located in a predominantly commercial area and features well-defined curbs, curb ramps, and sidewalks to support pedestrian safety. The intersection is illuminated, and the pavement is in good condition. There are no marked crosswalks present.

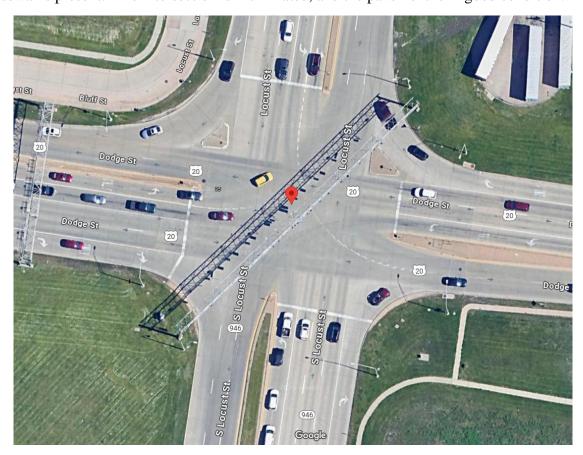
Figure 88: Intersection of US 20 and Locust Street

This site is a four-legged, semi-divided, low speed, signalized intersection (<u>Google Maps Link</u>). It has a high PCR level for KABCO crashes, indicating the need for attention and potential countermeasures. The intersection is located in a mixed-use area of commercial and undeveloped land and features well-defined curbs but lacks curb ramps and sidewalks. There are no marked crosswalks present. The intersection is illuminated, and the pavement is in good condition.

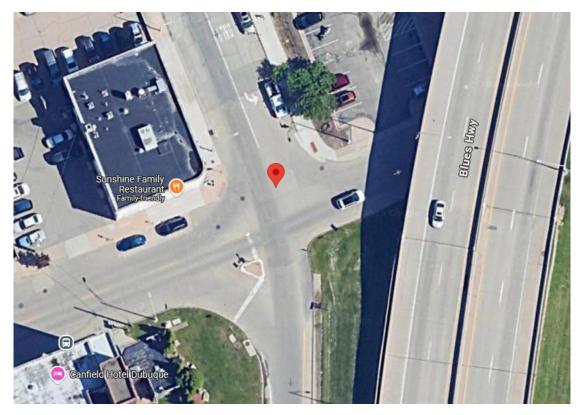
Figure 92: Intersection of Central Avenue and 4th Street

attention and potential countermeasures. The intersection is located in a predominantly commercial area and features well-defined curbs, curb ramps, and sidewalks. Overhead lighting is present at the intersection, and the pavement is in good condition. There are no marked crosswalks present.

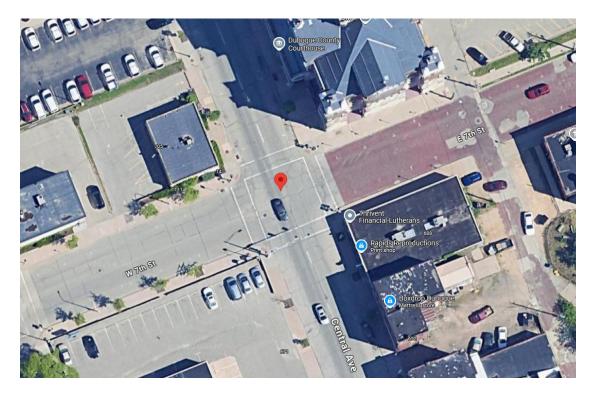
Figure 97: Intersection of Central Avenue and West 7th Street

This site is a four-legged, undivided, low speed, signalized intersection (<u>Google Maps Link</u>). It has a high PCR level for KABCO crashes, indicating the need for attention and potential countermeasures. The intersection is located in a predominantly commercial area and features well-defined curbs, curb ramps, sidewalks, and marked crosswalks with pedestrian signals. The intersection is illuminated, and the pavement is in good condition.

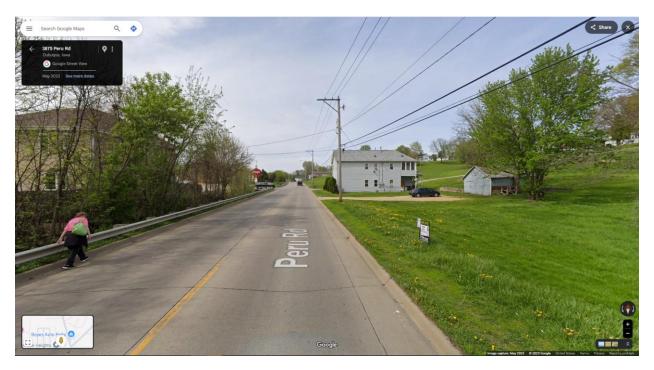
Figure 234: Pedestrian Activity and Worn Path Along Peru Road Between Walker Street and Toledo Street (Image Source: Google)
