# Appendix B: RPA Region Sites

This section provides a review of sites identified as candidates for safety improvements in the overall RPA region. These sites were identified as having High ( $\geq 0.25$ ) KAB or KABCO ( $\geq 1.0$ ) PCR values. [Note: KABCO is defined as K = fatal, A = Incapacitating injury, B = minor injury, C = possible injury, O = property damage only.] Based on the crash trends and existing features of these sites, potential safety countermeasures have been identified that can serve as a starting point for pursuing improvements.

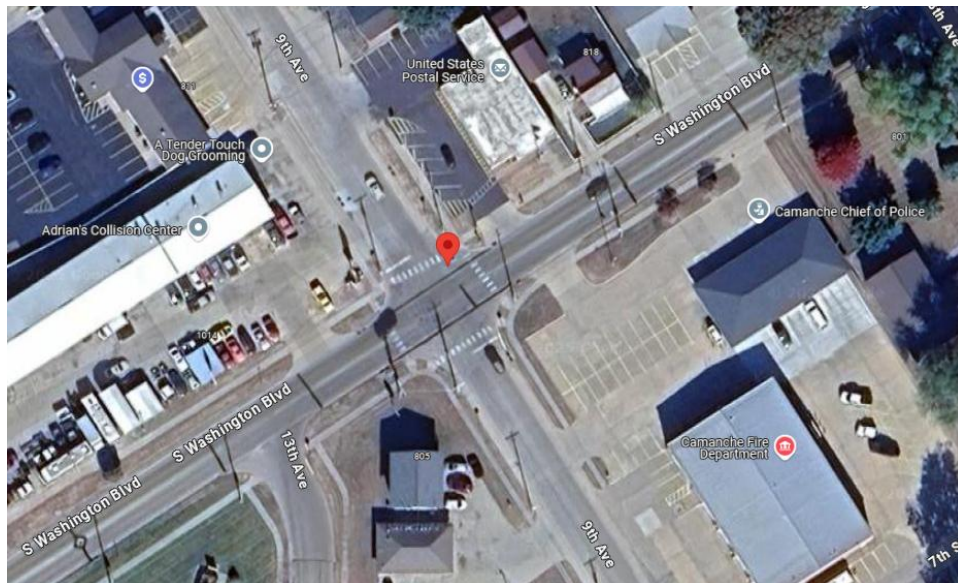
Figure 1: Intersection of 9th Avenue and Washington Boulevard

This site is a Four-legged, Undivided, Low Speed, Partial Stop Controlled intersection ([Google Map Link](#)). It has a medium PCR level for KAB crashes, indicating the need for immediate attention and potential countermeasures. The area surrounding the intersection is predominantly commercial, with well-defined curbs, curb ramps, and sidewalks. Overhead lighting is present at the intersection, improving nighttime visibility. The road pavement is in good condition, and pedestrian facilities, including marked crosswalks and pedestrian crossing signs, are available for enhanced safety.

The primary contributing factor to KAB crashes is failure to yield right-of-way (FTYROW) from stop signs, which led to broadside crashes at the intersection. The contributing factors for CO

Based on the crash history, contributing factors, and performance data, the following safety improvements are recommended along with their associated cost levels:

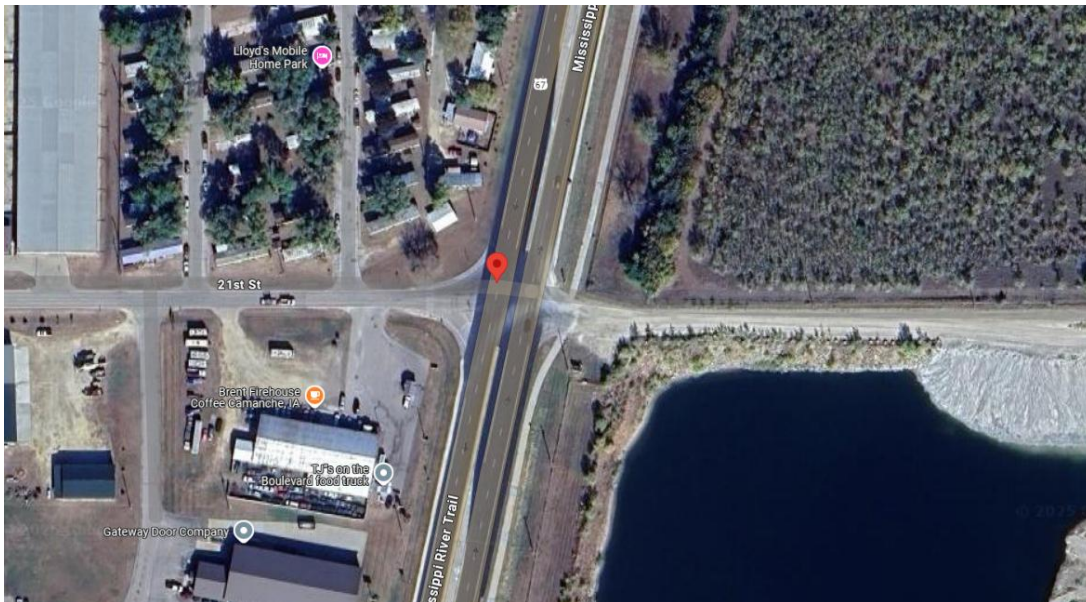
Figure 2: Intersection of 21<sup>st</sup> Street and US 67/Washington Boulevard

This site is a Three-legged, Divided, Low Speed, Partial Stop Controlled intersection ([Google Map Link](#)). It has a medium PCR level for KAB crashes, indicating the need for immediate attention and potential countermeasures. The area surrounding the intersection consists of a mix of undeveloped, commercial, and residential land-use. A bike trail is located near the intersection, adding another dimension to potential conflict points. Overhead lighting is present but may not provide adequate lighting at night. The road pavement is in good condition, ensuring a stable driving surface.

The primary contributing factors to the KAB crashes include failure to yield to an emergency vehicle and losing control, both of which indicate a potential need for driver awareness and increased enforcement. The most significant contributing factor to the CO crashes is failure to yield right-of-way from a stop sign. The KAB Annual PCR for the intersection is 0.062624, indicating a medium severity level, while the KABCO Annual PCR is 0.725893, which is also categorized as medium. Based on statewide rankings, this intersection is ranked 1,535th for KAB crashes and 1,662nd for KABCO crashes out of 115,274 intersections statewide.

Based on the crash history, contributing factors, and performance data, the following safety improvements are recommended along with their associated cost levels:

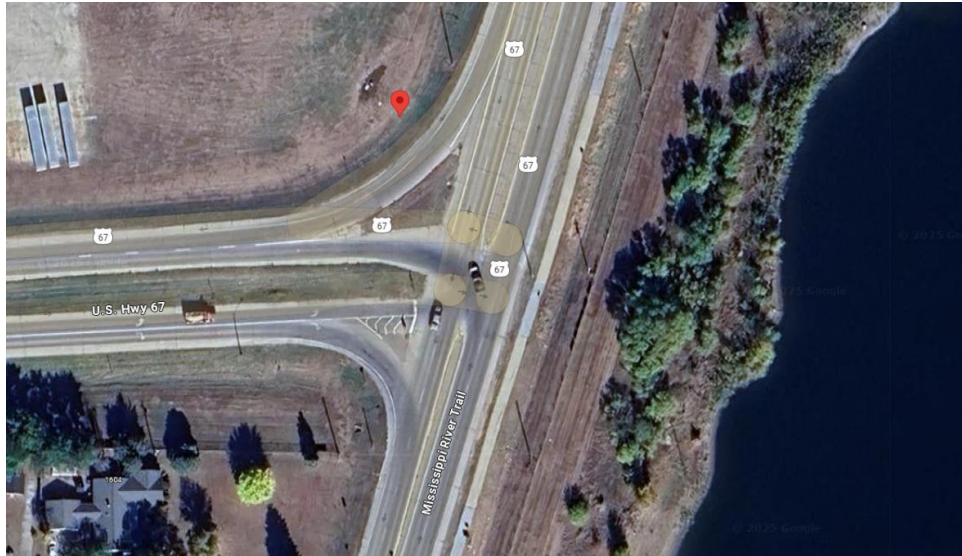
Figure 3: Intersection of US 67 and Mississippi River Trail

This site is a Three-legged, Divided, High Speed, Partial Stop Control intersection ([Google Map Link](#)). It has a medium PCR level for KABCO crashes, indicating the need for immediate attention and potential countermeasures. The surrounding area is largely undeveloped, with sidewalks present only one side of the north-south direction. The intersection lacks well-defined curbs, but overhead lighting is present, however, significant number of crashes occurred at night. The road pavement is in good condition. There are no marked crosswalks to facilitate pedestrian movement.

The primary contributing factors to crashes at this intersection include failure to yield the right-of-way (FTYROW) at stop signs and running stop signs. Other notable contributing factors include following too closely and running off the road, either to the left or straight. The KABCO Annual PCR for this intersection is 0.545969, classifying it as a medium-risk location. Statewide, the intersection is ranked 2,167th for KABCO crashes out of 115,274 intersections.

Based on the crash history, contributing factors, and performance data, the following safety improvements are recommended along with their associated cost levels:

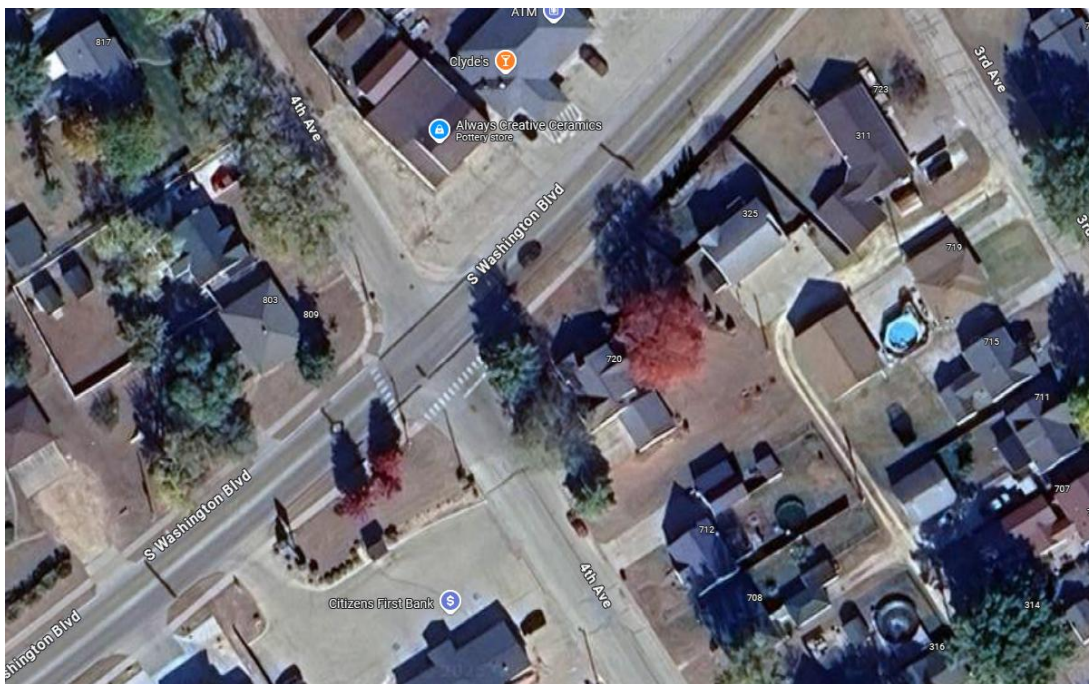
Figure 4: Intersection of Washington Boulevard and 4th Avenue (Image: Google Maps)

Washington Boulevard is the major roadway, while 4th Avenue is a lower-volume roadway with stop control on both approaches. The intersection does not have dedicated turn lanes, and lane markings appear in photographic sources as being faded in multiple areas. The presence of trees and store parking near the intersection obstructs sight distance at the stop-controlled approaches. Crosswalks exist on all approaches; however, only two are clearly painted.

This intersection has experienced multiple crashes, including one KAB crash and four CO crashes in the past few years. The primary manner of collision is broadside, with two crashes occurring between northbound and westbound vehicles, and one crash each involving southbound and eastbound vehicles, and southbound and westbound vehicles. The predominant contributing factor is failure to yield right-of-way (FTYROW) at stop signs. Additionally, a rear-end collision was reported on the eastbound approach, attributed to driver distraction (interior distraction). The KABCO PCR value at this intersection is 0.307382, indicating a moderate severity level. Speed data shows that 14.3 percent of vehicles exceed the speed limit by at least 10 mph on Washington Boulevard, raising concerns about speeding behavior at the location.

Based on the crash history at the site and existing roadway conditions, potential safety improvements that have been identified include:

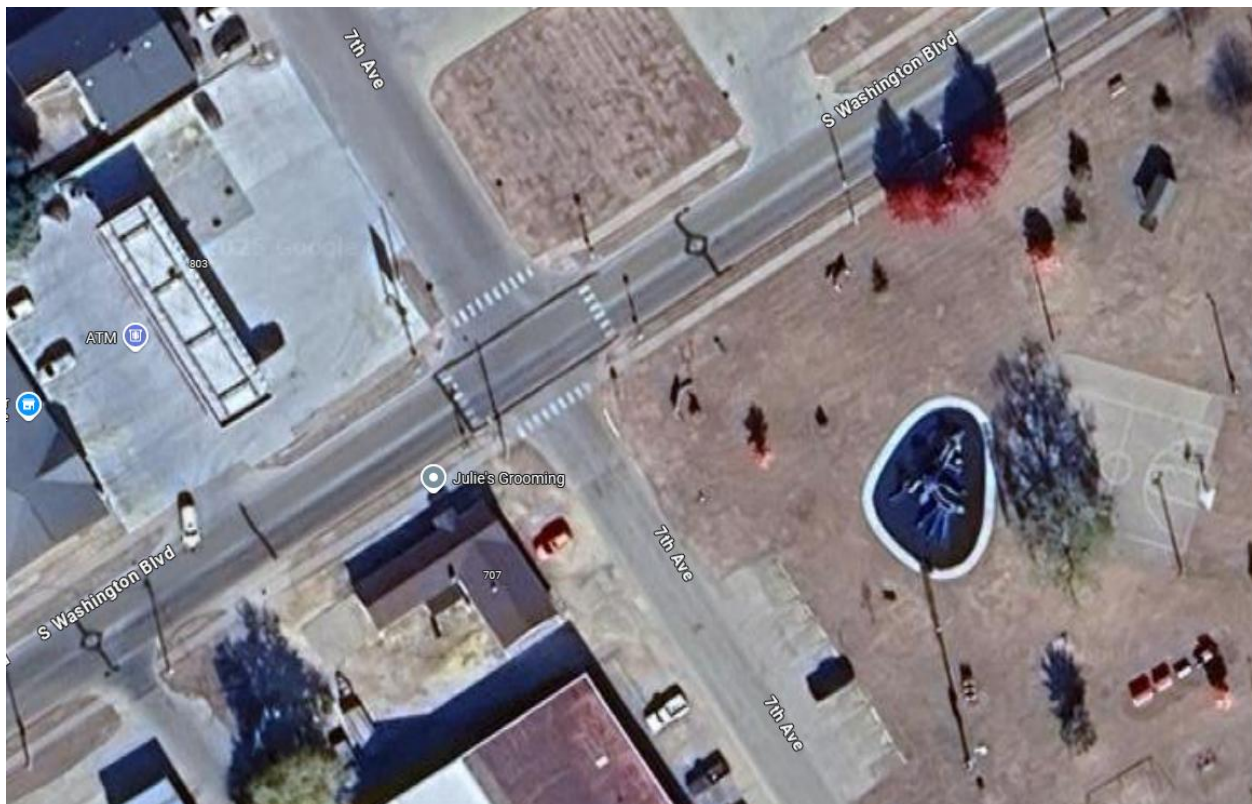
Figure 5: Intersection of Washington Boulevard and 7th Avenue (Image: Google Maps)

This site is classified as a four-leg, undivided, low-speed, partial stop intersection ([Google Map Link](#)). Washington Boulevard serves as the primary roadway, while 7th Avenue is a stop-controlled minor street. The intersection pavement markings and signage are in poor condition, particularly on the northbound (NB) and southbound (SB) approaches. Additionally, a gas station entrance is located very close to the intersection, which may contribute to increased traffic conflicts and maneuvering challenges.

This intersection has experienced multiple crash types, including one KAB crash and four CO crashes in recent years. The most common crash type is rear-end collisions, with one occurring on the northbound approach and another involving westbound and southbound vehicles, primarily due to drivers following too closely. A head-on collision between southbound and northbound vehicles was reported, attributed to failure to yield right-of-way (FTYROW) from a parked position. Additionally, a broadside crash occurred at the northbound and westbound approaches due to FTYROW from a stop sign, and a rear-to-rear collision involving southbound and eastbound vehicles was caused by improper backing from the eastbound approach. The

Based on the crash history and existing roadway conditions, potential safety improvements that have been identified include:

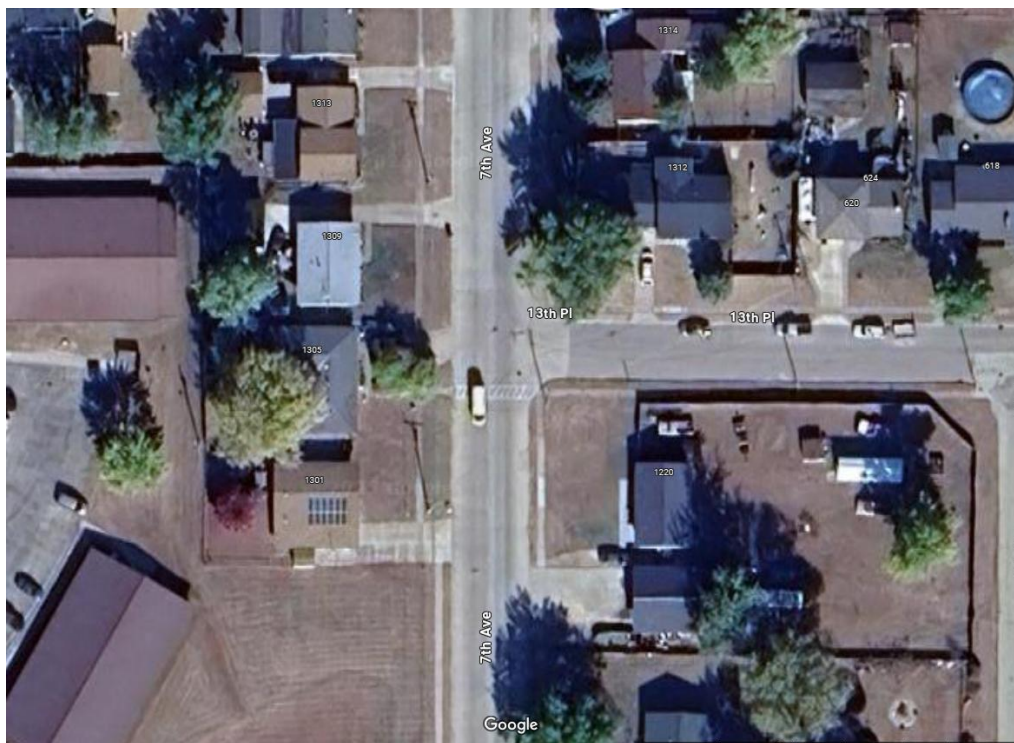
Figure 6: Intersection of 7th Avenue and 13th Place (Image: Google Maps)

This site is classified as a three-leg, undivided, low-speed, partial stop intersection ([Google Map Link](#)). 7th Avenue serves as the primary roadway, while 13th Place is a stop-controlled minor street. The intersection pavement markings and signage appear to be in poor condition in photographic data. On-street parking and multiple driveways are present near the intersection, potentially contributing to traffic conflicts.

Based on the crash history and existing roadway conditions, potential safety improvements that have been identified include:

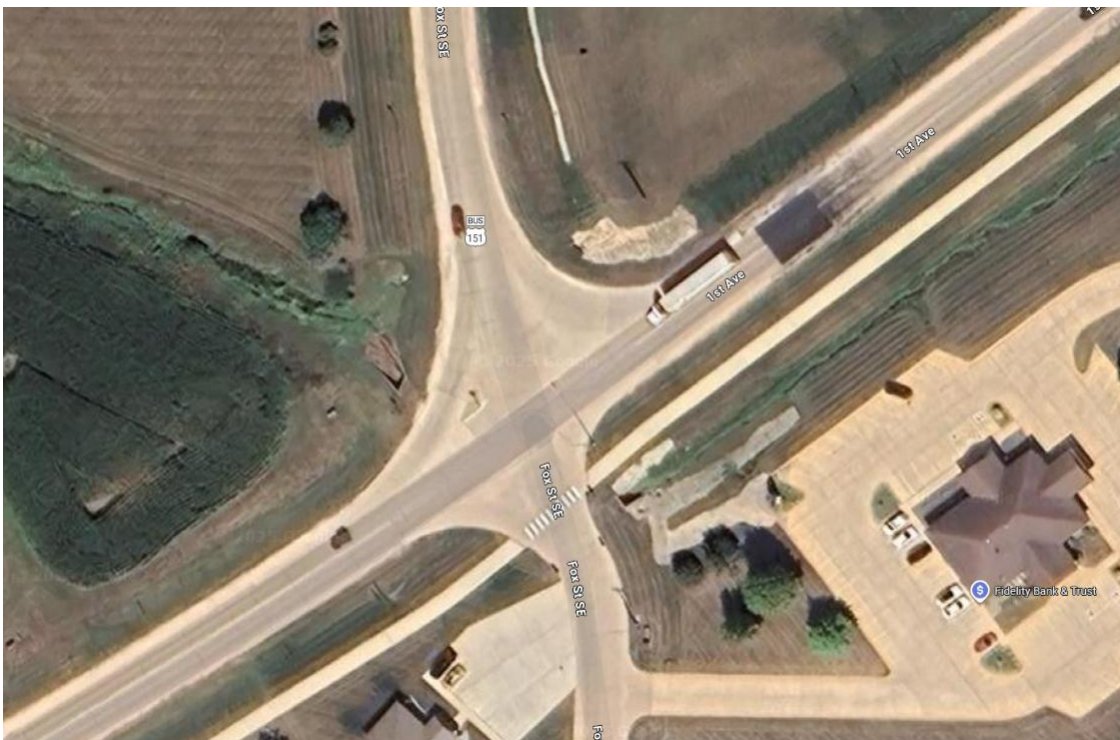
Figure 7: Intersection of 1st Avenue East, Fox Street Southeast, and Industrial Park Road  
(Image: Google Maps)

This site is classified as a four-leg, undivided, low-speed, partial stop intersection ([Google Map Link](#)). 1st Avenue East serves as the primary roadway, while Fox Street Southeast and Industrial Park Road is stop-controlled. The intersection lacks dedicated turn lanes, and pavement markings and signage are in poor condition based on observations from photographic data.

This intersection has experienced multiple crashes, including four CO crashes in recent years. The primary manner of collision includes broadside and rear-end crashes. Broadside crashes occurred at three different locations: one between southbound (SB) and westbound (WB) vehicles, another between southbound (SB) and eastbound (EB) vehicles, and a third between northbound (NB) and westbound (WB) vehicles, all attributed to failure to yield right-of-way (FTYROW) from a stop sign. A rear-end crash was also reported on the southbound (SB) approach, caused by following too closely. Additionally, one vehicle ran off the road to the right, though no specific contributing factors were recorded. The KABCO PCR value for this intersection is 0.232127, indicating a moderate severity level. Speed data shows that 10.4% of vehicles on the northbound (NB) approach exceed the speed limit by at least 5 mph, suggesting a potential speeding concern in that direction.

Based on the crash history and existing roadway conditions, potential safety improvements that have been identified include:

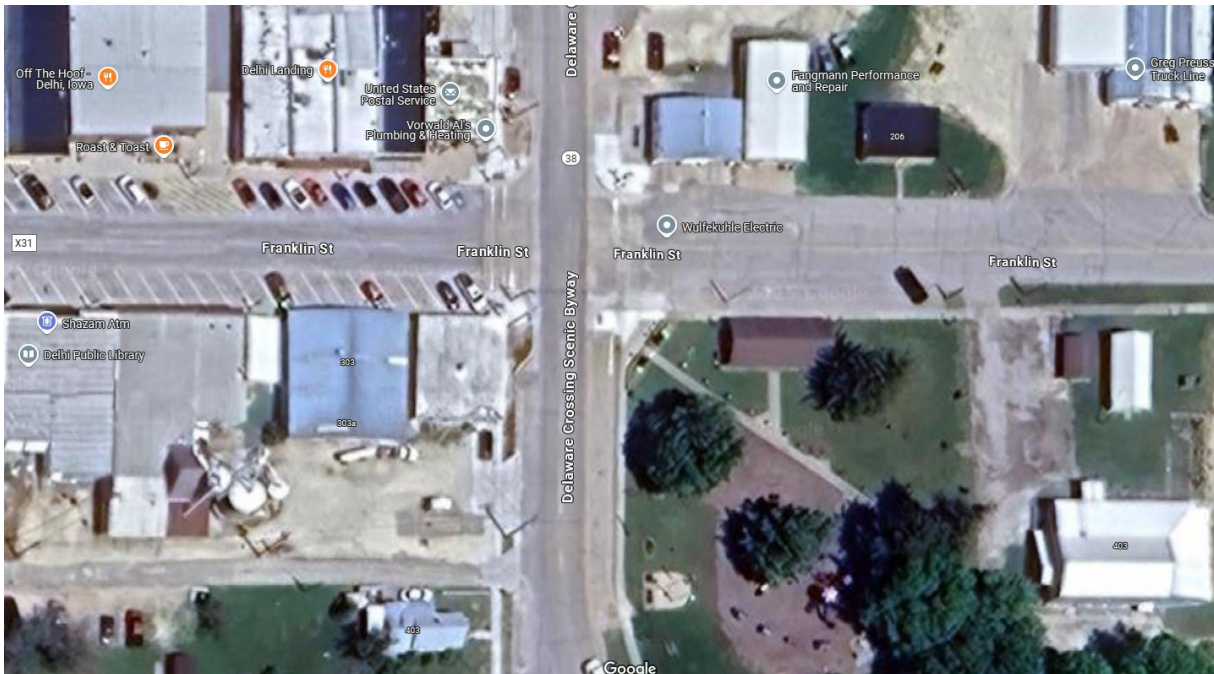
Figure 8: Intersection of Franklin Street and IA 38/3rd Street (Image: Google Maps)

This site is classified as a four-leg, undivided, low-speed, partial stop controlled intersection ([Google Map Link](#)). IA 38/3rd Street serves as the primary roadway, while Franklin Street is the stop-controlled minor street. On-street parking is present at the intersection, which may contribute to traffic conflicts. Pedestrian infrastructure at the intersection includes sidewalks, curb ramps and marked crosswalks on both Franklin Street approaches. Decorative street lamps are present in three of the four corners of the intersection to provide lighting.

This intersection has experienced four crashes, all classified as CO crashes in recent years. The primary manner of collision includes broadside, sideswipe, rear-to-rear, and rear-to-side crashes. A broadside crash occurred between eastbound (EB) and northbound (NB) vehicles, attributed to failure to yield right-of-way (FTYROW) from the stop sign on the eastbound approach, occurring under snowy conditions. A sideswipe crash was reported between southbound (SB) and northbound (NB) vehicles, caused by driver distraction, occurring under icy conditions. Additionally, a rear-to-rear collision involved a southbound (SB) vehicle and a backing vehicle, with the contributing factor classified as "other", while a rear-to-side crash occurred between eastbound (EB) and southbound (SB) vehicles, attributed to failure to keep in the proper lane. The KABCO PCR value for this intersection is 0.290834, indicating a moderate severity level. Speed data shows that 65.3% of vehicles on the northbound (NB) and southbound (SB) approaches exceed the speed limit by at least 10 mph+, suggesting a significant speeding issue on these approaches.

Based on the crash history and existing roadway conditions, potential safety improvements that have been identified include:

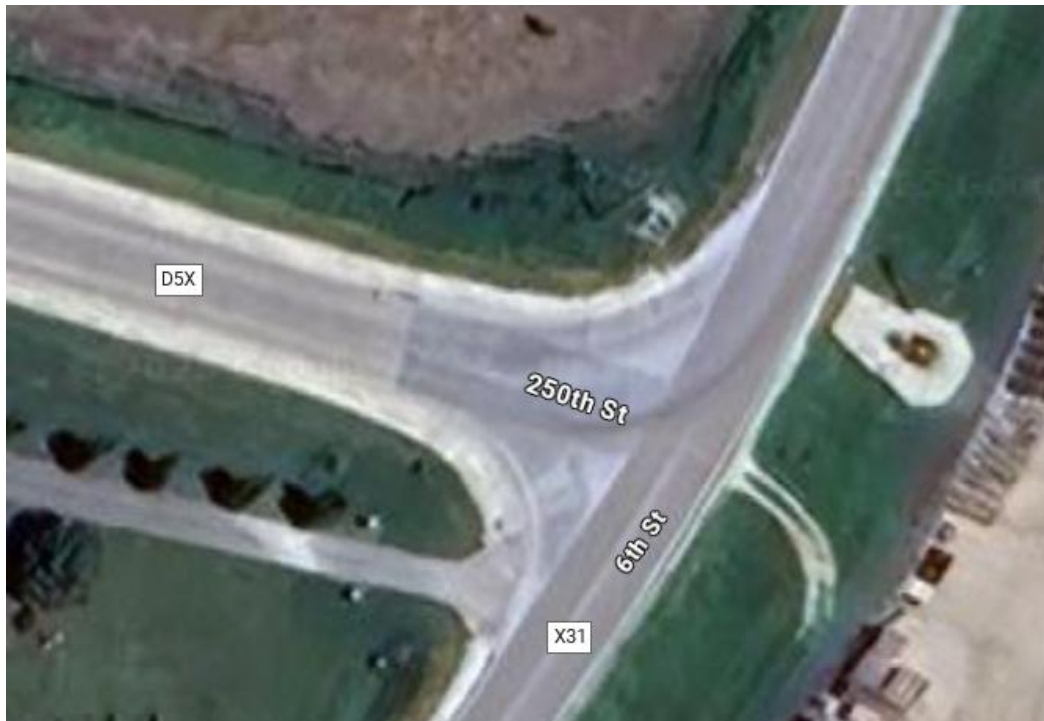
Figure 9: Intersection of D5X and X31 (Image: Google Maps)

This site, which was identified when meeting with the city as one of concern, is a three leg, partial stop controlled intersection ([Google Map Link](#)). X31 serves as the primary roadway, while D5X is the stop-controlled minor street. This is a tee intersection, and approach rumble strips are present on D5X. Overhead lighting is present, and it appears from photographic data that an oversized stop sign is in place.

This intersection has experienced a few crashes in recent years. One was KAB, while three were CO crashes. The primary manner of collision included single vehicle, angle and broadside. Three crashes were some form of FTYROW. It was indicated that the concern at this intersection is with drivers sliding through the intersection during wet/snowy weather. None of the four crashes was specifically cited as occurring in such conditions, although one was characterized as “other”.

Based on the crash history and existing roadway conditions, potential safety improvements that have been identified include:

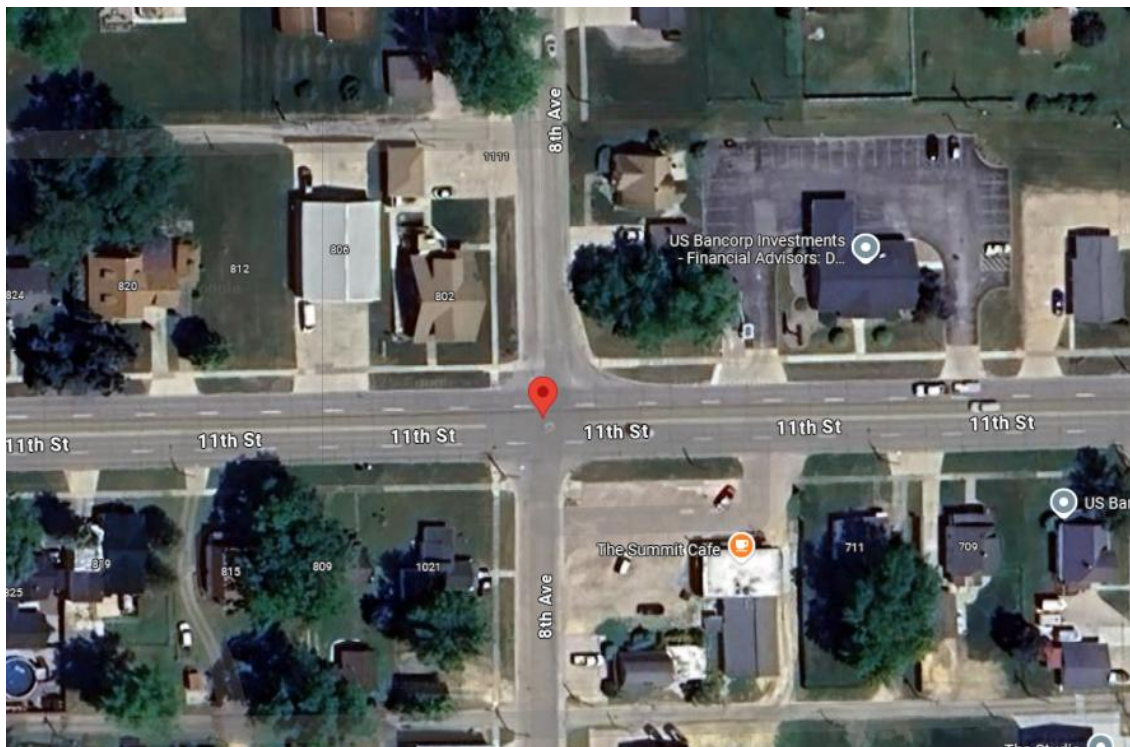
Figure 10: Intersection of 11<sup>th</sup> Street and 8<sup>th</sup> Avenue

This site is a Four-legged, Undivided, Low Speed, Partial Stop Controlled intersection ([Google Map Link](#)). It has a medium PCR level for KAB crashes, indicating the need for immediate attention and potential countermeasures. The intersection has curbs, curb ramps, and sidewalks, but lacks marked crosswalks for pedestrian safety. The road delineation and pavement are in good condition, ensuring clear visibility of the roadway.

The primary contributing factors to KABCO crashes are improper lane changing, failure to yield the right-of-way from a stop sign, and failure to yield the right-of-way while making a left turn. The KAB Annual PCR for the intersection is 0.168256, indicating a medium severity level, while the KABCO Annual PCR is 0.639871, which is considered high. Based on statewide rankings, this intersection is ranked 594th for KAB crashes and 1,889th for KABCO crashes out of 115,274 intersections statewide. While the overall crash frequency is moderate, the nature of these crashes highlights safety concerns are present.

Based on the crash history, contributing factors, and performance data, the following safety improvements are recommended along with their associated cost levels:

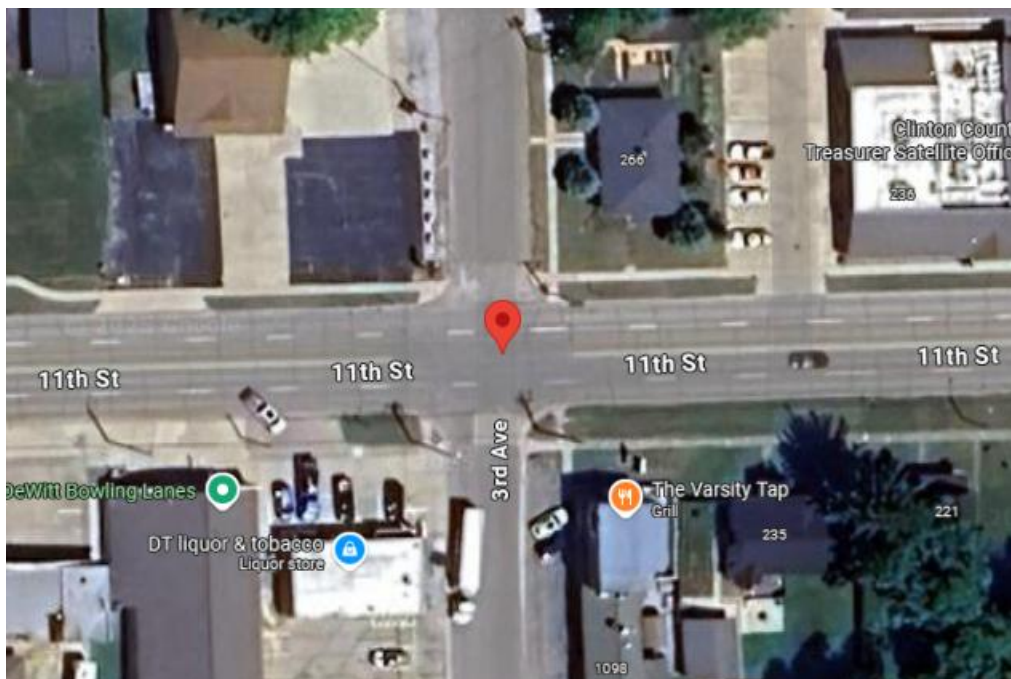
Figure 11: Intersection of 11<sup>th</sup> street and 3<sup>rd</sup> Avenue**Crash Summary**

This site has a medium PCR level for KABCO crashes, indicating the need for immediate attention and potential countermeasures. It is a Four-legged, Undivided, Low Speed, Partial Stop Controlled intersection ([Google Map Link](#)). The area is a mixture of a commercial and residential area. The intersection has well-defined curbs, curb ramps, and sidewalks. Overhead lighting is present at the intersection, enhancing nighttime visibility. The road pavement is in good condition. There are no marked crosswalks present.

Crash reports indicate that a total of 10 crashes have occurred at this intersection over a five-year period (2018-2022), including one KAB crash and nine CO crashes. The predominant manner of collision includes broadside (50%), angle-oncoming left turn (20%), sideswipe same direction (20%), and rear-end (10%). The primary contributing factors to the crashes at this intersection are failure to yield right-of-way (FTYROW) from stop signs and while making left turns, improper or erratic lane changes, driving too fast for conditions, and making improper turns. The KAB Annual PCR for the intersection is 0.031871, indicating a low severity level, while the KABCO Annual PCR is 0.908251, which is considered medium. Based on statewide rankings, this intersection is ranked 2,641st for KAB crashes and 1,309th for KABCO crashes out of 115,274 intersections statewide.

Based on the crash history, contributing factors, and performance data, the following safety improvements are recommended along with their associated cost levels:

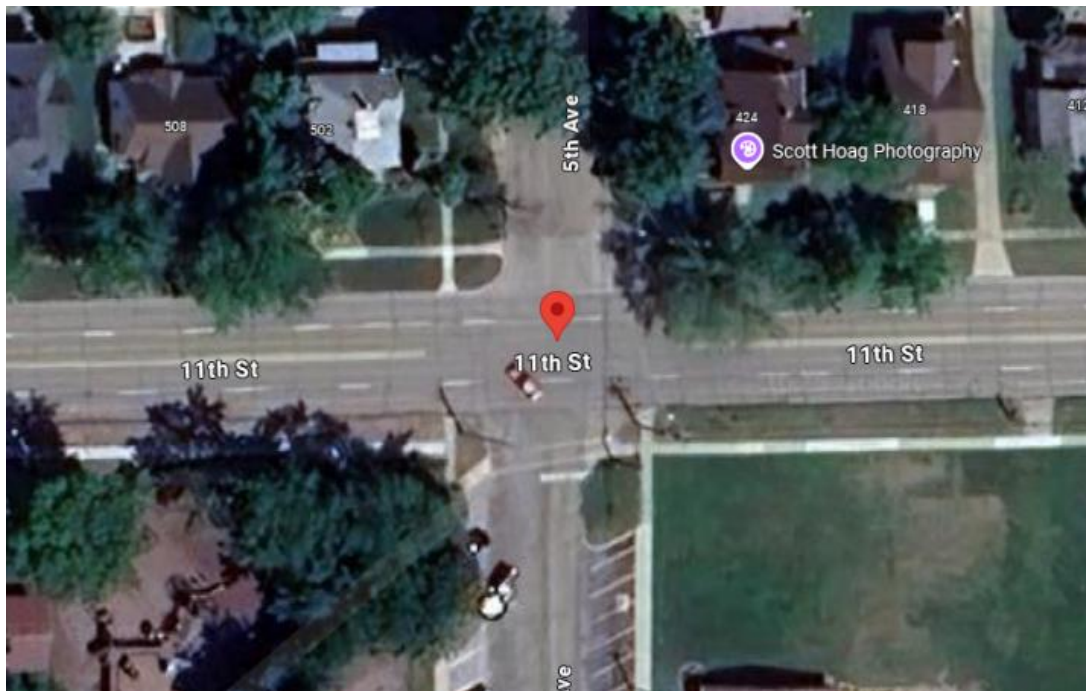
Figure 12: Intersection of 11<sup>th</sup> Street and 5<sup>th</sup> Avenue

This site is a Four-legged, Undivided, Low Speed, Partial Stop Controlled intersection in a predominantly residential area ([Google Maps Link](#)). It has a medium PCR level for KABCO crashes, indicating the need for immediate attention and potential countermeasures. The intersection has well-defined curbs, curb ramps, and sidewalks. Overhead lighting is present, improving nighttime visibility. The road pavement is in good condition. There is a marked crosswalk on one approach of the intersection, while the other three approaches lack crosswalks.

Crash data indicate that a total of 8 crashes have occurred at this intersection over a five-year period (2018-2022). The predominant manner of collision includes broadside (50%), sideswipe same direction (25%), angle-oncoming left turn (12.5%), and other. The primary contributing factors to the crashes at this intersection are failure to yield right-of-way (FTYROW) from stop signs and while making left turns, improper or erratic lane changes, driver distraction, and making improper turns. The KAB Annual PCR for the intersection is -0.012938, indicating no severe crashes, while the KABCO Annual PCR is 0.65976, which is considered medium. Based on statewide rankings, this intersection is ranked 109,913th for KAB crashes and 1,820th for KABCO crashes out of 115,274 intersections statewide.

Based on the crash history, contributing factors, and performance data, the following safety improvements are recommended along with their associated cost levels:

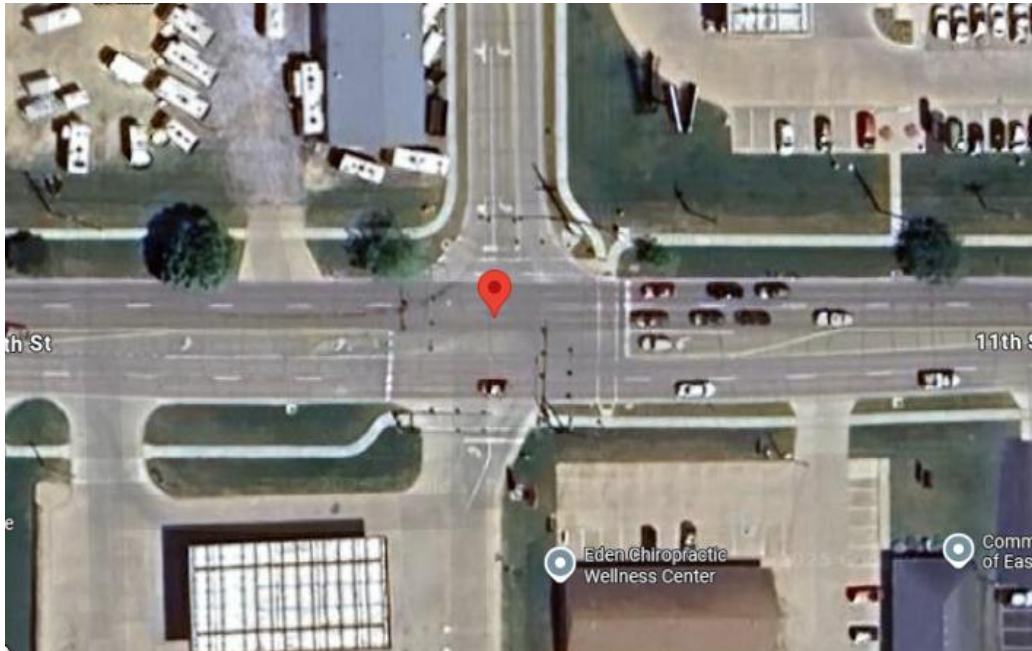
Figure 13: Intersection of 11<sup>th</sup> Street and Maynard Way

This site is a Four-legged, Undivided, Low Speed, signalized intersection ([Google Map Link](#)). It has a medium PCR level for KABCO crashes, indicating the need for immediate attention and potential countermeasures. The area is predominantly a commercial area. The intersection has well-defined curbs, curb ramps, and sidewalks. Overhead lighting is present at the intersection. The pavement is in good condition. Additionally, there are marked crosswalks present on three approaches of the intersection.

Crash data indicate that a total of 10 crashes have occurred at this intersection over a five-year period (2018-2022), with no KAB crashes. The predominant manner of collision includes broadside (40%), rear-end (40%), head-on (10%), and sideswipe (10%). The primary contributing factors to crashes at this intersection are running a traffic signal, driver distraction (both inattentive and adjusted), failure to keep in the proper lane, following too closely, and failure to yield right-of-way (FTYROW) from driveways. The KAB Annual PCR for the intersection is -0.036856, indicating no severity level, while the KABCO Annual PCR is 0.499686, which is considered medium. Based on statewide rankings, this intersection is ranked 112,780th for KAB crashes and 2,380th for KABCO crashes out of 115,274 intersections statewide.

Based on the crash history, contributing factors, and performance data, the following safety improvements are recommended along with their associated cost levels:

- Review signal timings and optimize signal timing all-red clearance interval (Low)
- Add crosswalk markings to approach where they are missing (Low)

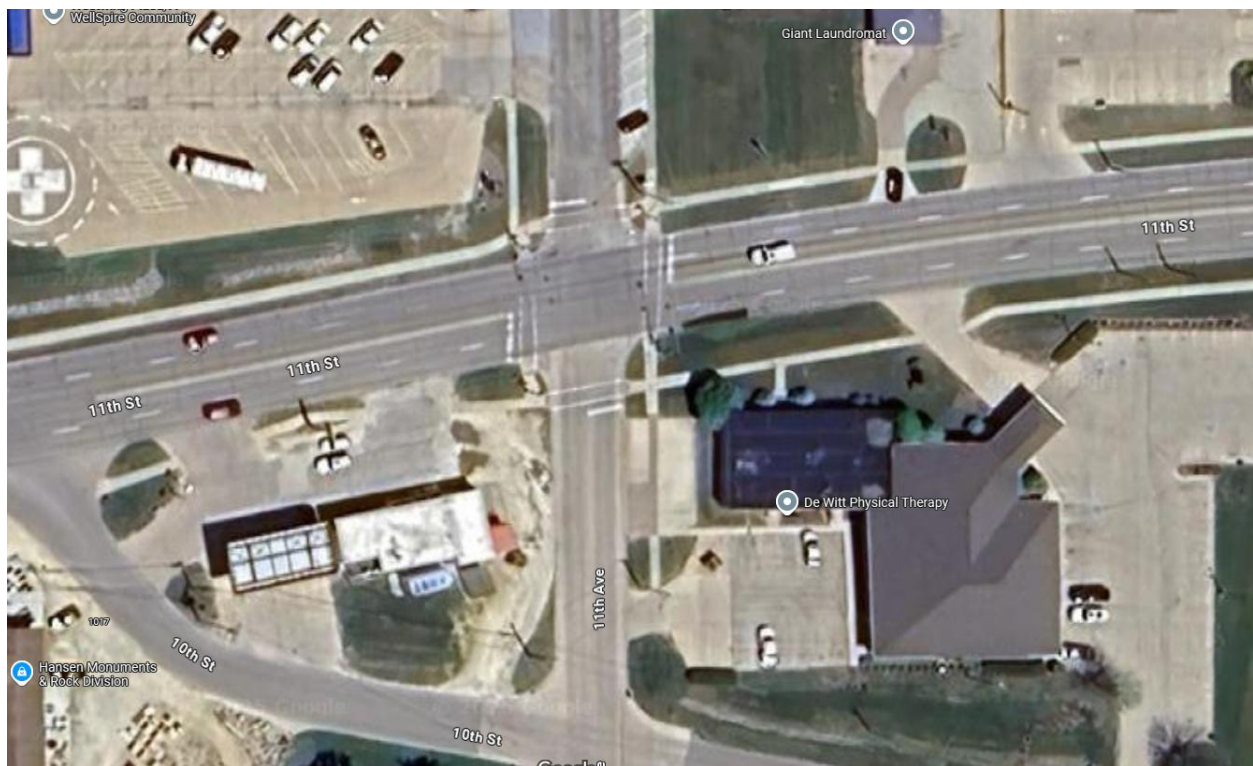
Figure 14: Intersection of 11th Street and 11th Avenue (Image: Google Maps)

This site is classified as a four-leg, undivided, low-speed, traffic-controlled intersection ([Google Map Link](#)). The intersection is signalized, but pavement markings and signage appear poor in photographic data, particularly on the northbound (NB) and southbound (SB) approaches. Driveways are present near the intersection on all approaches, which may contribute to additional traffic conflicts.

This intersection has experienced multiple crashes, including one KAB crash and six CO crashes in recent years. The primary manner of collision includes angle, broadside, head-on, and non-collision crashes. Angle crashes occurred on the eastbound (EB) and westbound (WB) approaches, attributed to failure to yield right-of-way (FTYROW) while making a left turn, with one westbound driver operating the vehicle in a reckless or negligent manner. Broadside crashes were reported at two locations: one between northbound (NB) and eastbound (EB) vehicles, and another between westbound (WB) and northbound (NB) vehicles, both due to eastbound drivers running the traffic signal. A head-on collision occurred between westbound (WB) and eastbound

(EB) vehicles, caused by failure to yield while making a left turn. Additionally, a non-collision incident involved an eastbound (EB) vehicle running off the road to the right on a wet surface. The KABCO PCR value for this intersection is 0.218069, indicating a moderate severity level. Speed data shows that 8.3% of vehicles on the northbound (NB) and southbound (SB) approaches, and 3.9% on the eastbound (EB) and westbound (WB) approaches, exceed the speed limit by at least 10 mph, suggesting a mild speeding concern on all approaches.

Based on the crash history and existing roadway conditions, potential safety improvements that have been identified include:

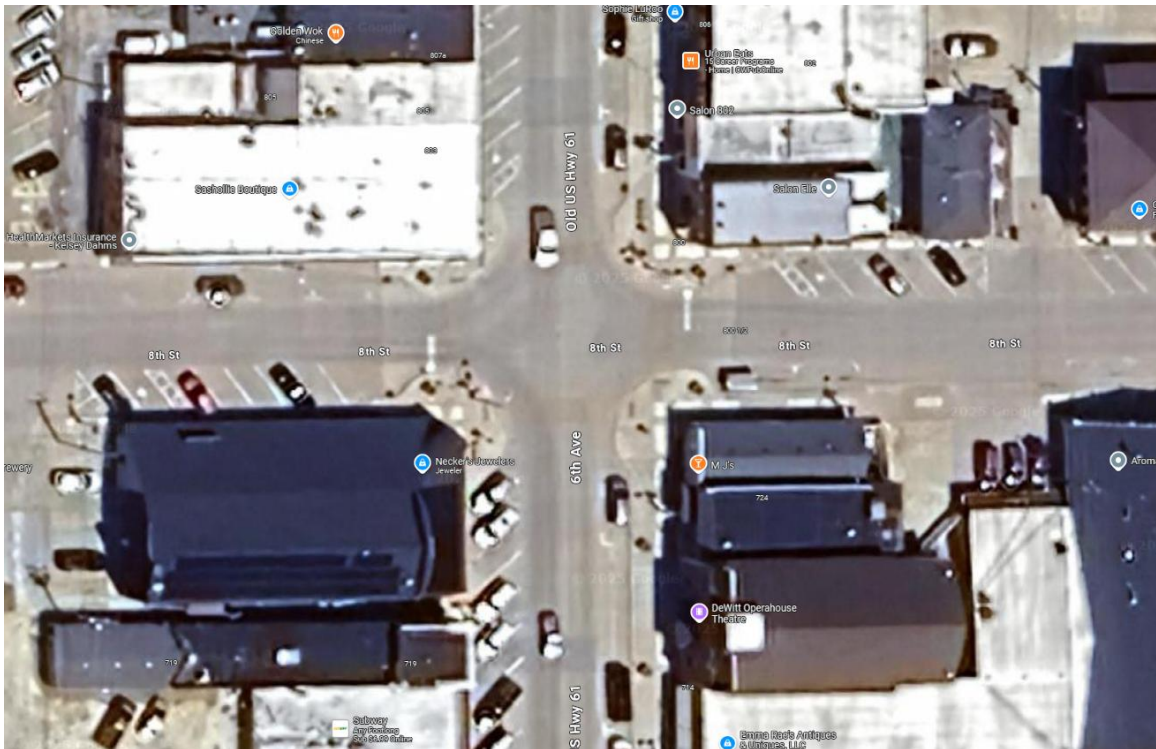
Figure 15: Intersection of 6th Avenue and 8th Street (Image: Google Maps)

This site is a four-leg, undivided, low-speed, partial stop-controlled intersection ([Google Map Link](#)). 6th Avenue serves as the primary roadway, while 8th Street is stop-controlled on both approaches. The intersection lacks dedicated turn lanes, and pavement markings for stop bars and lane configurations are in poor condition based on photographic data. Additionally, on-street parking is present on all approaches, which may contribute to sight distance issues and traffic conflicts.

This intersection has experienced multiple crashes, including one KAB crash and four CO crashes in recent years. The primary manners of collision include rear-to-side, sideswipe, rear-end, and backing incidents. Rear-to-side collisions involved northbound (NB) and southbound (SB) vehicles, as well as northbound (NB) and eastbound (EB) vehicles, with contributing factors such as failure to yield right-of-way (FTYROW) and improper backing, including incidents with parked vehicles, one of which occurred under wet roadway conditions. A sideswipe collision occurred on the westbound (WB) approach during a vehicle's attempt to enter a parked position. A rear-end collision on the northbound (NB) approach was attributed to driver distraction due to exterior factors. Additionally, a backing incident between westbound (WB) and eastbound (EB) vehicles involved a legally parked vehicle under icy or frosty conditions. The KABCO PCR value for this intersection is 0.251327, indicating a moderate severity level.

Based on the crash history and existing roadway conditions, potential safety improvements that have been identified include:

- Investigate the parking layout near the intersection by conducting a parking study (low cost)
- Implement parking restrictions near the intersection if the parking study recommends this is an option (Low)

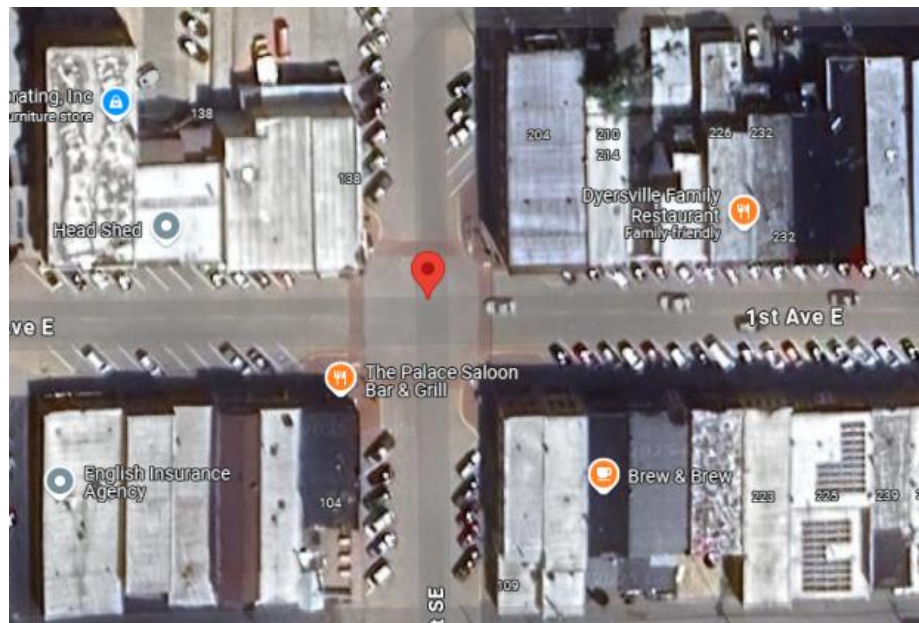
Figure 16: Intersection of 1<sup>st</sup> Avenue East and 2<sup>nd</sup> Street Northeast/Southeast

This site is a Four-legged, Undivided, Low Speed, Traffic Signal Controlled intersection ([Google Map Link](#)). It has a medium PCR level for KAB crashes, indicating the need for immediate attention and potential countermeasures. The area surrounding the intersection is predominantly commercial. The intersection has well-defined curbs, curb ramps, and sidewalks. Overhead lighting is present, and the road pavement appears to be in good condition. Additionally, there are marked crosswalks providing facilities for pedestrian safety, but no pedestrian signal is present at this intersection.

The primary contributing factors to KAB crashes at this intersection include failure to yield right-of-way to a pedestrian, while the cause of the second KAB crash is unknown. The predominant contributing factor for CO crashes is improper backing. The KAB Annual PCR for this intersection is 0.079564, while the KABCO Annual PCR is 0.428994, indicating a medium crash frequency. Based on statewide rankings, this intersection is ranked 1347th for KAB crashes and 2709th for KABCO crashes out of 115,274 intersections statewide, highlighting its status as a moderate-risk location.

Based on the crash history, contributing factors, and performance data, the following safety improvements are recommended along with their associated cost levels:

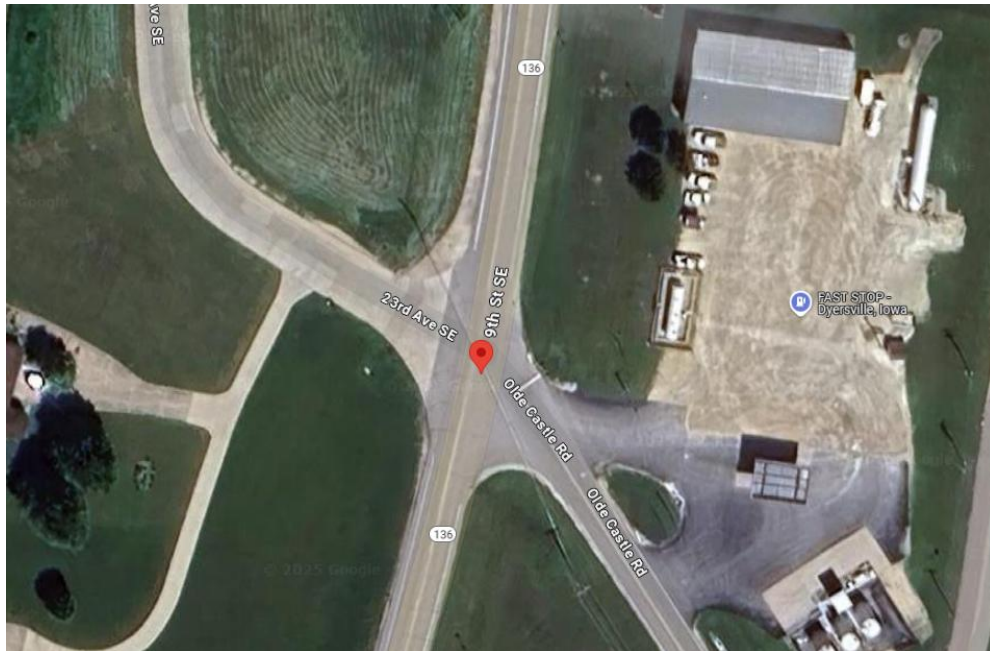
Figure 17: Intersection of 23rd Avenue Southeast and IA 136/9th Street Southeast

This site is a Four-legged, Undivided, Low Speed, Partial Stop Controlled intersection ([Google Map Link](#)). It has a medium PCR level for KAB crashes, indicating the need for potential countermeasures. The surrounding area is mostly undeveloped, with no curbs or sidewalks. There is no overhead lighting at the intersection, which may impact nighttime visibility. The road pavement is in good condition. Additionally, there are no marked crosswalks, and it is unclear if any pedestrian traffic is present in the area.

Based on the crash history, contributing factors, and performance data, the following safety improvements are recommended along with their associated cost levels:

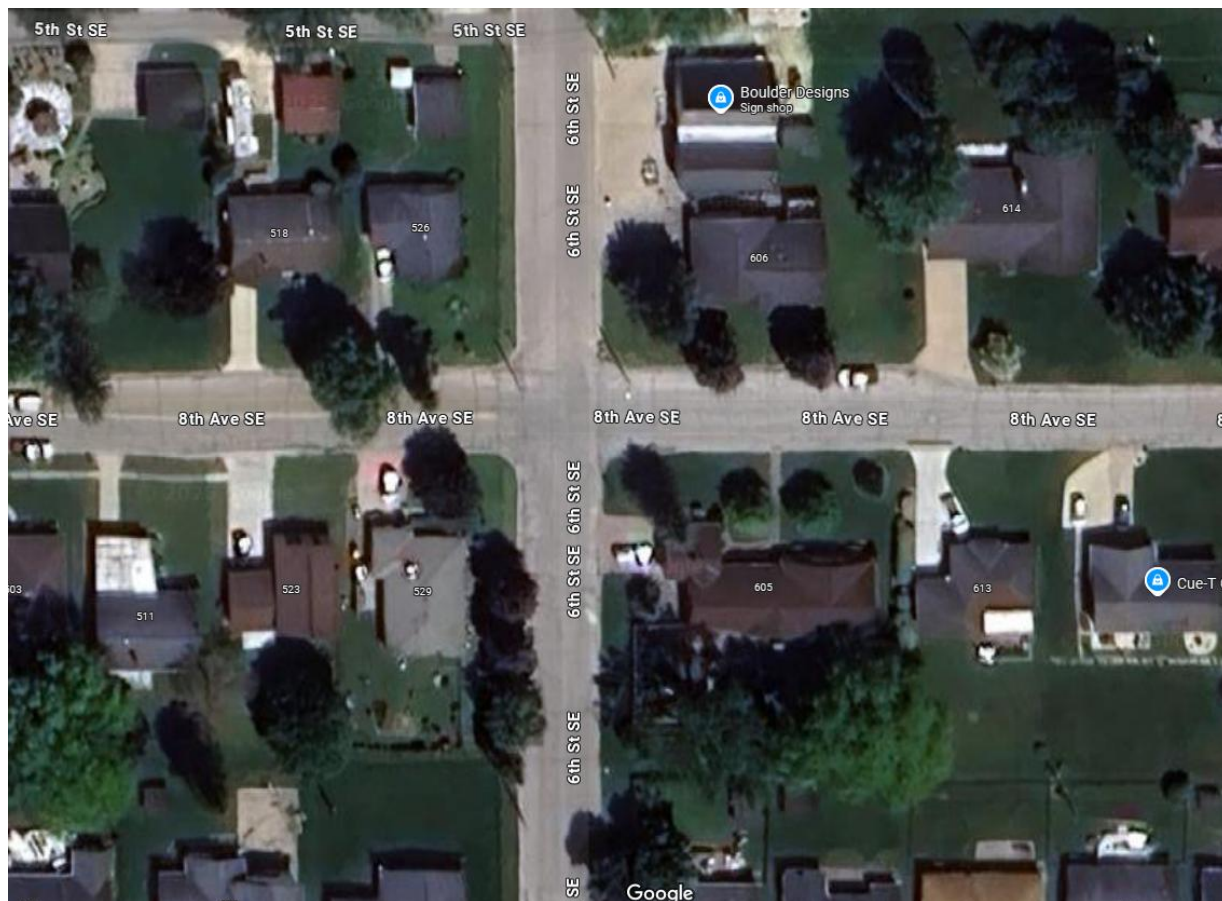
Figure 18: Intersection of 6th Street Southeast and 8th Avenue Southeast (Image: Google Maps)

This site is a four-leg, undivided, low-speed, partial stop intersection ([Google Map Link](#)). 8th Avenue Southeast serves as the primary roadway, while 6th Street Southeast is a stop-controlled minor roadway. The current markings and signage appear to be in poor condition based on photographic data.

Based on the crash history and existing roadway conditions, potential safety improvements have been identified:

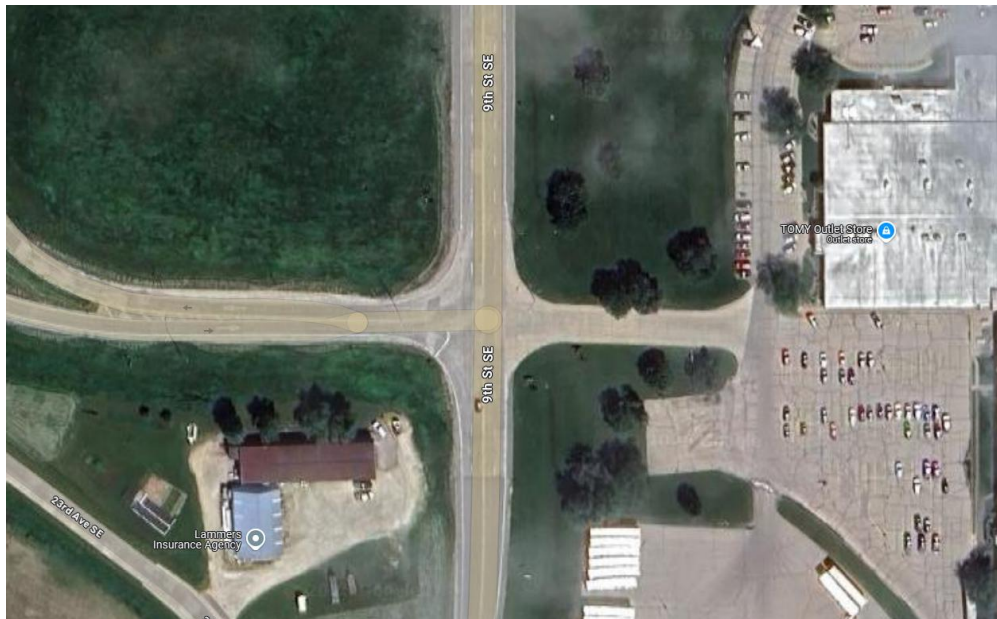
Figure 19: Intersection of IA 136/9th Street Southeast and US 20 eastbound ramps (Image: Google Maps)

This site is a four-leg, undivided, low-speed, partial stop intersection between IA 136/9th Street Southeast and the entrance and exit ramps of US 20 eastbound ([Google Map Link](#)). IA 136 serves as the primary roadway (north-south approaches), while the exist portion of the ramps (west approach) is stop-controlled. The fourth (east) approach of the intersection is a driveway serving a visitor center and factory for a toy manufacturer. This approach is also stop-controlled. No pedestrian facilities are present at the intersection

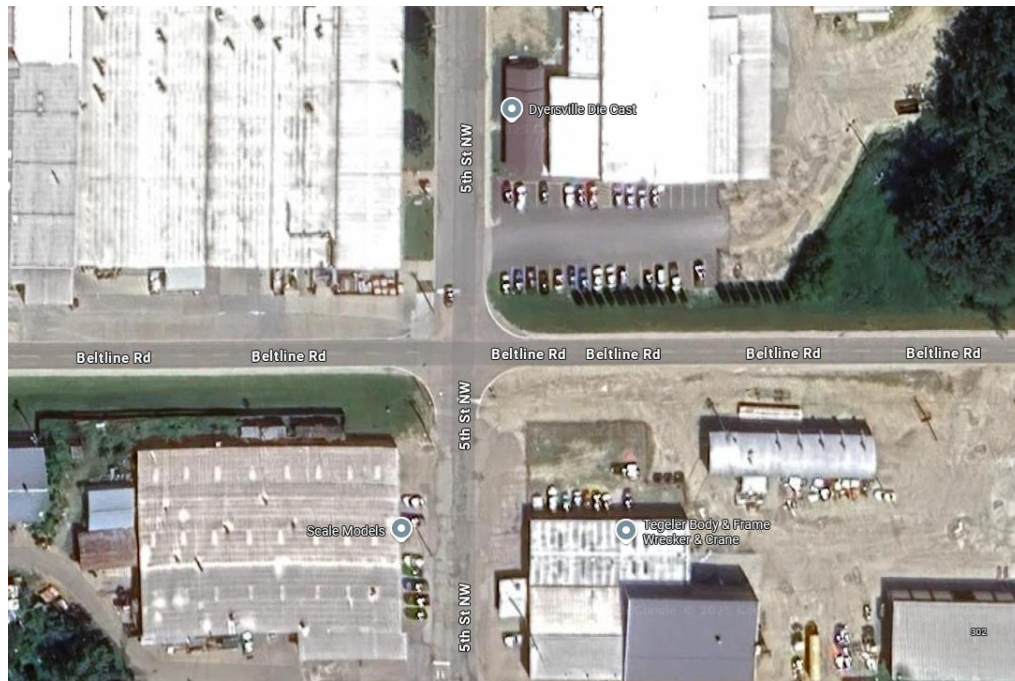
Figure 20: Intersection of 5th Street Northwest and Beltline Road (Image: Google Maps)

This site is a four-leg, undivided, low-speed, partial stop-controlled intersection ([Google Maps Link](#)). Beltline Road serves as the primary roadway, while 5th Street Northwest is a stop-controlled minor street. There are parking lot entrances near the intersection, which may contribute to potential traffic conflicts. No pedestrian facilities are present at the intersection.
