# Appendix B: RPA Region Sites

This section provides a review of sites identified as candidates for safety improvements in the overall RPA region. These sites were identified as having High ( $\geq 0.25$ ) KAB or KABCO ( $\geq 1.0$ ) PCR values. [Note: KABCO is defined as K = fatal, A = Incapacitating injury, B = minor injury, C = possible injury, O = property damage only.] Based on the crash trends and existing features of these sites, potential safety countermeasures have been identified that can serve as a starting point for pursuing improvements.

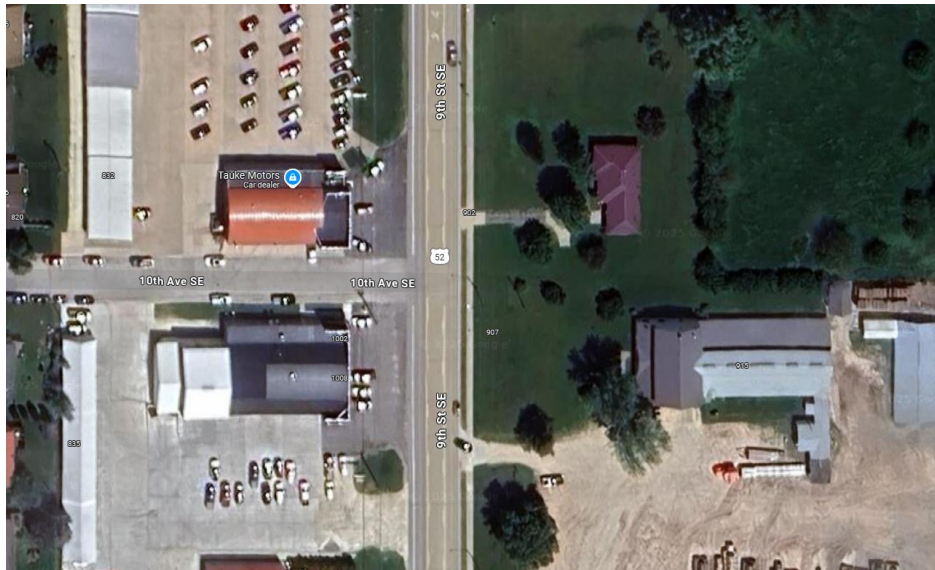
Figure 21: Intersection of 10th Avenue Southeast and 9th Street Southeast (Image: Google Maps)

This site is a three-leg, undivided, low-speed, partial stop intersection ([Google Maps Link](#)). 9th Street Southeast serves as the primary roadway, while 10th Avenue Southeast is a stop-controlled minor roadway. The intersection faces concerns related to on-street parking, which may hinder visibility and contribute to traffic conflicts. Additionally, the stop sign is located a significant distance from the intersection, which may be causing drivers to make improper decisions.

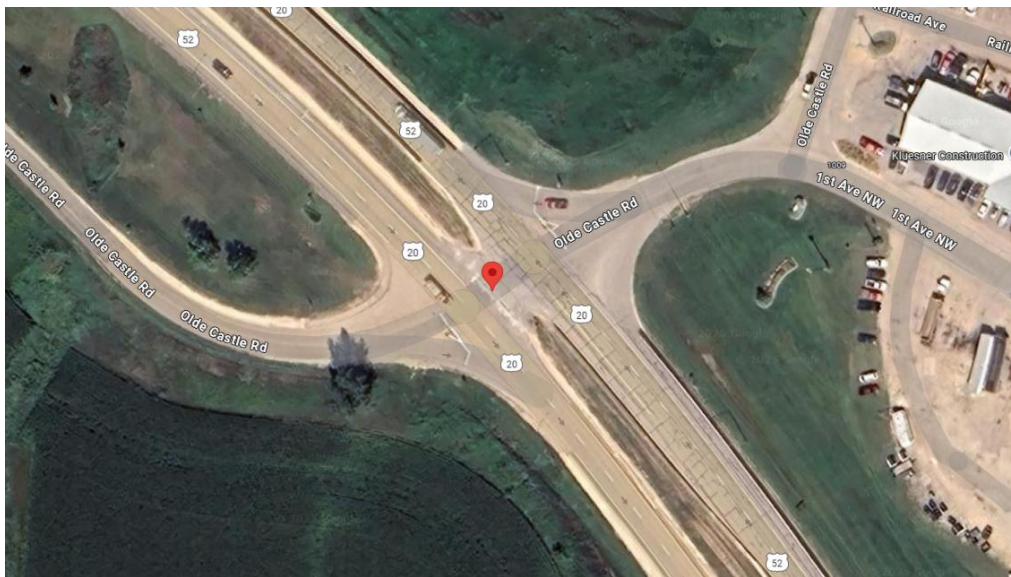
Figure 22: Old Castle Road and US 20/US 52 (Google Maps)

This site is a complex intersection involving a four-lane, divided highway with a speed limit of 65 mph and a two-lane municipal roadway with varying speed limits (25 mph on the north approach and 45 mph on the south approach) ([Google Map Link](#)). The east approach of US 20 has channelized right and left-turn lanes, while the west approach features a channelized left-turn lane. Olde Castle Road includes channelized right-turn lanes on both approaches. The median crossover area is narrow, limiting vehicle storage to a single passenger vehicle. Notably, the intersection lacks stop or yield signs, and there is no signage warning that cross traffic does not stop. However, overhead lighting is present.

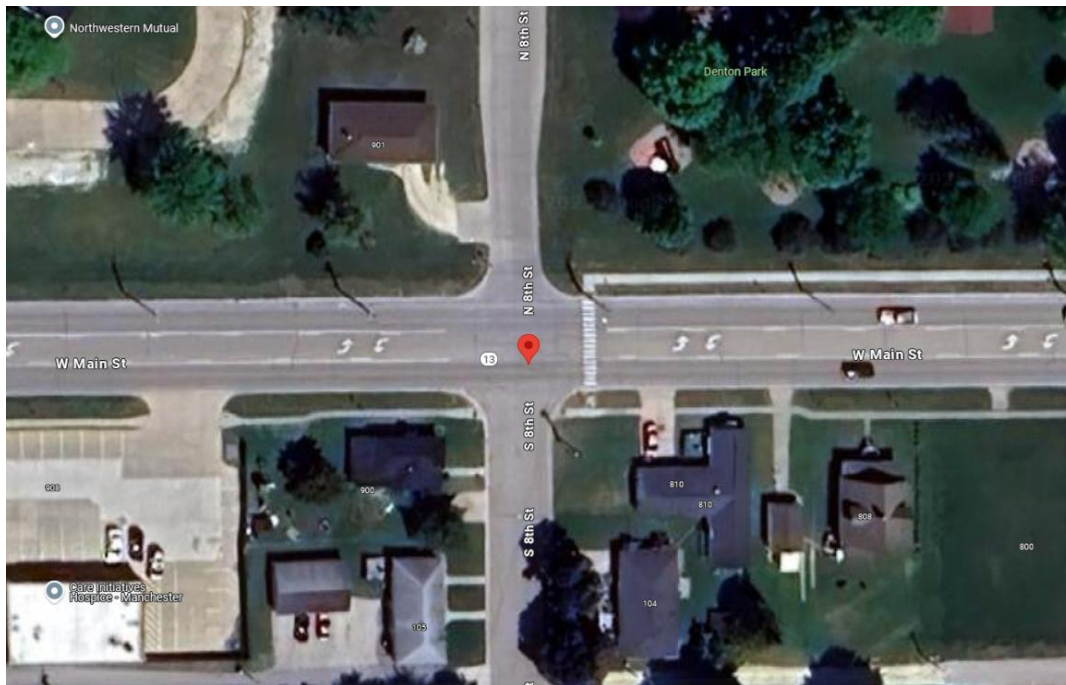
Figure 23: Intersection of North/South 8th Street and IA 13/West Main Street (Google Maps)

This site is a Four-legged, Undivided, Low Speed, Partial Stop Controlled intersection ([Google Map Link](#)). It has a medium PCR level for KAB crashes, indicating the need for potential countermeasures. West Main Street is a three-lane roadway with a two-way left-turn lane, while 8th Street is a two-lane roadway with stop control on the north and south approaches. The speed limit on West Main Street is 35 mph, while 8th Street is unposted but presumed to be 25 mph due to its residential nature. This intersection serves as one of three hospital access points along West Main Street, adding to its importance for emergency vehicle access. Overhead lighting is present, and curb and gutter are installed along both roadways. Sidewalks are available on the south side of West Main Street and on the north side along the east approach. A crosswalk and pedestrian crossing signage are located on the east approach to facilitate pedestrian movement.

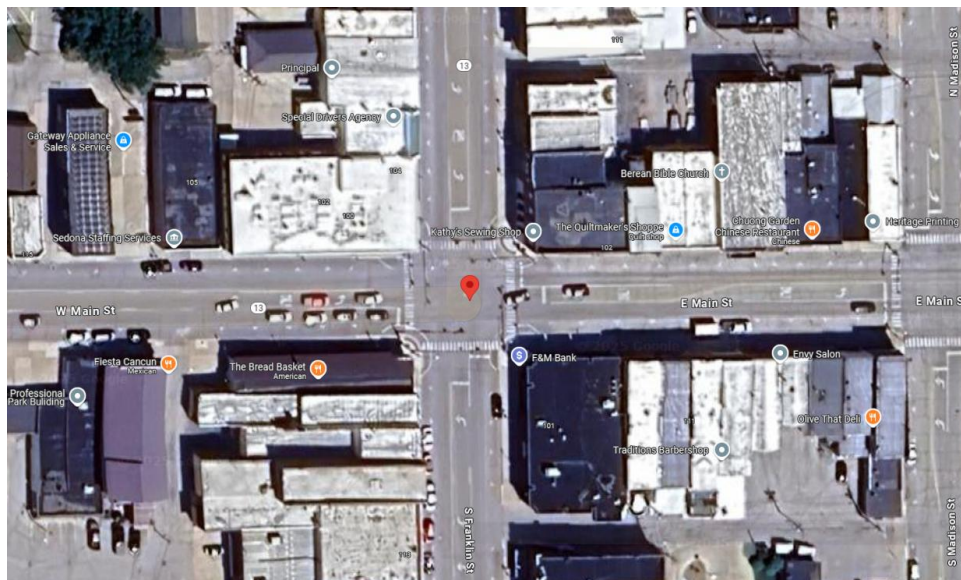
Figure 24. East/West Main Street and North/South Franklin Street (Google Maps)

This site is a Four-legged, Undivided, Low Speed, Traffic Signal Controlled intersection ([Google Map Link](#)). It has a high PCR level for KABCO crashes, indicating the need for immediate attention and potential countermeasures. The area surrounding the intersection is predominantly commercial, with well-defined curbs, curb ramps, and sidewalks. Overhead lighting is present at the intersection, improving nighttime visibility. The road pavement is in good condition, and pedestrian facilities, including marked crosswalks and pedestrian signals, are available for enhanced safety.

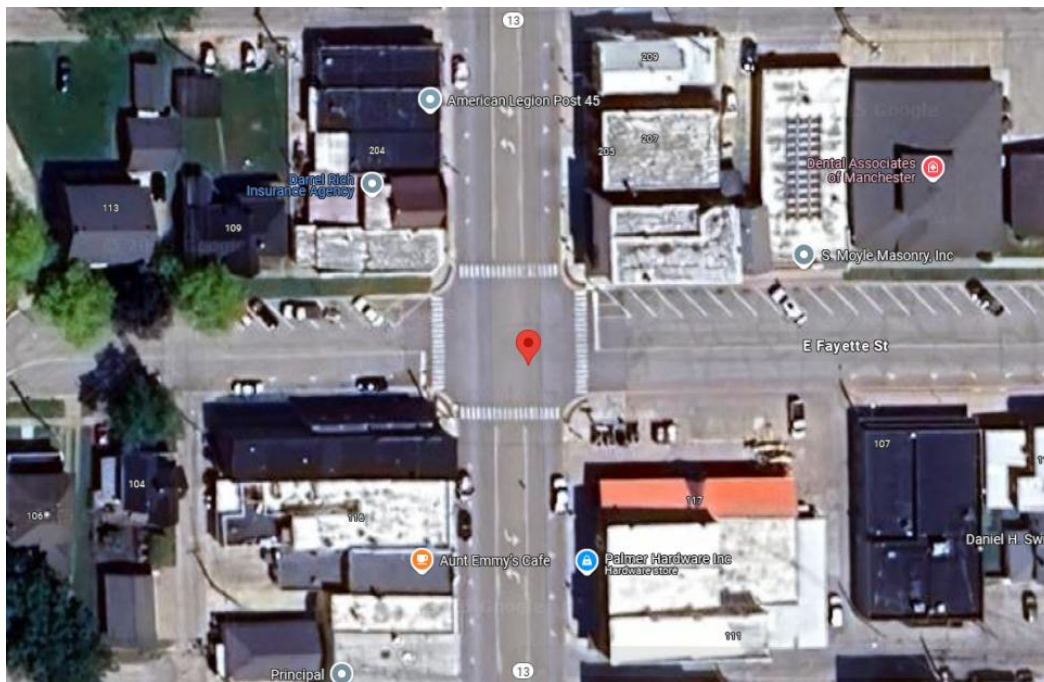
Figure 25: Intersection of East/West Fayette Street and IA 13/North Franklin Street

This site is a Four-legged, Undivided, Low Speed, Partial Stop Controlled intersection ([Google Map Link](#)). It has a medium PCR level for KABCO crashes, indicating the need for potential countermeasures. The surrounding area is predominantly commercial, with well-defined curbs, curb ramps, and sidewalks. Overhead lighting is present, improving nighttime visibility. The pavement appears to be in good condition, and marked crosswalks provide enhanced safety for non-motorists.

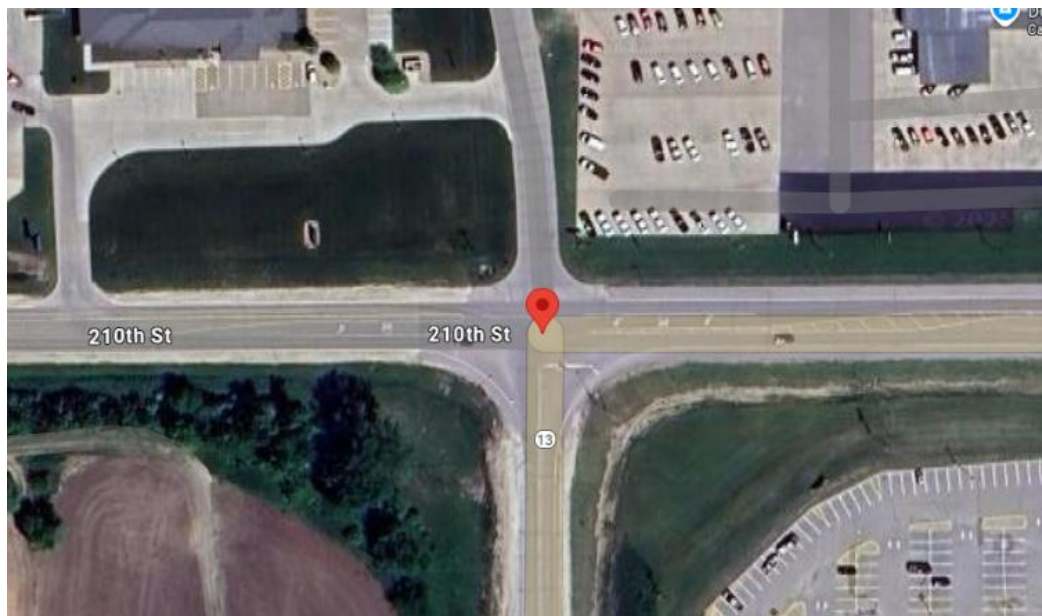
Figure 26: Intersection of North 13th Street and West Main Street/IA 13 (Google Maps)

This site is a Four-legged, Undivided, Low Speed, Partial Stop Controlled intersection ([Google Map Link](#)). It has a medium PCR level for KABCO crashes, indicating the need for potential countermeasures. The intersection has well-defined curbs except for the south leg. However, the intersection lacks curb ramps and sidewalks. Overhead lighting is available to enhance visibility. The road pavement is in good condition. There are no marked crosswalks providing facilities for pedestrian safety.
