Appendix A: Dubuque MPO Sites

Intersections

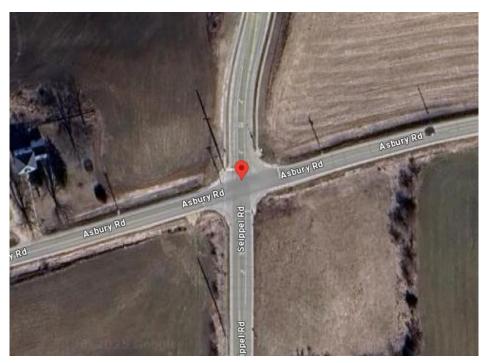
This site is a Four-legged, Undivided, Low Speed, Partial Stop Control intersection (Google Map Link). It has a medium PCR level for KAB crashes, indicating the need for immediate attention and potential countermeasures. The area surrounding the intersection is undeveloped, although residential areas are located nearby, and the pavement surface and delineation are in good condition, ensuring clear visibility of the roadway.

Figure 1: Intersection of Asbury Road and Seippel Road

Crash data indicate that a total of 17 crashes have occurred at this intersection over a five-year period (2018-2022), including two KAB crashes and fifteen CO crashes. The predominant manner of collision is broadside (front-to-side), accounting for the majority of crashes. Additionally, angle crashes (oncoming left turn) and rear-end collisions were also reported.

The primary contributing factor to KAB crashes is failure to yield right-of-way (FTYROW) at stop signs, which led to broadside crashes at the intersection. [It is noted that this crash pattern has been addressed in recent years with the conversion of the intersection to all way stop control early 2023.] Other contributing factors include running a stop sign, driver distraction, exceeding the authorized speed limit, improper turning movements, following too closely, etc.

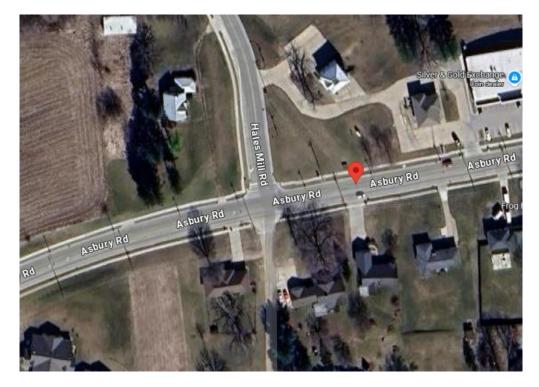
This site is a Three-legged, Undivided, Low Speed, Partial Stop Controlled intersection (Google Map Link). It has a high PCR level for KABCO crashes, indicating the need for immediate attention and potential safety countermeasures. The surrounding area is predominantly residential, and the intersection has well-defined curbs, curb ramps, and sidewalks. Overhead lighting is present, and the road pavement is in good condition. However, there are no marked crosswalks, which may impact pedestrian safety.

Figure 2: Intersection of Asbury Road and Hales Mill Road

Crash data indicate that a total of 10 crashes have occurred at this intersection over a five-year period (2018-2022), including one KAB crash and nine CO crashes. The predominant manner of collision is broadside (front-to-side), accounting for the majority of crashes. Additionally, angle crashes (oncoming left turn), rear-end collisions, and sideswipe crashes in opposite direction were also reported, indicating issues with right-of-way compliance, and driver attentiveness.

The primary contributing factor to KABCO crashes at this intersection is failure to yield right-of-way (FTYROW) from stop signs, which has led to multiple broadside collisions. Other major contributing factors include driver distraction, failure to yield when making left turns, driving too fast for conditions, improper turning movements, and operating a vehicle in an unsafe manner. The KAB Annual PCR for this intersection is 0.011071, indicating a low severity level, while the KABCO Annual PCR is 0.659642, which is considered medium. Based on statewide rankings, this intersection is ranked 5602nd for KAB crashes and 1821st for KABCO crashes out of 115,274 intersections statewide, signifying that while severe crashes are low, the overall frequency of crashes is a concern.

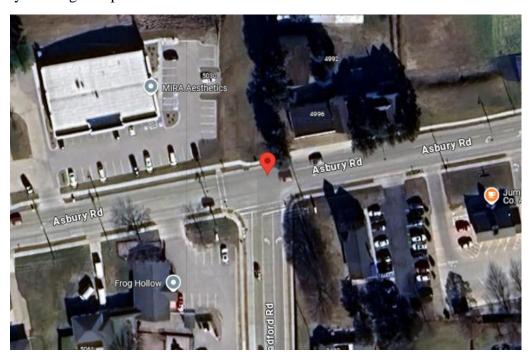
This site is a Three-legged, Undivided, Low Speed, Partial Stop Controlled intersection (Google Map Link). It has a medium PCR level for KABCO crashes, indicating the need for immediate attention and potential safety countermeasures. The surrounding area is a mix of commercial and residential properties, and the intersection has well-defined curbs, curb ramps, and sidewalks. Overhead lighting is present, and the road pavement is in good condition. Additionally, marked crosswalks are provided for pedestrian facilities, but they are only present on two approaches, potentially limiting safe pedestrian movements.

Figure 3: Intersection of Asbury Road and Radford Road

The primary contributing factor to KABCO crashes at this intersection is following too closely, which has led to multiple rear-end collisions. Other major contributing factors include driver distraction, failure to yield right-of-way (FTYROW) from stop signs, failure to yield when making left turns, improper turning movements, and loss of vehicle control. The KAB Annual PCR for this intersection is 0.006014, indicating a low severity level, while the KABCO Annual PCR is 0.595867, which is considered medium. Based on statewide rankings, this intersection is ranked 6893rd for KAB crashes and 2017th for KABCO crashes out of 115,274 intersections statewide, signifying that while severe crashes are low, the overall frequency of crashes remains a concern.

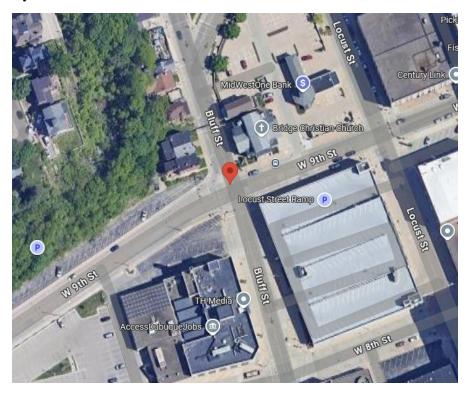
This site is a four-legged, undivided, low speed, signalized intersection (Google Map Link). It has the highest KAB PCR level out of 115,274 intersections statewide, indicating the need for immediate attention and potential safety countermeasures. The surrounding area is predominantly commercial. The intersection has well defined curbs, curb ramps and sidewalks. Overhead lighting is present at the intersection. The road delineation and pavement are in good condition. Additionally, marked crosswalks and pedestrian signals **are present**, enhancing pedestrian safety.

Figure 4: Intersection of Bluff Street and West 9th Street (Image: Google Maps)

Crash reports indicate that a total of 54 crashes have occurred at this intersection over a five-year period (2018-2022), including eight KAB crashes and forty-six CO crashes. The predominant manner of collision is broadside (front-to-side), accounting for most of the KAB crashes (87.5%). Other reported crash types include rear-end, sideswipe (same direction), and angle (oncoming left turn) collisions, suggesting a mix of signal violations.

The primary contributing factor to KAB crashes at this intersection is running a traffic signal, which accounts for the majority of severe crashes (79.63%). Additional contributing factors include loss of control, failure to signal, following too closely, and failure to yield right-of-way (FTYROW) while making a left turn. The KAB Annual PCR for this intersection is 0.791382, making it a high-severity location. Based on statewide rankings, this intersection is ranked 39th for KAB crashes and 46th for KABCO crashes out of 115,274 intersections, highlighting its critical safety concerns.

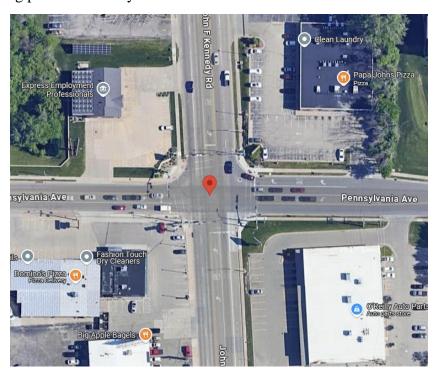
This site is a four-legged, undivided, low speed, signalized intersection (Google Map Link). It has a higher PCR level for KAB crashes, indicating the need for immediate attention and potential countermeasures. The intersection is located in an urban area, and the surrounding environment is predominantly commercial. The intersection has well-defined curbs, curb ramps and sidewalks. Overhead lighting is present at the intersection. The roadway delineation and pavement are in good condition. Additionally, marked crosswalks and pedestrian signals are present, providing pedestrian safety facilities.

Figure 5: Intersection of Kennedy Road and Pennsylvania Avenue (Image: Google Maps)

Crash reports indicate that a total of 59 crashes have occurred at this intersection over a five-year period (2018-2022), including eight KAB crashes and fifty-one CO crashes. The predominant manner of collision is broadside (37.29%), accounting for the majority of KAB crashes. Other reported crash types include rear-end, angle (oncoming left turn), and head-on collisions, indicating a mix of turning conflicts, and signal violations.

The primary contributing factors to KAB crashes at this intersection included failure to yield right-of-way while making a left turn, running a traffic signal, failure to yield right-of-way from a driveway, and following too closely. The KAB Annual PCR for this intersection is 0.538382, while the KABCO Annual PCR is 2.101679, indicating a high crash frequency. Based on statewide rankings, this site is ranked 91st for KAB crashes and 467th for KABCO crashes out of 115,274 intersections statewide, making it a high-risk location.

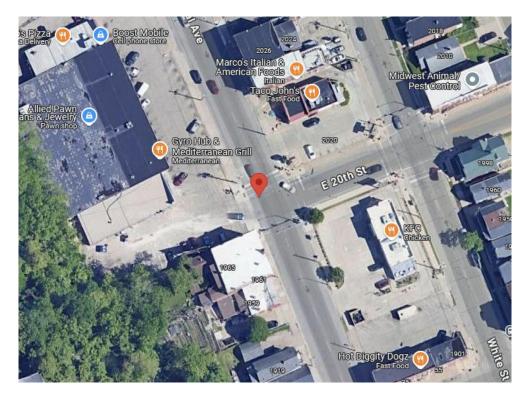
This site is a three-legged, undivided, low speed, signalized intersection (Google Map Link). It has a higher PCR level for KAB crashes, indicating the need for immediate attention and potential countermeasures. The intersection is located in an urban area, where Central Avenue operates as a one-way roadway with a speed limit of 25 mph, while East 20th Street is a two-way roadway with a speed limit of 30 mph. Speeding is not a significant issue, as only a very small percentage of vehicles exceed the speed limit by more than 10 mph. The surrounding area is predominantly commercial. The intersection has well-defined curbs, curb ramps and sidewalks. Overhead lighting is present at the intersection. The delineation and pavement are in good condition. Additionally, marked crosswalks and pedestrian signals are present, providing facilities for pedestrian safety.

Figure 6: Intersection of Central Avenue and East 20th Street (Image: Google Maps)

Crash reports indicate that a total of 27 crashes have occurred at this intersection over a five-year period (2018-2022), including six KAB crashes and twenty-one CO crashes. The predominant manner of KAB collision is single-vehicle (non-collision), accounting for the majority of severe crashes. Other reported crash types include broadside, rear-end, sideswipe (same direction), and angle (oncoming left turn) collisions, indicating a mix of driver control issues, turning conflicts, and intersection-related crashes.

The primary contributing factors to KAB crashes at this intersection include improper turning movements, driver distraction, and loss of control. Among these six KAB crashes, two involved pedestrians, highlighting the need for enhanced pedestrian safety measures. The KAB Annual PCR for this intersection is 0.527477, while the KABCO Annual PCR is 2.333091, indicating a high crash frequency. Based on statewide rankings, this intersection is ranked 93rd for KAB crashes and 397th for KABCO crashes out of 115,274 intersections statewide, making it a high-risk location.

- Install lane assignment pavement markings on the southbound approach (Low)
- Relocate the utility poles from the intersection approaches (High)
- Implement safety recommendations made in Central and White Corridor Study (Varies)

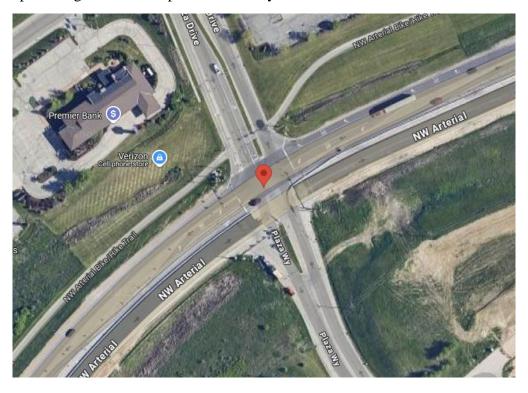
This site a four-legged, divided, low speed, signalized intersection (Google Map Link). It has a higher PCR level for KAB crashes, indicating the need for immediate attention and potential safety countermeasures. A significant concern at this location is excessive speeding, as approximately 53% of vehicles exceed the speed limit by more than 10 mph+ on Northwest Arterial based on available data. The surrounding area is predominantly commercial. The intersection has well-defined curbs on minor roads; there are no curb ramps or sidewalks, but a bike trail does run parallel to the Northwest Arterial. Overhead lighting is present at the intersection. The delineation and pavement are in good condition. There are no marked crosswalk providing facilities for pedestrian safety.

Figure 7: Intersection of Northwest Arterial and Plaza Drive (Image: Google Maps)

Crash reports indicate that a total of 18 crashes have occurred at this intersection over a five-year period (2018-2022), including six KAB crashes and twelve CO crashes. The predominant manner of collision is broadside (50%), which accounts for the majority of severe crashes. Other reported crash types include angle (oncoming left turn), rear-end, and sideswipe (same direction) collisions, suggesting turning conflicts, signal violations, and aggressive driving.

The primary contributing factors to KAB crashes at this intersection include running a traffic signal and failure to yield right-of-way (FTYROW) while making a left turn. Additionally, reckless driving behaviors have been identified as contributing factors to crash occurrences at this location. The KAB Annual PCR for this intersection is 0.459806, while the KABCO Annual PCR is 1.746321, indicating a high crash frequency. Based on statewide rankings, this site is ranked 119th for KAB crashes and 607th for KABCO crashes out of 115,274 intersections statewide, highlighting its significance as a high-risk location.

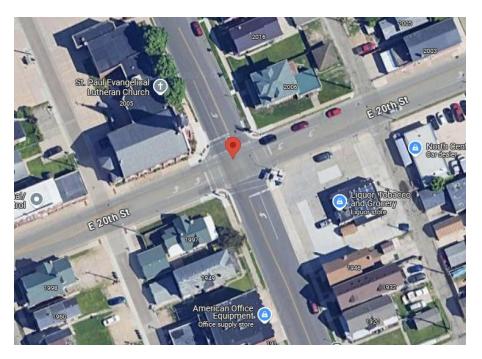
This site is a four-legged, undivided, low speed, signalized intersection (Google Map Link). It has a higher PCR level for KAB crashes, indicating the need for immediate attention and potential countermeasures. The surrounding area is predominantly commercial. The intersection has well-defined curbs, curb ramps and sidewalks. Overhead lighting is present at the intersection. The delineation and pavement are in good condition. Additionally, marked crosswalks and pedestrian signals are present, providing facilities for pedestrian safety.

Figure 8: Intersection of East 20th Street and Jackson Street (Image: Google Maps)

Crash reports indicate that a total of 27 crashes have occurred at this intersection over a five-year period (2018-2022), including five KAB crashes and twenty-two CO crashes. The crashes are varied in type, with two KAB crashes being broadside, while the others involve rear-end, sideswipe (same direction), and head-on collisions. This suggests a mix of turning conflicts, signal violations, and driver misjudgments.

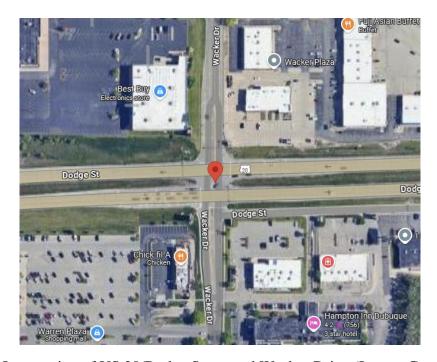
This site four-legged, divided, moderate speed, signalized intersection (<u>Google Map Link</u>). It has a higher PCR level for KAB crashes, indicating the need for immediate attention and potential countermeasures. The intersection is located in an urban area, and the surrounding land use is predominantly commercial. The intersection has well-defined curbs on minor roads; there are no curb ramps or sidewalks. Overhead lighting is present at the intersection. The delineation and pavement are in good condition. There are no marked crosswalk facilities for pedestrian safety.

Figure 9: Intersection of US 20/Dodge Street and Wacker Drive (Image: Google Maps)

Crash reports indicate that a total of 84 crashes have occurred at this intersection over a five-year period (2018-2022), including nine KAB crashes and seventy-five CO crashes. The crash types at this intersection vary, with KAB crashes involving rear-end, broadside, angle, head-on, and non-collision incidents. The majority of KAB crashes (55.56%) were broadside collisions, indicating significant risks associated with right-of-way violations and traffic signal compliance issues.

The primary contributing factor to KAB crashes at this intersection is running traffic signals, leading to high-severity crashes. For KABCO crashes, the predominant causes are loss of control, running traffic signals, following too close, and failing to yield right-of-way while making left turn. The KAB Annual PCR for this intersection is 0.413412, while the KABCO Annual PCR is 6.034437, indicating a high crash frequency. Based on statewide rankings, this

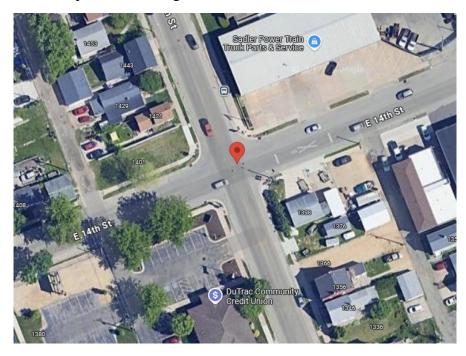
This site is a four-legged, undivided, low speed, signalized intersection (Google Map Link). It has a higher PCR level for KAB crashes, indicating the need for immediate attention and potential countermeasures. The land use surrounding the intersection is mixed, with residential homes in the northwest quadrant and commercial areas in the remaining quadrants. The intersection has well-defined curbs, curb ramps and sidewalks. Overhead lighting is present at the intersection and the pavement is in good condition. There are no marked crosswalks present.

Figure 10: Intersection of East 14th Street and Elm Street (Image: Google Maps)

associated with right-of-way violations and traffic signal compliance issues. Other crash types include rear-end, sideswipe (same direction), and non-collision (single-vehicle) incidents.

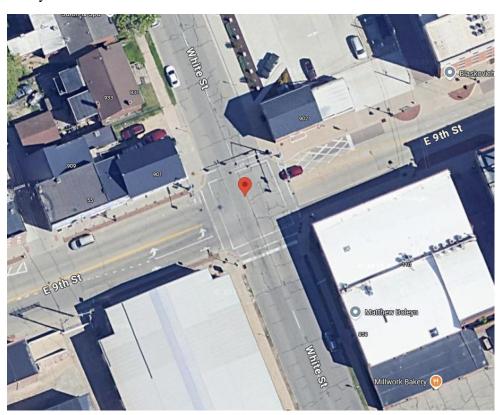
This site is a four-legged, undivided, low speed, signalized intersection (Google Map Link). It has a higher PCR level for KAB crashes, indicating the need for immediate attention and potential countermeasures. Speeding is not a major concern, as data indicated that only a small percentage of vehicles exceed the speed limit by more than 10 mph. The surrounding area is predominantly commercial. The intersection has well-defined curbs, curb ramps and sidewalks. Overhead lighting is present at the intersection. The delineation and pavement are in good condition. Additionally, marked crosswalks and pedestrian signals are present, providing for pedestrian safety.

Figure 12: Intersection of East 9th Street and White Street (Image: Google Maps)

Crash reports indicate that a total of 18 crashes have occurred at this intersection over a five-year period (2018-2022), including four KAB crashes and fourteen CO crashes. The majority of both KAB and CO crashes are broadside collisions (55.56%), suggesting significant risks associated with right-of-way violations and traffic signal compliance issues. Other crash types include non-collision (single-vehicle), rear-end, sideswipe (same direction), and angle (oncoming left turn) crashes.

The primary contributing factor to KAB crashes at this intersection is running traffic signals, which is the same for CO, leading to multiple broadside collisions. Other contributing factors are loss of control, making improper turns, failure to yield right-of-way while making left turn, failure to yield right-of-way to pedestrian, and improper or erratic lane departure. The KAB Annual PCR for this intersection is 0.302398, while the KABCO Annual PCR is 1.233488, indicating a high crash frequency. Based on statewide rankings, this intersection is ranked 239th for KAB crashes and 934th for KABCO crashes out of 115,274 intersections statewide, highlighting its significance as a high-risk location.

- Improve visibility of the intersection by providing lighting (Moderate)
- Install night-time flash with steady operation (Low)
- Relocate the utility poles near intersection approaches (Moderate)
- Install pedestrian crossing signage (Low)
- Install lane directional signage (Low)
- Install sign ahead signage (Low)
- Implement safety recommendations made in Central and White Corridor Study (Varies)

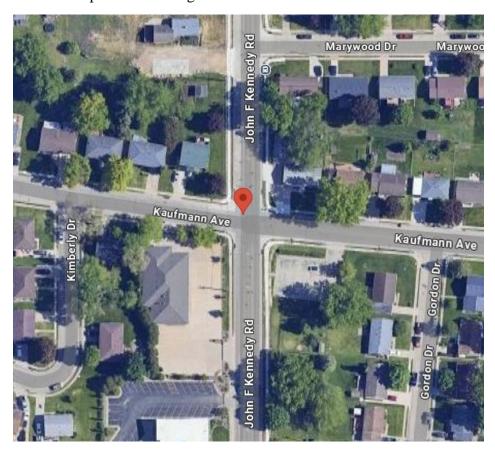
This site is a four-legged, undivided, low speed, partially stop-controlled intersection (Google Map Link). It has a higher PCR level for KAB crashes, indicating the need for immediate attention and potential countermeasures. The surrounding area is predominantly residential. The intersection has well-defined curbs, curb ramps and sidewalks. Overhead lighting is present at the intersection and the pavement is in good condition. There are no marked crosswalks present.

Figure 14: Intersection of Kennedy Road and Kaufmann Avenue (Image: Google Maps)

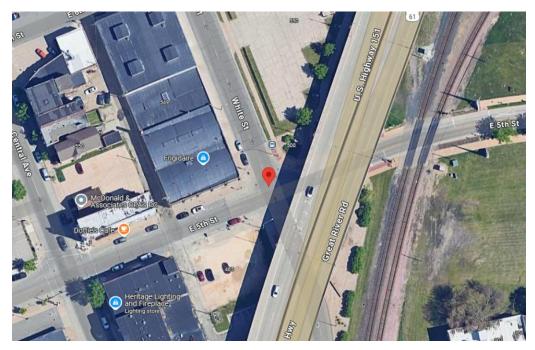
This site has a high PCR level for KAB crashes, indicating the need for immediate attention and potential countermeasures. It is a four-legged, undivided, low speed, partial stop-controlled intersection located in an commercial area (<u>Google Map Link</u>). The intersection has well-defined curbs, curb ramps, and sidewalks. Overhead lighting is present at the intersection, and the pavement is in good condition. There are no marked crosswalks present.

Figure 15: Intersection of East 5th Street and White Street (Image: Google Maps)

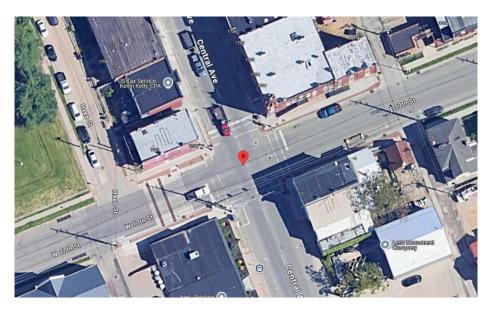
This site has a high PCR level for KAB crashes, indicating the need for immediate attention and potential countermeasures. It is a four-legged, undivided, low speed, signalized intersection located in a commercial area (Google Map Link). The intersection has well-defined curbs, curb ramps, and sidewalks. Overhead lighting is present at the intersection. The pavement is in good condition. Additionally, there are marked crosswalks and pedestrian signals, providing facilities for pedestrian safety.

Figure 16: Intersection of Central Avenue and 17th Street (Image: Google Maps)

Crash reports indicate that a total of 35 crashes have occurred at this intersection over a five-year period (2018-2022), including four KAB crashes and thirty-one CO crashes. The data shows that two of the KAB collisions are broadside, while the other two are non-collision. The predominant manner of collision for KABCO crashes is broadside (42.86%), followed by rear-end (28.57%), non-collision (11.43%), sideswipe (11.43%), and angle-oncoming left turn (5.71%).

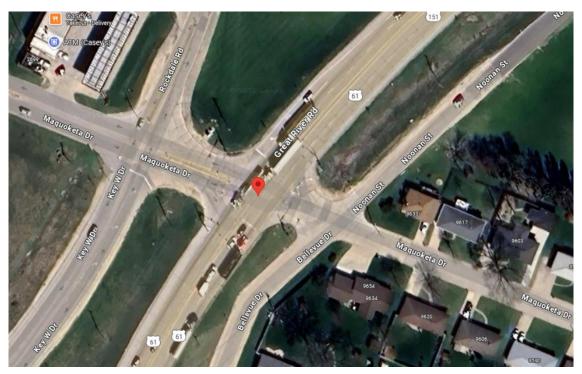
This site has a medium PCR level for KAB crashes, indicating the need for immediate attention and potential countermeasures. It is a four-legged, divided, low speed, signalized intersection located in an urban area (Google Maps Link). The surrounding area is predominantly residential land use, with some commercial uses also present. The intersection lacks well-defined curbs in some places, and it does not have any curb ramps or sidewalks. Overhead lighting is present at the intersection and the pavement is in good condition. There are no marked crosswalks present.

Figure 17: Intersection of Great River Road and Maquoketa Drive

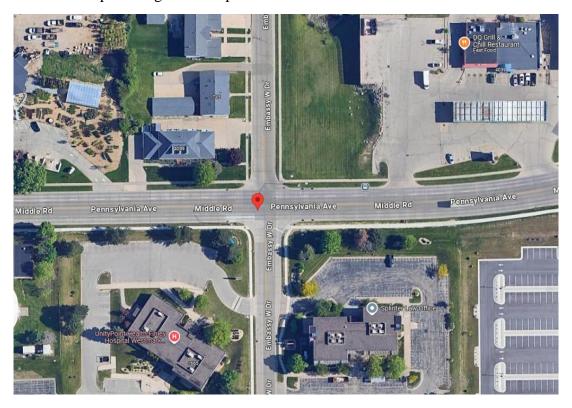
This site has a medium PCR level for KAB crashes, indicating the need for immediate attention and potential countermeasures. It is a four-legged, undivided, low speed, partial stop-controlled intersection located in an urban area (Google Maps Link). The north leg of the intersection is on an upgrade into the intersection, which may impact driver visibility and stopping distance. The north side of the intersection is primarily a residential area, while the south side includes commercial establishments. The intersection has curbs, curb ramps, sidewalks, and well-maintained vegetation. The delineation and pavement are in good condition. There are no marked crosswalks providing facilities present.

Figure 18: Intersection of Embassy West Drive and Pennsylvania Avenue

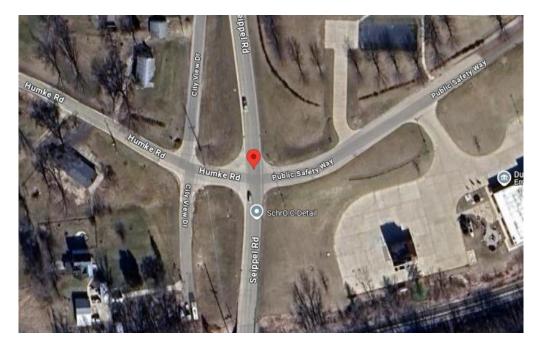
This site has a medium PCR level for KAB crashes, indicating the need for immediate attention and potential countermeasures. It is a four-legged, undivided, high speed, partially stop-controlled intersection located in an urban area (<u>Google Maps Link</u>). The intersection has well-defined curbs and maintained vegetation; however, it does not have curb ramps or sidewalks. The delineation and pavement are in good condition. Existing lighting may be insufficient to adequately illuminate the entire intersection.

Figure 19: Intersection of Humke Road and Seippel Road

Crash reports indicate that a total of six crashes have occurred at this intersection over a five-year period (2018-2022), including three KAB crashes and three CO crashes. The predominant manner of KABCO crashes includes broadside (50%), rear-end (33.33%), and head-on (16.67%). The primary contributing factors to the crashes at this intersection are loss of control, failure to yield right of way from a stop sign, and running a stop sign. The KAB Annual PCR for the intersection is 0.19758, indicating a medium severity level, while the KABCO Annual PCR is 0.292547, which is also considered medium. Based on rankings, this intersection is ranked 450th for KAB crashes and 3,704th for KABCO crashes out of 115,274 intersections statewide.

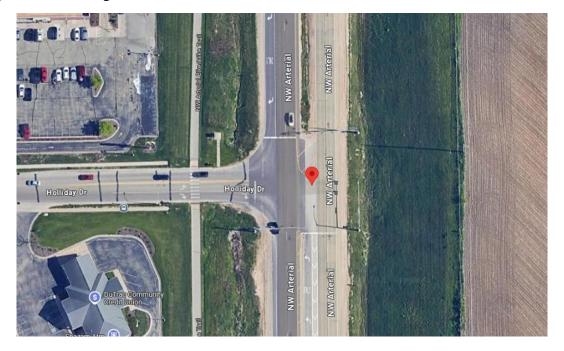
This site has a medium PCR level for KAB crashes, indicating the need for immediate attention and potential countermeasures. It is a three-legged, divided, high speed, signalized intersection

located in an urban area (<u>Google Maps Link</u>). The northwest and southwest sides are predominantly commercial, and a bicycle trail nearby the intersection includes stop control and appropriate signage. However, there are no sidewalks at this intersection. The road delineation and pavement are in good condition.

Figure 20: Intersection of Northwest Arterial and Holliday Drive

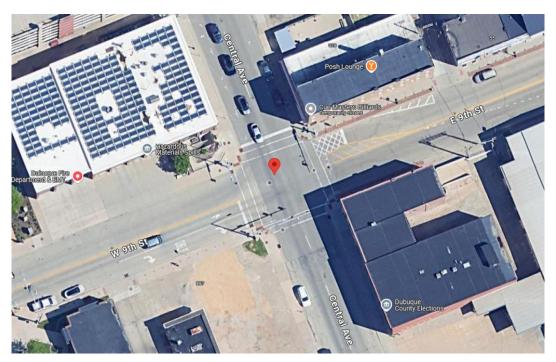
This site has a medium PCR level for KAB crashes, indicating the need for immediate attention and potential countermeasures. It is a four-legged, undivided, low speed, signalized intersection located in a predominantly commercial area (Google Maps Link). The intersection has curbs, curb ramps, and sidewalks, as well as marked crosswalks and pedestrian signals to enhance pedestrian safety. The delineation and pavement are in good condition, and overhead lighting is present.

Figure 21: Intersection of Central Avenue and 9th Street

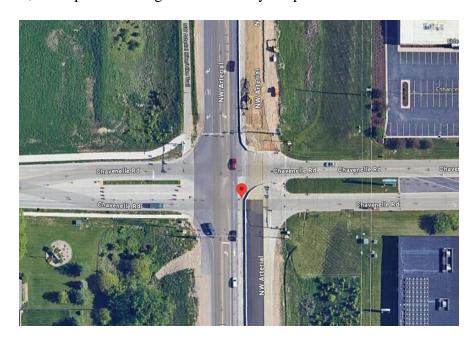
Figure 22: Intersection of Northwest Arterial and Chavenelle Road

This site has a medium PCR level for KAB crashes, indicating the need for immediate attention and potential countermeasures. It is a four-legged, divided, moderate speed, signalized intersection located in a predominantly commercial area (<u>Google Maps Link</u>). The intersection features curbs on the minor roads; only one side of the intersection has curb ramps, and sidewalks. The road delineation and pavement are in good condition. Overhead light is present ensuring visibility at night. There are no marked crosswalks providing facilities for pedestrian safety, however, it has pedestrian signals as a facility for pedestrian.

The primary contributing factors to KAB crashes include running a traffic signal, failing to yield the right of way when making a left turn, loss of control, and driver distraction. Most of the CO crashes occurred due to loss of control, followed by running traffic signal and followed too close. The KAB Annual PCR for the intersection is 0.183026, indicating a medium severity level, while the KABCO Annual PCR is 0.854911, which is also considered medium. Based on statewide rankings, this intersection is ranked 519th for KAB crashes and 1,409th for KABCO crashes out of 115,274 intersections statewide.

Based on the crash history, contributing factors, and performance data, the following safety improvements are recommended along with their associated cost levels:

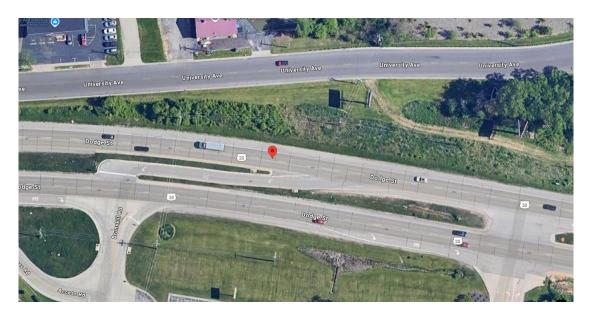
Figure: Intersection of US 20 and Brunskill Road

This site has a medium PCR level for KAB crashes, indicating the need for immediate attention and potential countermeasures. It is a three-legged, divided, moderate speed, partial stop-control intersection (Google Maps Link). The intersection does not have any curbs, curb ramps, or sidewalks. The delineation and pavement are in good condition. There are no marked crosswalks providing facilities in the vicinity, as it appears that pedestrian traffic is not present in this location. The design of this intersection, along with nearby intersections, is complex. One nearby driveway/intersection primarily serves a hotel and restaurant.

Crash reports indicate that a total of 23 crashes have occurred at this intersection over a five-year period (2018-2022), including three KAB crashes and twenty CO crashes. The predominant manner of KABCO collision include rear-end crashes (56.52%), broadside crashes (26.09%), and smaller occurrences of angle, non-collision, and sideswipe crashes. Among the three KAB crashes, two of them are rear-end and one of them are broadside collision. The primary contributing factors to KAB crashes at this intersection are loss of control, following too closely, and failing to yield the right-of-way. Additional contributing factors include driver distraction, speeding, running a stop sign, reckless driving and improper turning movements. The KAB Annual PCR for the intersection is 0.181315, indicating a medium severity level, while the KABCO Annual PCR is 0.829864, which is also categorized as medium. Based on statewide rankings, this intersection is ranked 527th for KAB crashes and 1,439th for KABCO crashes out of 115,274 intersections statewide.

Based on the crash history, contributing factors, and performance data, the following safety improvements are recommended along with their associated cost levels:

- Install flashing beacons at the stop-controlled intersection (Low)
- Intersection consolidation/access management (High)
- Install protective shielding/guardrails as needed where roadside hazards exist (Moderate)

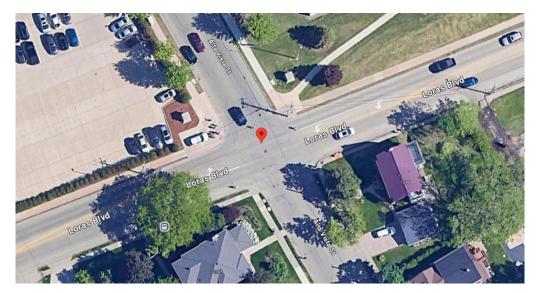
Figure 23: Intersection of Alta Vista Street and Loras Boulevard

This site has a medium PCR level for KAB crashes, highlighting the need for immediate attention and potential countermeasures. It is a four-legged, undivided, low speed, partial stop-control intersection (Google Maps Link). The east approach is on an upgrade into the

intersection. The surrounding area includes a mix of educational and residential land use. The intersection has curbs, curb ramps, and sidewalks present, and the pavement and delineation are in good condition. However, there are no marked crosswalks.

Crash reports indicate that a total of 15 crashes occurred at this intersection over a five-year period (2018-2022), including three KAB crashes and twelve CO crashes. The predominant manner of KABCO collision includes broadside (40%), angle-oncoming left turn (20%), and non-collision (20%). These crash patterns suggest issues related to right-of-way compliance, turning maneuvers, and driver attentiveness. The primary contributing factors to KAB crashes at this intersection are failure to yield the right-of-way, improper turning movements, and driver distraction. Additional contributing factors include speeding and loss of control. The KAB Annual PCR for this location is 0.177275, indicating a medium severity level, while the KABCO Annual PCR is 1.477338, which is considered high. Based on statewide rankings, this intersection is ranked 548th for KAB crashes and 749th for KABCO crashes out of 115,274 intersections statewide.

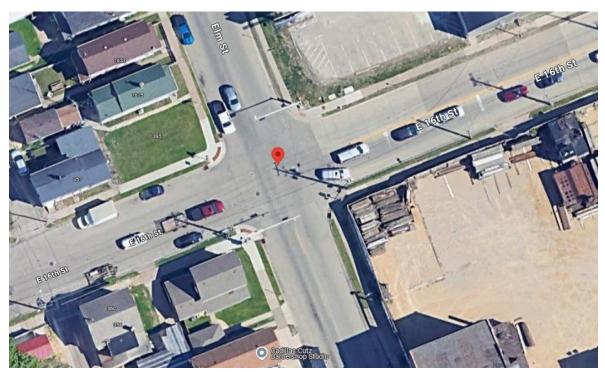
Figure 24: Intersection of East 16th Street and Elm Street

This site is a four-legged, undivided, low speed, signalized intersection (Google Maps Link). It has a medium PCR level for KAB crashes, indicating the need for attention and potential countermeasures. The intersection is located in a predominantly commercial area and features well-defined curbs, curb ramps, sidewalks, and pedestrian signals. However, there are no marked crosswalks at this intersection. The delineation and pavement are in good condition. Overhead lighting is present.

Crash reports indicate that a total of 17 crashes have occurred at this intersection over a five-year period (2018-2022), including three KAB crashes and 14 CO crashes. The predominant manner of collision is broadside (front-to-side), , followed by non-collision crashes. Additionally, angle and rear-end crashes were recorded for CO crashes. The primary contributing factors to KAB crashes include running a traffic signal and failure to yield the right-of-way. Loss of control is another predominant factor for CO crashes. The KAB Annual PCR for the intersection is 0.167449, indicating a medium severity level, while the KABCO Annual PCR is -0.061391. Based on statewide rankings, this intersection is ranked 596th for KAB crashes and 101,389th for KABCO crashes out of 115,274 intersections statewide.

Based on the crash history, contributing factors, and performance data, the following safety improvements are recommended along with their associated cost levels:

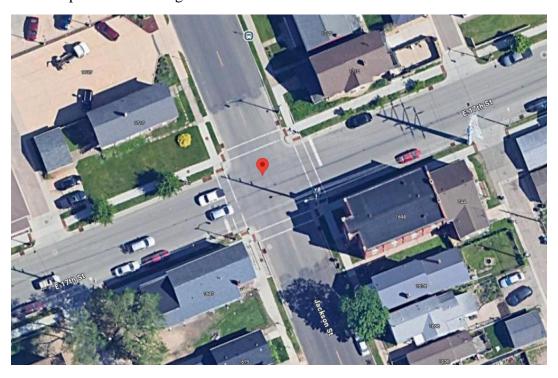
Figure 25: Intersection of East 17th Street and Jackson Street

This site is a four-legged, undivided, low speed, partial stop controlled intersection with a medium PCR level for KAB crashes, highlighting the need for attention and potential countermeasures (<u>Google Maps Link</u>). The area surrounding the intersection is primarily residential. It features well-defined curbs, curb ramps, sidewalks, and marked crosswalks. The delineation and pavement are in good condition.

factors to KABCO crashes at this intersection include running stop signs, failure to yield the right-of-way at stop signs, and loss of control. The KAB Annual PCR for the intersection is 0.152908, indicating a medium severity level, while the KABCO Annual PCR is 1.403969, which is considered high. Based on statewide rankings, this intersection is ranked 644th for KAB crashes and 803rd for KABCO crashes out of 115,274 intersections statewide, underscoring its importance as a high-risk location.

Based on the crash history, contributing factors, and performance data, the following safety improvements are recommended along with their associated cost levels:

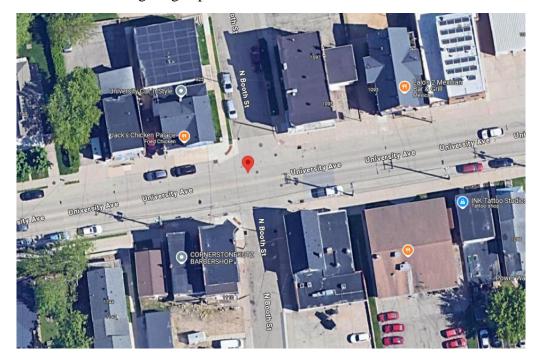
Figure 26: Intersection of University Avenue and Booth Street

This site is a four-legged, undivided, low speed, partially stop controlled intersection (Google Maps Link). It has a medium PCR level for KAB crashes, indicating the need for attention and potential countermeasures. The intersection is located in a predominantly commercial area and features well-defined curbs, curb ramps, sidewalks, and school zone crosswalk signs. However, there are no marked crosswalks to support pedestrian safety. The delineation and pavement are in good condition. Overhead lighting is present.

Crash reports indicate that a total of 13 crashes have occurred at this intersection over a five-year period (2018-2022), including three KAB crashes and ten CO crashes. The predominant manner of collision is broadside (front-to-side). Additionally, rear-end, head-on, and angle collisions were reported, suggesting potential issues with right-of-way compliance and driver attentiveness. The primary contributing factor to KAB crashes is failure to yield right-of-way from a stop sign, which led to broadside crashes at the intersection. Other contributing factors include driver distraction due to manually operated electronic communication devices, making improper turns, and FTYROW from parking. The KAB Annual PCR for the intersection is 0.139336, indicating a medium severity level, while the KABCO Annual PCR is 1.295354, which is considered high. Based on statewide rankings, this intersection is ranked 714th for KAB crashes and 884th for KABCO crashes out of 115,274 intersections statewide, highlighting its significance as a high-risk location.

Based on the crash history, contributing factors, and performance data, the following safety improvements are recommended along with their associated cost levels:

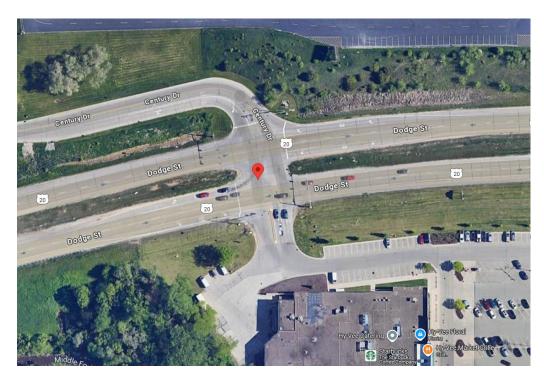
Figure 27: Intersection of US 20 and Century Drive

This site is a four-legged, divided, moderate speed, signalized intersection. It has a medium PCR level for KAB crashes, indicating the need for attention and potential countermeasures. The intersection is located in a predominantly commercial area and includes curbs on the minor roads but lacks curb ramps, sidewalks, and marked crosswalks. Overhead lighting is present, and the delineation and pavement are in good condition.

Crash reports indicate that a total of 42 crashes have occurred at this intersection over a five-year period (2018–2022), including six KAB crashes and thirty-six CO crashes. The predominant manner of KABCO collision is rear-end (front-to-rear), followed by sideswipe collisions and broadside crashes. Among the six KAB crashes, three were broadside, two were rear-end, and one was an angle (oncoming left turn) crash. This distribution suggests issues related to both right-of-way violations and vehicle control.

The primary contributing factors to the KAB crashes were running the traffic signal and loss of control. Other contributing factors across all crashes include improper or erratic lane changes, following too closely, and various forms of driver distraction. The KAB Annual PCR for the intersection is 0.128459, indicating a medium severity level. Based on statewide rankings, this intersection is ranked 746th for KAB crashes and 114,367th for KABCO crashes out of 115,274 intersections statewide. Despite the low overall crash severity ranking, the higher relative severity of KAB crashes at this location signals the need for targeted interventions.

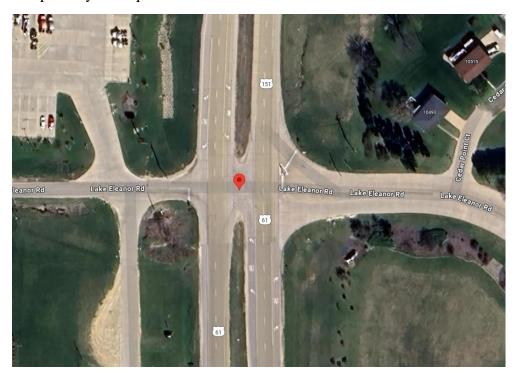
Figure 28: Intersection of US 52/US 61 and Lake Eleanor Road

This site is a four-legged, divided, high-speed, partial stop-controlled intersection (Google Maps Link). It has a medium PCR level for KAB crashes, indicating the need for immediate attention and potential countermeasures. The surrounding area consists of a mix of commercial, residential, and undeveloped land uses. The intersection lacks curbs, curb ramps, sidewalks, and marked crosswalks. While the pavement and delineation are in good condition, lighting at the intersection is possibly inadequate.

Crash reports indicate six crashes occurred at this intersection over a five-year period (2018–2022), including three KAB crashes and three CO crashes. Among the KAB crashes, two were broadside (front-to-side) and one was an angle collision (oncoming left turn). For KABCO crashes, the most frequent manner of collision was broadside, followed by rear-end, sideswipe, and angle crashes, each contributing one crash to the total. These patterns highlight potential issues with turning movements. The primary contributing factor to the KAB crashes was failure to yield right-of-way while making a left turn. Other factors included loss of control and one crash with an unknown cause. Similarly, the dominant contributing factor to KABCO crashes was failure to yield during left-turn maneuvers, followed by loss of control. The KAB Annual PCR is 0.120386, indicating a medium severity level, while the KABCO Annual PCR is -

Based on the crash history, contributing factors, and performance data, the following safety improvements are recommended along with their associated cost levels:

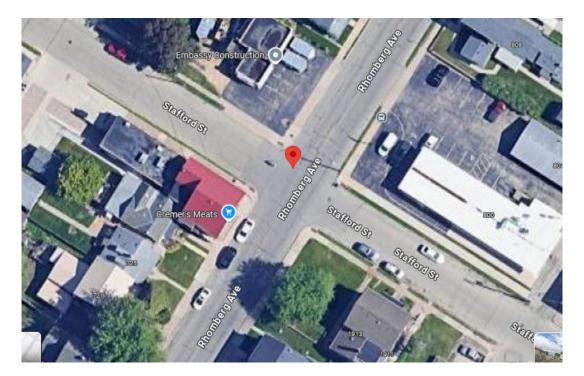
Figure 30: Intersection of Rhomberg Avenue and Stafford Street

This site is a four-legged, undivided, low speed, partial stop controlled intersection with a medium PCR level for KAB crashes, indicating the need for attention and potential countermeasures (Google Maps Link). The area is a mix of commercial and residential land use. The intersection features curbs, curb ramps, and sidewalks. The delineation and pavement are in good condition, but there are no marked crosswalks present.

Crash reports indicate that 16 crashes have occurred at this intersection over a five-year period (2018-2022), including three KAB crashes and 13 CO crashes. The predominant manner of collision is broadside (front-to-side), accounting for two of the three KAB crashes. Additional crash types include rear-end, non-collision, and angle crashes, suggesting potential issues with driver behavior and compliance. The primary contributing factors to KAB crashes at this location include loss of control and failure to yield the right-of-way at a stop sign. Other contributing factors for CO crashes include improper backing, making an improper turn, and failing to yield the right-of-way to pedestrian. The KAB Annual PCR for the intersection is 0.115296, indicating a medium severity level, while the KABCO Annual PCR is 1.640778, which is considered high. Based on statewide rankings, this intersection is ranked 787th for KAB crashes and 656th for KABCO crashes out of 115,274 intersections statewide, emphasizing its status as a high-risk location.

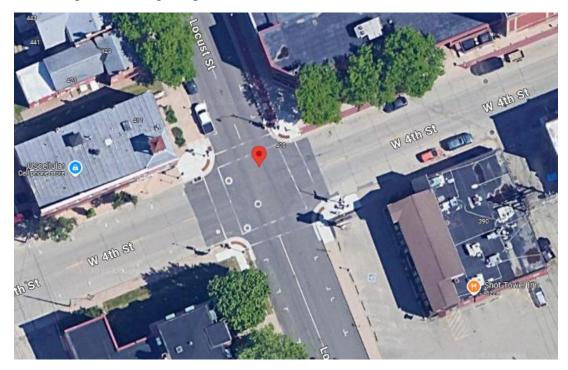
Figure 31: Intersection of Locust Street and West 4th Street

This site is a four-legged, undivided, low speed, signalized intersection with a medium PCR level for KAB crashes, indicating the need for attention and potential countermeasures (Google Maps Link). The area is predominantly commercial. The intersection has curbs, curb ramps, and sidewalks. The delineation and pavement are in good condition. Additionally, there are marked crosswalks and pedestrian signals present.

Based on the crash history, contributing factors, and performance data, the following safety improvements are recommended along with their associated cost levels:

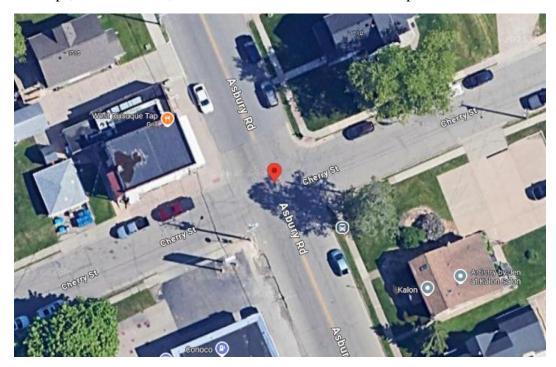
Figure 32: Intersection of Asbury Road and Cherry Street

This site has a medium PCR level for KAB crashes, indicating the need for attention and potential countermeasures. It is a four-legged, undivided, low speed, partial stop-controlled intersection located in a predominantly residential area (<u>Google Maps Link</u>). The intersection has curbs, curb ramps, and sidewalks, but there are no marked crosswalks present.

Crash reports indicate that a total of nine crashes have occurred at this intersection over a five-year period (2018-2022), including two KAB crashes and seven CO crashes. The predominant manner of collision for KAB crashes includes one broadside (front-to-side) collision and one non-collision event. For KABCO crashes, the most common types of collisions include broadside, rear-end, angle, non-collision, sideswipe, and other unspecified collisions. The primary contributing factors to KAB crashes include running a stop sign and failing to yield the right of way to pedestrians. Additional contributing factors for KABCO crashes involve loss of control, driver distraction, improper passing in prohibited areas, and failing to yield to pedestrians. The KAB Annual PCR for the intersection is 0.106933, indicating a medium

Based on the crash history, contributing factors, and performance data, the following safety improvements are recommended along with their associated cost levels:

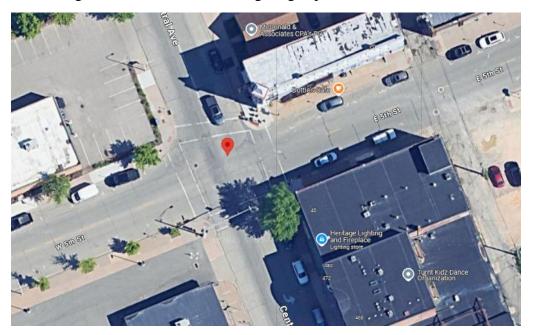
Figure 33: Intersection of Central Avenue and West 5th Street

This site is a four-legged, undivided, low speed, signalized intersection (Google Maps Link). It has a medium PCR level for KAB crashes, indicating the need for attention and potential countermeasures. The area is predominantly commercial. The intersection has curbs, curb ramps, and sidewalks. Additionally, there are marked crosswalks and pedestrian signals. The delineation and pavement are in good condition. Overhead lighting is present.

Based on the crash history, contributing factors, and performance data, the following safety improvements are recommended along with their associated cost levels:

- Employ multiphase signal operation (Low)
- Provide left-turn channelization (Moderate)
- Install overhead traffic signals on east and west approaches to improve signal visibility (Moderate)
- Implement safety recommendations made in Central and White Corridor Study (Varies)

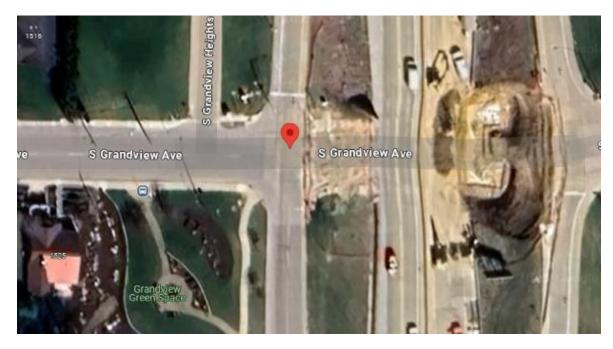
Figure 34: Intersection of US 61 and Grandview Avenue South Interchange (note ongoing construction in this aerial view)

This site has the medium PCR level for KAB crashes, indicating the need for immediate attention and potential countermeasures. It is a diamond interchange with stop control on the exit ramp portions of the roadway (<u>Google Maps Link</u>). The overhead lighting appears to be adequate, and the intersections feature curbs, curb ramps, and sidewalks. The pavement in good condition.

Crash reports indicate that a total of nine crashes have occurred at this intersection over a five-year period (2018-2022), including two KAB crashes and seven CO crashes. The predominant manner of collision for KABCO crashes includes broadside, rear-end, head-on, non-collision, and rear-to-side. The two KAB crashes consist of one head-on collision and one non-collision collision. The primary contributing factor to KAB crashes is loss of control, which resulted in severe outcomes. Other major causes of crashes at this intersection include failure to yield right-of-way from a stop sign, improper backing, and running a stop sign. The KAB Annual PCR for the intersection is 0.106088, indicating a medium severity level, while the KABCO Annual PCR is 0.50431, which is also categorized as medium. Based on statewide rankings, this intersection is ranked 894th for KAB crashes and 2365th for KABCO crashes out of 115,274 intersections statewide.

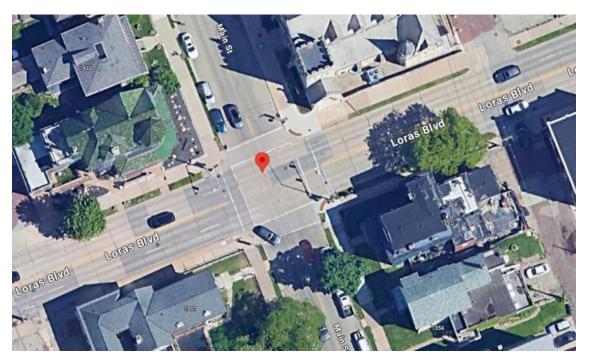
Figure 35: Intersection of Main Street and West 14th Street

This site is a four-legged, undivided, low speed, signalized intersection with a medium PCR level for KAB crashes, indicating the need for immediate attention and potential countermeasures (<u>Google Maps Link</u>). The area is predominantly residential, although there is a church at the northeast quadrant of the intersection. The lighting condition is adequate in this intersection. The intersection has curbs, curb ramps, and sidewalks. The delineation and pavement are in good condition. Additionally, there are marked crosswalks and pedestrian signals.

Based on the crash history, contributing factors, and performance data, the following safety improvements are recommended along with their associated cost levels:

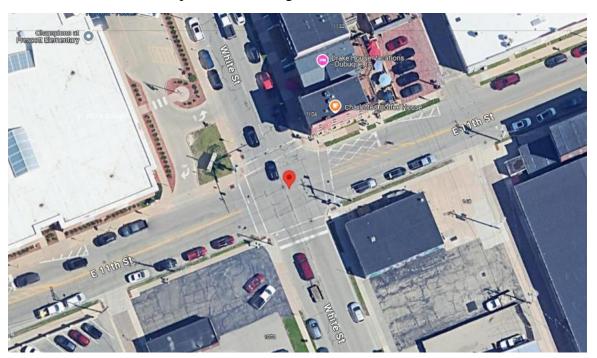
Figure 36: Intersection of East 11th Street and White Street

This site is a four-legged, undivided, low speed, signalized intersection with a medium PCR level for KAB crashes, requiring immediate attention and potential countermeasures (Google Maps Link). The area consists of a mixture of commercial and educational land use. An elementary school is located on the northwest side of the intersection. School zone crossing signs are in place to alert drivers of pedestrian presence. Additionally, there are marked crosswalks and pedestrian signals. The intersection has curbs, visible traffic signals, and good lighting conditions. The delineation and pavement are in good condition.

sideswipe (same direction) collisions. The primary contributing factor to KAB crashes is running a traffic signal, which led to severe broadside collisions at the intersection. Other contributing factors for KABCO crashes include making improper turns, improper or erratic lane changes, driver distraction, loss of control, and following too closely. The KAB Annual PCR for the intersection is 0.105856, classifying it as medium severity, while the KABCO Annual PCR is 2.078111, which is high. Based on statewide rankings, this intersection ranks 908th for KAB crashes and 472nd for KABCO crashes out of 115,274 intersections statewide, highlighting its significance as a high-risk location.

Based on the crash history, contributing factors, and performance data, the following safety improvements are recommended along with their associated cost levels:

- Optimize yellow and all red change interval (Low)
- Employ multiphase signal operation (Low/Moderate)
- Provide left-turn channelization on south approach (Moderate)
- Implement safety recommendations made in Central and White Corridor Study (Varies)

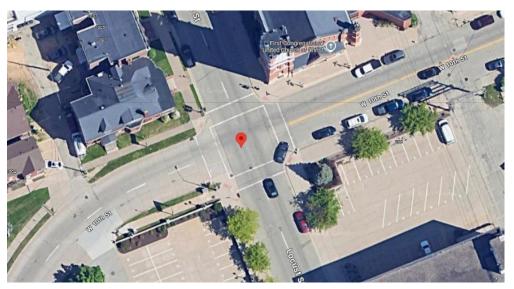
Figure 37: Intersection of Locust Street and West 10th Street

This site is a four-legged, undivided, low speed, signalized intersection with a medium PCR level for KAB crashes, highlighting the need for attention and possible countermeasures (Google Maps Link). The surrounding area is predominantly commercial, as well as two churches. The intersection is equipped with well-defined curbs, curb ramps, and sidewalks, while the delineation and pavement appear to be in good condition. Additionally, marked crosswalks and pedestrian signals are present.

Crash data from a five-year period (2018-2022) indicates that a total of 19 crashes occurred at this intersection, including two KAB crashes and seventeen CO crashes. The predominant manner of collision is broadside (front-to-side). Other notable collision types include sideswipe (same direction), rear-end (front-to-rear), and rear-to-rear crashes. The primary contributing factor to KAB crashes at this intersection is running a traffic signal. Additionally, major causes for KABCO crashes include driver distraction, improper backing, and operating a vehicle in an erratic or reckless manner. The KAB Annual PCR for this intersection is 0.105826, which is classified as medium, while the KABCO Annual PCR is 2.13559, indicating a high level of overall crash severity.

Based on the crash history, contributing factors, and performance data, the following safety improvements are recommended along with their associated cost levels:

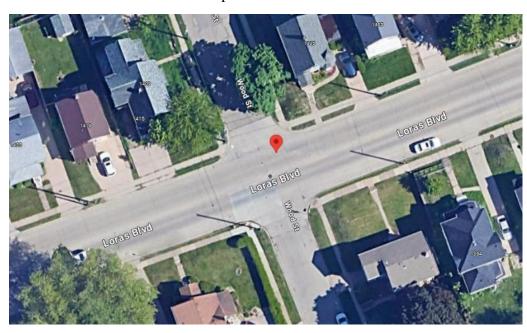
Figure 38: Intersection of Loras Boulevard and Wood Street

This site is a four-legged, undivided, low speed, partially stop controlled intersection with a medium PCR level for KAB crashes, highlighting the need for attention and potential countermeasures (Google Maps Link). The area is predominantly residential. There is an upward slope transitioning to a downward slope from the east to the west leg of the intersection. The intersection has well-defined curbs, curb ramps and sidewalks. The road pavement is in good condition. There are no marked crosswalks present.

Crash reports indicate that eight crashes have occurred at this intersection over a five-year period (2018-2022), including two KAB crashes and six CO crashes. The predominant manner of collision for KAB crashes is rear-end (front to rear), which accounts for 100% of the KAB crashes. Additionally, for KABCO crashes, rear-end collisions account for half of all incidents, while other crash types include angle (oncoming left turn), head-on (front to front), sideswipe (same direction), and rear-to-side collisions. The primary contributing factors to KAB crashes are loss of control and following too closely, which led to rear-end collisions at this intersection. Other contributing factors for KABCO crashes include improper turning movements, driver distraction, and failing to yield the right-of-way while making a left turn. The KAB Annual PCR for the intersection is 0.105312, indicating a medium severity level, while the KABCO Annual PCR is 0.345413, which is also considered medium. Based on statewide rankings, this intersection is ranked 923rd for KAB crashes and 3,286th for KABCO crashes out of 115,274 intersections statewide.

Based on the crash history, contributing factors, and performance data, the following safety improvements are recommended along with their associated cost levels:

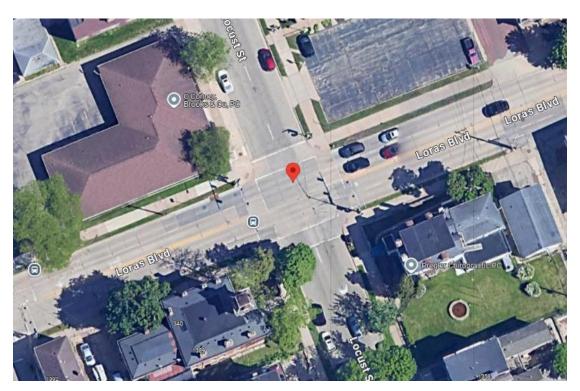
Figure 41: Intersection of Locust Street and West 14th Street

This site is a Four-legged, undivided, low speed, signalized intersection (<u>Google Maps Link</u>). It has a medium PCR level for KAB crashes, indicating the need for attention and potential countermeasures. The intersection features well-defined curbs, curb ramps, and sidewalks. Overhead lighting is present, and the pavement is in good condition. Additionally, there are marked crosswalks and pedestrian signals present.

Based on the crash history, contributing factors, and performance data, the following safety improvements are recommended along with their associated cost levels:

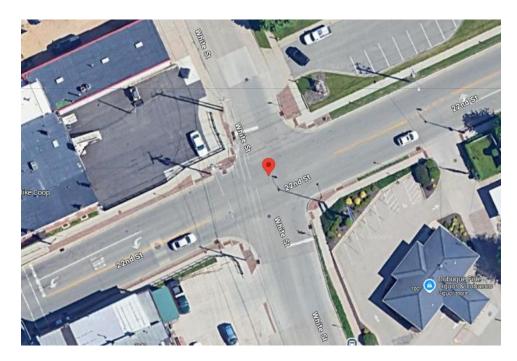
Figure 42: Intersection of East 22nd Street and Jackson Street

This site has a medium PCR level for KAB crashes, indicating the need for immediate attention and potential countermeasures. It is a four-legged, undivided, low speed, partial stop controlled intersection located in a mixed-use area with both commercial and residential land use present (Google Maps Link). The intersection features well-defined curbs, curb ramps, and sidewalks. Additionally, overhead lighting is present, and the pavement is in good condition.

Crash reports indicate that 13 crashes have occurred at this intersection over a five-year period (2018-2022), including two KAB crashes and eleven CO crashes. The predominant manner of collision is broadside (front-to-side), which accounts for the majority of the KABCO crashes. Both of the KAB crashes are broadside collision type. Other reported CO crash types include rear-end collisions, non-collision crashes, angle (oncoming left turn) crashes, and sideswipe (same direction) crashes. The significant proportion of broadside collisions suggests potential issues with right-of-way compliance and traffic control effectiveness. The primary contributing factor to KAB crashes at this intersection is failure to yield the right-of-way from a stop sign, which led to broadside collisions. Additionally, dominant contributing factors for CO crashes include loss of control, running a stop sign, and failing to yield the right-of-way from a stop sign and driver distraction. The KAB Annual PCR for the intersection is 0.101783, which is categorized as medium severity, while the KABCO Annual PCR is 1.217841, considered high. Based on statewide rankings, this intersection is ranked 1010th for KAB crashes and 941st for KABCO crashes out of 115,274 intersections statewide, highlighting its significance as a high-risk location.
