Appendix A: Dubuque MPO Sites

Intersections

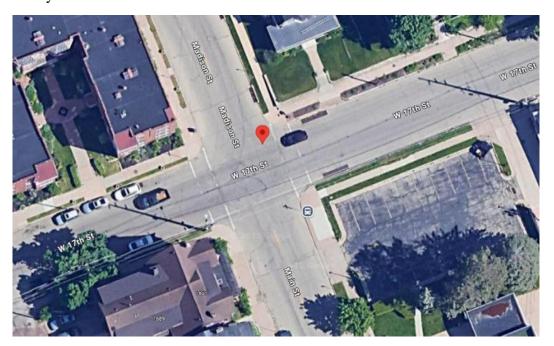
Figure 43: Intersection of Madison Street, Main Street and West 17th Street

This site is a four-legged, undivided, low speed, partial stop controlled intersection with a medium PCR level for KAB crashes, indicating the need for attention and potential countermeasures (Google Maps Link). The surrounding area is predominantly residential, and the intersection features well-defined curbs, curb ramps, and sidewalks. Overhead lighting is present, and the pavement is in good condition. There are marked crosswalks present, but they are located only on two sides of the intersection.

Crash data from 2018 to 2022 indicates that 28 crashes occurred at this intersection, including two KAB crashes and twenty-six CO crashes. The predominant manner of collision for both KAB and KABCO crashes is broadside (front-to-side), while other types of crashes include sideswipe, angle crashes involving left-turning vehicles, and rear-end collisions. The primary contributing factor to KAB crashes is running a stop sign, which directly led to broadside collisions. Similarly, the dominant contributing factors for CO crashes include failing to yield the right-of-way from a stop sign and running a stop sign. Other notable contributing factors include driver distraction, loss of control, and improper parking. The KAB Annual PCR for this intersection is 0.10106, indicating a medium severity level, while the KABCO Annual PCR is 3.449528, which is considered high. Based on statewide rankings, this intersection is ranked 1029th for KAB crashes and 221st for KABCO crashes out of 115,274 intersections statewide, highlighting its significance as a high-risk location.

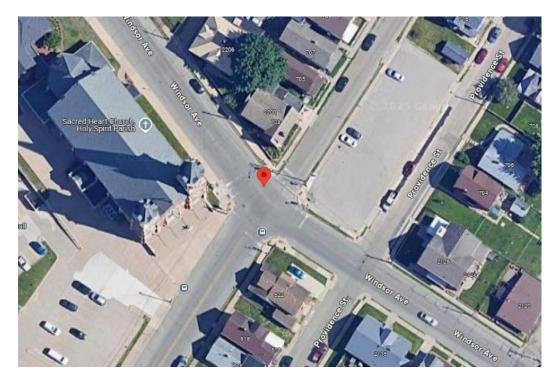
Figure 45: Intersection of East 22nd Street and Windsor Avenue

This site is a four-legged, undivided, low speed, signalized intersection (Google Maps Link). It has a medium PCR level for KAB crashes, indicating the need for attention and potential countermeasures. On the western side of the intersection, there is a church and a mall, while the other sides are residential areas. The intersection has well-defined curbs, curb ramps, and sidewalks. Overhead lighting is present at the intersection and the pavement is in good condition. Additionally, there are marked crosswalks present.

Crash reports indicate that 11 crashes have occurred at this intersection over a five-year period (2018-2022), including two KAB crashes and nine CO crashes. The predominant manner of collision for KAB crashes includes an angle (oncoming left turn) and a non-collision (single vehicle). Additionally, rear-end, sideswipe (same direction), broadside (front-to-side), and head-on (front-to-front) collisions were also reported in KABCO crashes. The primary contributing factors to KAB crashes include loss of control and passing in an unsafe manner, which resulted in severe crashes. Other contributing factors for CO crashes include failure to yield right-of-way at an uncontrolled intersection, making improper turns, and engaging in risky passing maneuvers. The KAB Annual PCR for the intersection is 0.094639, indicating a medium severity level, while the KABCO Annual PCR is 0.856087, also classified as medium. Based on statewide rankings, this intersection is ranked 1133rd for KAB crashes and 1406th for KABCO crashes out of 115,274 intersections statewide, underscoring its significance as a moderate-risk location.

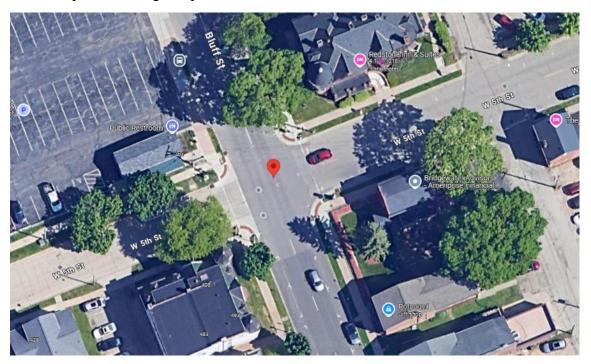
Figure 46: Intersection of Bluff Street and West 5th Street

This site has the medium PCR level for KAB crashes, indicating the need for immediate attention and potential countermeasures. It is a four-legged, undivided, low speed, signalized intersection (Google Maps Link). The area is a mixture of commercial and residential land-use. The intersection features well-defined curbs, curb ramps, and sidewalks. Overhead lighting is present at the intersection and the pavement is in good condition. Additionally, there are marked crosswalks and pedestrian signals present.

Crash reports indicate that eight crashes have occurred at this intersection over a five-year period (2018-2022), including two KAB crashes and six CO crashes. The predominant manner of collision for both KAB and KABCO crashes includes rear-end and non-collision types. Other crash types include broadside and sideswipe, same-direction collisions. The primary contributing factors to the KAB crashes are loss of control and failure to yield the right of way to pedestrians. Additionally, for CO crashes, making improper turns and loss of control were among the major causes. The KAB Annual PCR for the intersection is 0.091443, indicating a medium severity level, while the KABCO Annual PCR is 0.526619, also classified as medium. Based on statewide rankings, this intersection is ranked 1192nd for KAB crashes and 2254th for KABCO crashes out of 115,274 intersections statewide.

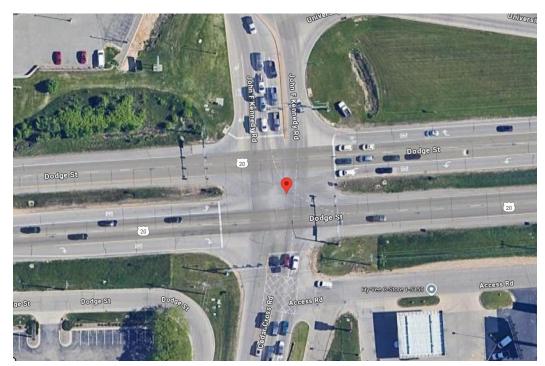
Figure 47: Intersection of US 20 and Cedar Cross Road

This site is a four-legged, divided, low speed, signalized intersection (<u>Google Maps Link</u>). It has a medium PCR level for KAB crashes, indicating the need for attention and potential countermeasures. The intersection is located in a predominantly commercial area, but lacks well-defined curbs, curb ramps, and sidewalks. Overhead lighting is present, and the pavement is in good condition.

crashes, followed by following too closely, failure to yield right-of-way while making left-turn and running a traffic signal. For KABCO crashes, the leading causes were also loss of control, following too closely, running traffic signal, failure to yield right-of-way from stop sign, driver distraction, improper backing, and improper lane changing. The KAB Annual PCR for the intersection is 0.089767, indicating a medium severity level, while the KABCO Annual PCR is 5.73234, which is considered very high. Based on statewide rankings, this intersection is ranked 1221st for KAB crashes and 80th for KABCO crashes out of 115,274 intersections statewide, making it a high-risk site that warrants significant attention.

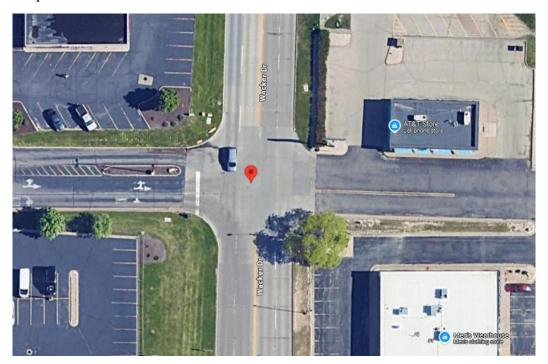
Figure 48: Intersection of Wacker Drive and Parking Entrances

This site has a medium PCR level for KAB crashes, indicating the need for immediate attention and potential countermeasures. It is a four-legged, divided, low Speed, partial stop controlled intersection (Google Maps Link). The area is predominantly commercial. Overhead lighting is present at the intersection and the pavement is in good condition. There are no marked crosswalks present.

Crash reports indicate that 24 crashes have occurred at this intersection over a five-year period from 2018 to 2022, including two KAB crashes and twenty-two CO crashes. The predominant manner of collision is broadside (front-to-side), accounting for the majority of crashes. Additionally, angle crashes (oncoming left turn), rear-end collisions, sideswipe (same direction), and head-on collisions were also reported, suggesting potential issues with right-of-way compliance and driver behavior. The two KAB crashes were classified as one rear-end collision and one angle collision. The primary contributing factors to KAB crashes at this intersection include failure to yield the right-of-way from a stop sign and making improper turns. The same issues also contributed significantly to CO crashes, along with failure to yield the right-of-way from a driveway, which was a dominating factor. Other contributing factors included failing to yield while making a left or right turn and improper turning movements. The KAB Annual PCR for the intersection is 0.088219, indicating a medium severity level, while the KABCO Annual PCR is 3.047159, which is considered high. Based on statewide rankings, this intersection is ranked 1234th for KAB crashes and 272nd for KABCO crashes out of 115,274 intersections statewide, making it a high-risk location.

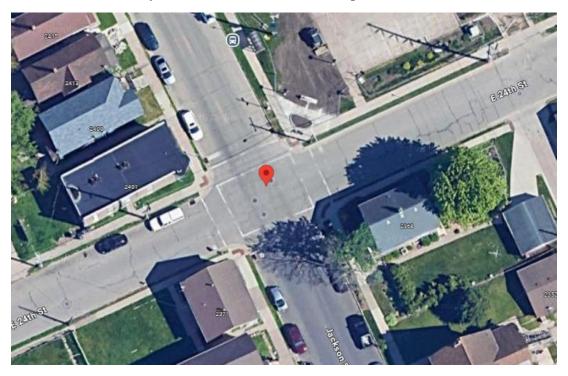
Figure 51: Intersection of East 24th Street and Jackson Street

This site is a four-legged, undivided, low speed, all way stop controlled intersection with a medium PCR level for KAB crashes, indicating the need for attention and potential countermeasures (Google Maps Link). The area is predominantly residential and features well-defined curbs, curb ramps, and sidewalks. Overhead lighting is present, and the pavement is in good condition. Additionally, there are marked crosswalks present.

Crash reports indicate that 17 crashes have occurred at this intersection over a five-year period (2018-2022), including two KAB crashes and fifteen CO crashes. The predominant manner of collision is broadside (front-to-side), accounting for a significant proportion of crashes, followed by rear-end and non-collision incidents. Among the KAB crashes, one was a broadside collision, while the other was a non-collision. The primary contributing factors to KAB crashes are running a stop sign and other unspecified causes. The dominating contribution factors to CO crashes include failure to yield the right-of-way from a stop sign, failure to keep in proper lane, and loss of control. The KAB Annual PCR for this intersection is 0.08338, indicating a medium severity level, while the KABCO Annual PCR is 1.98473, which is considered high. Based on statewide rankings, this intersection is ranked 1293rd for KAB crashes and 510th for KABCO crashes out of 115,274 intersections statewide, highlighting its significance as a high-risk location.

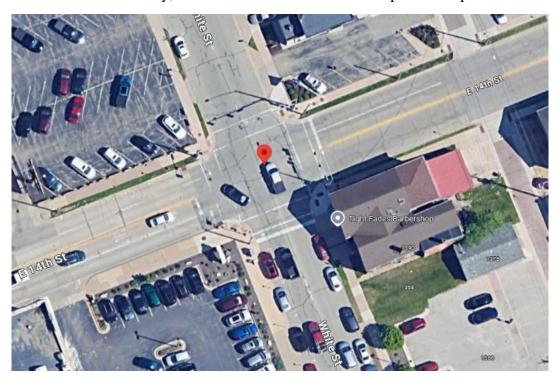
Figure 53: Intersection of East 14th Street and White Street

This site has a medium PCR level for KAB crashes, indicating the need for immediate attention and potential countermeasures. It is a four-legged, undivided, low speed, signalized intersection (Google Maps Link). The area is predominantly a commercial area. It has well-defined curbs, curb ramps, and sidewalks. Overhead lighting is present at the intersection and the pavement is in good condition. Additionally, there are marked crosswalks and pedestrian present.

Crash reports indicate that 39 crashes have occurred at this intersection over a five-year period (2018-2022), including two KAB crashes and 37 CO crashes. The predominant manner of collision is broadside (front-to-side), while other reported collision types include sideswipe (same direction), angle (oncoming left turn), rear-end (front-to-rear), non-collision (single vehicle), and head-on (front-to-front). The primary contributing factor to the KAB crashes is running a traffic signal. Other significant contributing factors to CO crashes include making improper turns, loss of control, and failure to yield right-of-way when making left turns. Additionally, improper or erratic lane changes and other miscellaneous factors also contributed to crashes at this intersection. The KAB Annual PCR for this intersection is 0.080622, which falls into the medium severity range, while the KABCO Annual PCR is 4.669363, classified as high. Based on statewide rankings, this intersection is ranked 1,336th for KAB crashes and 130th for KABCO crashes out of 115,274 intersections statewide, highlighting its significance as a high-risk location.

- Investigate and install alternative pedestrian signaling system (Moderate)
- Provide left-turn and right-turn channelization on south approach (High)
- Optimize signal timings (Low)
- Implement safety recommendations made in Central and White Corridor Study (Varies)

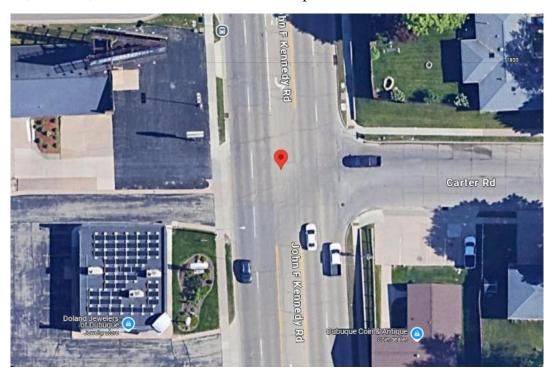
Figure 54: Intersection of Kennedy Road and Carter Road

This site has a medium PCR level for KAB crashes, indicating the need for immediate attention and potential countermeasures. It is a three-legged, undivided, low speed, partial stop controlled intersection located in a predominantly commercial area (<u>Google Maps Link</u>). The intersection features well-defined curbs, curb ramps, and sidewalks, with overhead. The pavement is in good condition; however, there are no marked crosswalks present.

Crash reports indicate that 39 crashes have occurred at this intersection over a five-year period (2018-2022), including three KAB crashes and 36 CO crashes. The predominant manner of collision is broadside (front-to-side), followed by rear-end and angle crashes. Two of the three KAB crashes were broadside collisions, while one involved an angle collision. The leading contributing factors to the KAB crashes were failure to yield the right-of-way from a stop sign

and failure to yield the right-of-way from a driveway. The dominant contributing factor for the CO crashes was failure to yield the right-of-way from a stop sign. Other contributing factors to crashes at this intersection include loss of control, running a stop sign, following too closely, failure to yield while making a left turn or from a driveway, driver distraction, and erratic lane changes. The KAB Annual PCR for the intersection is 0.076058, indicating a medium severity level, while the KABCO Annual PCR is 5.221809, which is considered high. Based on statewide rankings, this intersection is ranked 1,385th for KAB crashes and 97th for KABCO crashes out of 115,274 intersections statewide, emphasizing its significance as a high-risk location.

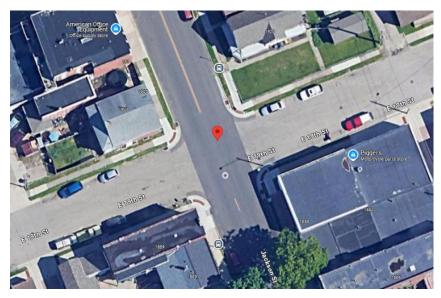
Figure 55: Intersection of East 19th Street and Jackson Street

This site has a medium PCR level for KAB crashes, indicating the need for attention and potential countermeasures. It is a four-legged, undivided, low speed, partial stop controlled intersection, located in a mixed commercial and residential area with bus stops near the intersection (Google Maps Link). The intersection has well-defined curbs, curb ramps, and sidewalks. Overhead lighting is present, and the pavement is in good condition. There are no marked crosswalks present.

Crash reports indicate that five crashes have occurred at this intersection over a five-year period (2018-2022), including two KAB crashes and three CO crashes. The predominant manner of collision is rear end (front-to-rear), followed by broadside collisions. Additionally, head-on and other crash types were recorded. The primary contributing factors to the KAB crashes include failure to yield right-of-way from a stop sign and running a stop sign. Other contributing factors in KABCO crashes include crossing the median (divided), driving too fast for conditions, and loss of control. The KAB Annual PCR for this intersection is 0.073778, indicating a medium severity level, while the KABCO Annual PCR is 0.361591, also classified as medium. Based on statewide rankings, this intersection is ranked 1,424th for KAB crashes and 3,155th for KABCO crashes out of 115,274 intersections statewide.

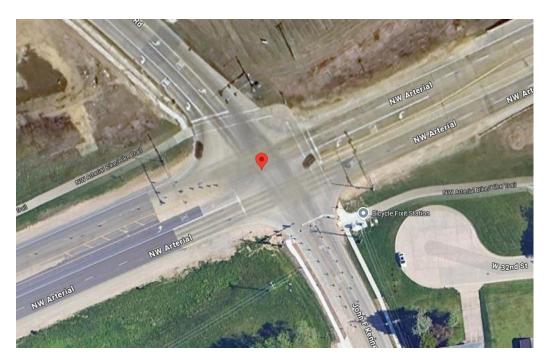
Figure 56: Intersection of Northwest Arterial and Kennedy Road

This site is a four-legged, divided, high speed, signalized intersection (<u>Google Maps Link</u>). It has a medium PCR level for KAB crashes, indicating the need for attention and potential countermeasures. The intersection is located in a predominantly residential area and features well-defined curbs, curb ramps, and sidewalks, but only on the north and east approaches. Marked crosswalks are also limited to these two legs. The intersection is well-lighted, and the pavement is in good condition.

Crash reports indicate that 35 crashes have occurred at this intersection over a five-year period (2018–2022), including three KAB crashes and thirty-two CO crashes. The predominant manner of collision is rear end (front-to-rear). Broadside collisions, sideswipes, unknown crash types, and rear-to-side crashes also have occurred. Among the KAB crashes, two were broadside and one was a rear-end collision, indicating a mix of severity and impact types. The primary contributing factors to the KAB crashes include running traffic signal, and improper or erratic lane changes. For CO crashes, the leading causes were loss of control and running traffic signals, along with following too closely, driver distraction and various forms of improper maneuvering. The KAB Annual PCR for this intersection is 0.066982, indicating a medium severity level, while the KABCO Annual PCR is 1.180091, which is considered high. Based on statewide rankings, this intersection is ranked 1,495th for KAB crashes and 984th for KABCO crashes out of 115,274 intersections statewide, making it a site of notable concern for both crash frequency and severity.

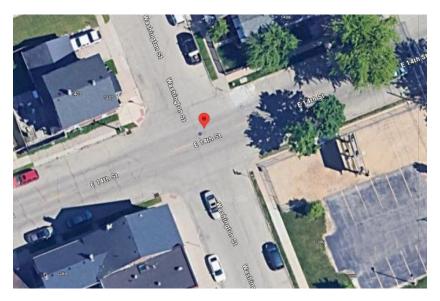
Figure 57: Intersection of East 14th Street and Washington Street

This intersection in the city of Dubuque has a medium PCR level for KAB crashes, indicating the need for immediate attention and potential countermeasures. It is a four-legged, undivided, low speed, partial stop controlled intersection in a predominantly residential area (Google Maps Link). The intersection has well-defined curbs, curb ramps, and sidewalks. Overhead lighting is present at the intersection, and the pavement is in good condition. There are no marked crosswalks present.

Crash reports indicate that seven crashes have occurred at this intersection over a five-year period (2018-2022), including two KAB crashes and five CO crashes. The predominant manner of collision includes broadside and rear-end crashes, with non-collision incidents also present. The KAB crashes consisted of one rear-end collision and one non-collision. The primary contributing factors to the KAB crashes are running off the road (right) and failing to yield the right of way to pedestrians. Additional contributing factors for CO crashes include loss of control and running a stop sign. The KAB Annual PCR for the intersection is 0.065014, indicating a medium severity level, while the KABCO Annual PCR is 0.549557, which is also considered medium. Based on statewide rankings, this intersection is ranked 1517th for KAB crashes and 2153rd for KABCO crashes out of 115,274 intersections statewide, highlighting its relevance as a potential safety concern.

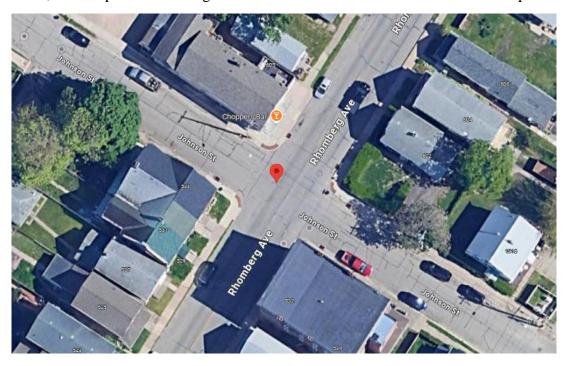
Figure 59: Intersection of Johnson Street and Rhomberg Avenue

This site has a medium PCR level for KAB crashes, indicating the need for immediate attention and potential countermeasures. It is a four-legged, undivided, low speed, partial stop controlled intersection (Google Maps Link). The area is predominantly a residential area. The intersection has well-defined curbs, curb ramps, and sidewalks. Overhead lighting is present at the intersection, and the pavement is in good condition. There are no marked crosswalks present.

Crash reports indicate that nine crashes occurred at this intersection over a five-year period (2018-2022), including two KAB crashes and seven CO crashes. The predominant manner of collision is broadside (front-to-side), along with rear-end collisions and non-collision crashes, suggesting potential issues with driver behavior, right-of-way compliance, and vehicle control. The primary contributing factors to the KAB crashes include aggressive driving/road rage for one crash, while the cause of the other was unknown. Other significant factors contributing to CO crashes include loss of control, driver distraction, improper backing, and failing to keep in

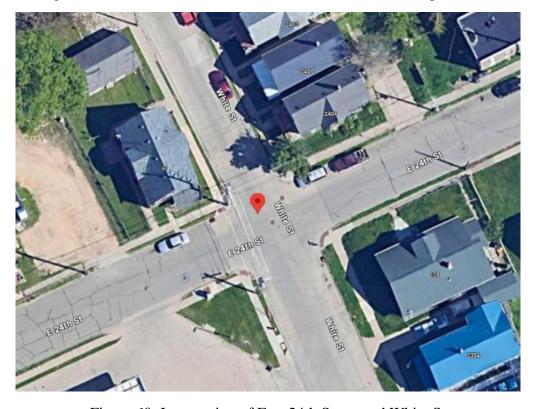
Figure 60: Intersection of East 24th Street and White Street

This site has a medium PCR level for KAB crashes, indicating the need for immediate attention and potential countermeasures. It is a Four-legged, undivided, low speed, partial stop controlled intersection located in a predominantly residential area (Google Maps Link). The intersection features well-defined curbs, curb ramps, and sidewalks. Overhead lighting is present, and the pavement is in good condition. However, there are no marked crosswalks present.

Crash reports indicate that 10 crashes have occurred at this intersection over a five-year period (2018-2022), including two KAB crashes and eight CO crashes. The predominant manner of collision is broadside (front-to-side), followed by non-collision and sideswipe crashes. The primary contributing factors to KAB crashes were unknown. However, the most significant contributing factor for CO crashes is running a stop sign. Other factors influencing crashes at this location include failure to yield right-of-way from stop signs and loss of control. The KAB Annual PCR for the intersection is 0.050017, indicating a medium severity level, while the KABCO Annual PCR is 0.945319, which is also considered medium. Based on statewide rankings, this intersection is ranked 1,660th for KAB crashes and 1,253rd for KABCO crashes out of 115,274 intersections statewide, underscoring its need for safety interventions.

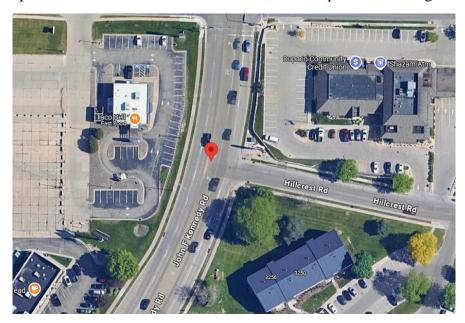
Figure 62: Intersection of Kennedy Road and Hillcrest Road

This site is a three-legged, undivided, low speed, partial stop controlled intersection (Google Maps Link). It has a high PCR level for KABCO crashes, indicating the need for immediate attention and potential countermeasures. The intersection is located in a predominantly commercial area and features well-defined curbs, curb ramps, and sidewalks. No marked crosswalks are present. The intersection is illuminated, and the pavement is in good condition.

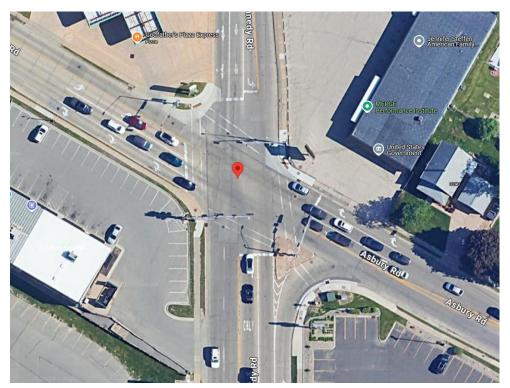
Figure 64: Intersection of Asbury Road and Kennedy Road

This site is a four-legged, undivided, low speed, signalized intersection (<u>Google Maps Link</u>). It has a high PCR level for KABCO crashes, indicating the need for immediate attention and potential countermeasures. The intersection is located in a predominantly commercial area and features well-defined curbs, curb ramps, sidewalks, and marked crosswalks with pedestrian signals. The intersection is illuminated, and the pavement is in good condition.

Crash reports indicate that 59 crashes have occurred at this intersection over a five-year period (2018–2022), including three KAB crashes and fifty-six CO crashes. The predominant manner of collision is rear end (front-to-rear), accounting for the largest share of KABCO crashes. Additionally, angle (oncoming left turn), broadside (front-to-side), sideswipe, and head-on crashes were also reported. Among the three KAB crashes, one each was categorized as rear-end, non-collision (single vehicle), and head-on, indicating a range of conflict types contributing to severe crash outcomes. The primary contributing factor to KABCO crashes is loss of control, improper or erratic lane changes, failure to yield right-of-way from driveway, failure to yield right-of-way while making a turn, running a traffic signal, and driver distraction. These behaviors point to intersection control violations and driver distraction. The KAB Annual PCR for the intersection is -0.071551, while the KABCO Annual PCR is 4.170753, which is considered high. Based on statewide rankings, this intersection is ranked 113,886th for KAB crashes and 164th for KABCO crashes out of 115,274 intersections statewide, emphasizing the high frequency of overall crash events at this location.

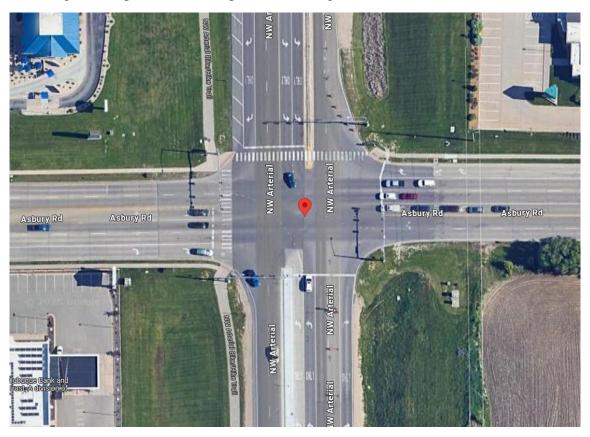
Figure 66: Intersection of Northwest Arterial and Asbury Road

This site is a four-legged, divided, moderate speed, signalized intersection (Google Maps Link). It has a low PCR level for KAB crashes but a high PCR level for KABCO crashes, indicating the need for immediate attention and potential countermeasures. The area is predominantly a commercial zone, with the southeast side of the intersection remaining undeveloped. The intersection includes well-defined curbs along the minor road, curb cuts, sidewalks, and overhead lighting is present. There is also a bike trail near the location. Marked crosswalks and pedestrian signals are present, and the pavement is in good condition.

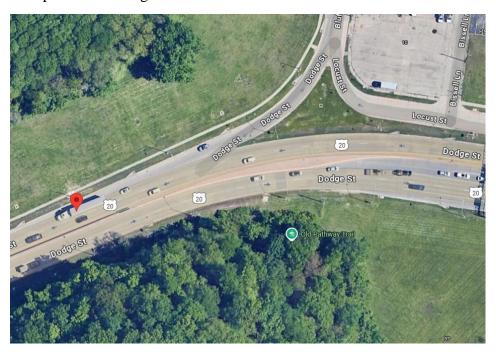
Figure 71: Intersection of US 20 and Bluff Street

This site is a three-legged, divided, low speed, yield controlled intersection (<u>Google Maps Link</u>). It has a medium PCR level for KABCO crashes, indicating the need for attention and potential countermeasures. The intersection is located in a predominantly commercial area and features overhead lighting and sidewalks on one side, but lacks curbs, curb ramps, and marked crosswalks. The pavement is in good condition.

Crash reports indicate that 38 crashes have occurred at this intersection over a five-year period (2018-2022), including three KAB crashes and thirty-five CO crashes. The predominant manner of collision is rear end (front-to-rear), followed by sideswipe (same direction) collisions. The primary contributing factors to KABCO crashes include loss of control and following too closely. Other major contributing causes across all crashes include failure to yield right-of-way from yielding, driver distraction and improper or erratic lane changes. The KAB Annual PCR for the intersection is 0.040713, indicating a low severity level, while the KABCO Annual PCR is 2.279263, which is considered high. Based on statewide rankings, this intersection is ranked 1,761st for KAB crashes and 411th for KABCO crashes out of 115,274 intersections statewide, highlighting its significance as a high-risk location.

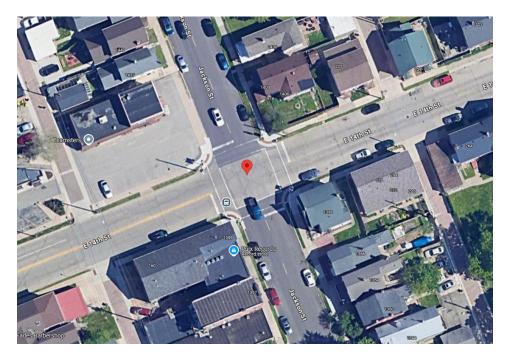
Figure 72: Intersection of East 14th Street and Jackson Street

This site is a four-legged, undivided, low speed, signalized intersection (Google Maps Link). It has a high PCR level for KABCO crashes, indicating the need for attention and potential countermeasures focused on overall crash reduction. The intersection is located in a mixed-use area with both commercial and residential. It features well-defined curbs, curb ramps, sidewalks, marked crosswalks, and pedestrian signals. The intersection is illuminated, and the pavement is in good condition.

Crash reports indicate that 19 crashes have occurred at this intersection over a five-year period (2018–2022), including one KAB crash and eighteen CO crashes. The predominant manner of collision is broadside (front-to-side), followed by rear-end collisions and sideswipes in the opposite direction. The primary contributing factor to KABCO crashes at this location is running a traffic signal, followed by loss of control, driver distraction, following too closely, and speeding. The KAB Annual PCR for the intersection is 0.032362, indicating a low severity level, while the KABCO Annual PCR is 2.238555, which is considered high. Based on statewide rankings, this intersection is ranked 2,541st for KAB crashes and 424th for KABCO crashes out of 115,274 intersections, highlighting its significance for non-severe crash frequency.

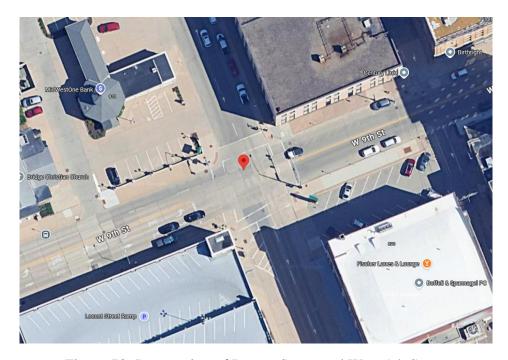
Figure 73: Intersection of Locust Street and West 9th Street

This site is a four-legged, undivided, low speed, signalized intersection (<u>Google Maps Link</u>). It has a high PCR level for KABCO crashes, indicating the need for immediate attention and potential countermeasures. The intersection is located in a predominantly commercial area and features well-defined curbs, curb ramps, sidewalks, and marked crosswalks with pedestrian signals. The intersection is illuminated, and the pavement is in good.

Crash reports indicate that 23 crashes have occurred at this intersection over a five-year period (2018–2022), including no KAB crashes and 23 CO crashes. The predominant manner of collision is broadside (front-to-side), accounting for more than half of the total crashes. Rear-end collisions, sideswipe and non-collision crashes were also reported, highlighting issues such as lane discipline and insufficient gap acceptance. There are no KAB crashes reported during this period. The primary contributing factor to KABCO crashes is running a traffic signal, which led to a significant number of broadside collisions at the intersection. Other contributing factors include improper or erratic lane changes, driver distraction, failure to yield right-of-way from driveways or to pedestrians, improper backing, etc. The KAB Annual PCR for the intersection is -0.103307, indicating no severe crash involvement, while the KABCO Annual PCR is 2.219743, which is considered high. Based on statewide rankings, this intersection is ranked 114,340th for KAB crashes and 430th for KABCO crashes out of 115,274 intersections statewide, underscoring its importance as a high-risk location for non-severe crashes.

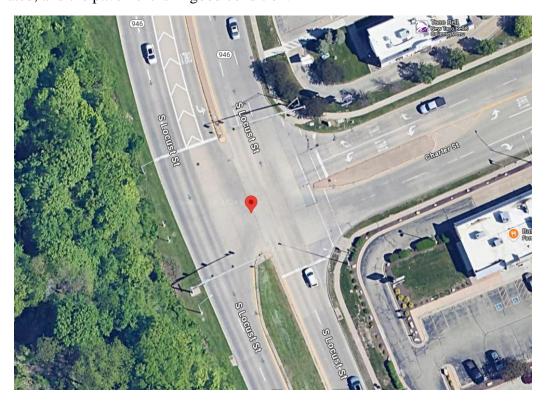
Figure 74: Intersection of Charter Street and South Locust Street

This site is a three-legged, divided, low speed, signalized intersection (<u>Google Maps Link</u>). It has a high PCR level for KABCO crashes, indicating the need for attention and potential countermeasures. The intersection is located in a predominantly commercial area and features well-defined curbs, curb ramps, sidewalks, and marked crosswalks. The intersection is illuminated, and the pavement is in good condition.

Crash reports indicate that 27 crashes have occurred at this intersection over a five-year period (2018–2022), including one KAB crash and twenty-six CO crashes. The predominant manners of collision are rear end, angle, and broadside, which together account for the majority of all crashes. The KAB crash was a rear-end collision. The primary contributing factor to KABCO crashes is failure to yield right-of-way while making left turns, which contributed to more than a third of all reported crashes. Other significant contributing factors include loss of control, making improper turns, running traffic signals, and driver distraction. The KAB Annual PCR for the intersection is -0.09683, indicating no severity level, while the KABCO Annual PCR is 2.181302, which is considered high. Based on statewide rankings, this intersection is ranked 114,263rd for KAB crashes and 446th for KABCO crashes out of 115,274 intersections statewide, highlighting its importance as a location needing safety improvements.

Based on the crash history, contributing factors, and performance data, the following safety improvements are recommended along with their associated cost levels:

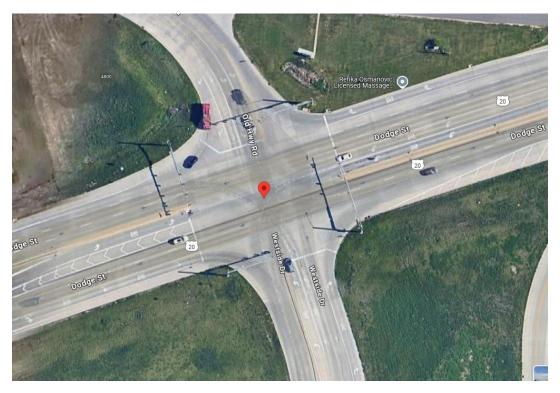
Figure 75: Intersection of US 20 and Westside Drive

This site is a four-legged, divided, high speed, signalized intersection (<u>Google Maps Link</u>). It has a high PCR level for KABCO crashes, indicating the need for immediate attention and potential countermeasures. The intersection is located in a predominantly commercial area and features well-defined curbs but lacks sidewalks. Overhead lighting is present, and the pavement is in good condition.

Crash reports indicate that 45 crashes have occurred at this intersection over a five-year period (2018–2022), including one KAB crash and forty-four CO crashes. The predominant manner of collision is rear end (front-to-rear), accounting for more than half of the total crashes. Additionally, sideswipes in the same direction were also reported, suggesting issues with following distance and potential lane-change conflicts. The primary contributing factor to KABCO crashes is loss of control, which led to the only severe crash at this location. Other contributing factors include improper or erratic lane movements, following too closely, making improper turns, and running traffic signals. The KAB Annual PCR for the intersection is -

Based on the crash history, contributing factors, and performance data, the following safety improvements are recommended along with their associated cost levels:

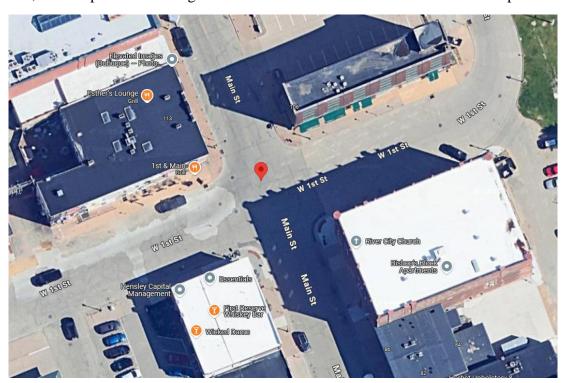
Figure 78: Intersection of Main Street and West 1st Street

This site is a four-legged, undivided, low speed, partial stop controlled intersection (Google Maps Link). It has a high PCR level for KABCO crashes, indicating the need for immediate attention and potential countermeasures. The intersection is located in a predominantly commercial area and features well-defined curbs, curb ramps, and sidewalks. Adequate lighting is present, and the pavement is in good condition. There are no marked crosswalks present.

Crash reports indicate that 16 crashes have occurred at this intersection over a five-year period (2018–2022), all of which were CO level crashes, with no recorded KAB crashes. The predominant manner of collision includes rear-to-rear crashes and sideswipe collisions (same direction), followed by rear-end, broadside, rear-to-side and sideswipes (opposite direction). The primary contributing factors to these KABCO crashes are loss of control and improper backing. Other significant contributors include driver distraction, failure to yield right-of-way from driveways, and improper turning movements. The KAB Annual PCR for the intersection is -0.04681 (indicating no serious injuries), while the KABCO Annual PCR stands at 1.585087, which is considered high. Based on statewide rankings, the intersection is positioned at

Based on the crash history, contributing factors, and performance data, the following safety improvements are recommended along with their associated cost levels:

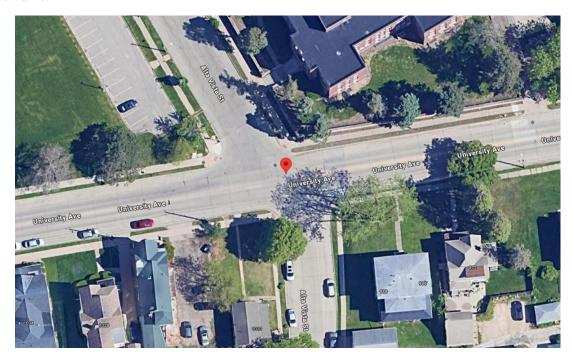
Figure 79: Intersection of University Avenue and Alta Vista Street

This site is a four-legged, undivided, low speed, partial stop controlled intersection (Google Maps Link). It has a low PCR level for KAB crashes but a high PCR level for KABCO crashes, indicating the need for attention and potential countermeasures. The intersection is located in a predominantly residential area and features well-defined curbs, curb ramps, sidewalks, and overhead lighting. Although the pavement is in good condition, there is a lack of marked crosswalks.

Crash reports indicate that 15 crashes have occurred at this intersection over a five-year period (2018-2022), including one KAB crash and fourteen CO crashes. The predominant manner of collision is broadside (front-to-side), followed by rear-end collisions and head-on crashes, suggesting possible concerns related to visibility, lane discipline, or yielding behavior. The primary contributing factor to the KABCO crash is loss of control and failure to yield right-of-

way from stop signs. Other contributing factors include running stop signs, following too closely, failure to yield right-of-way from driveways and while making left-turn. The KAB Annual PCR for the intersection is 0.033507, indicating a low severity level, while the KABCO Annual PCR is 1.559643, which is considered high. Based on statewide rankings, this intersection is ranked 2,291st for KAB crashes and 702nd for KABCO crashes out of 115,274 intersections statewide, highlighting its significance as a site requiring potential safety improvements.

Based on the crash history, contributing factors, and performance data, the following safety improvements are recommended along with their associated cost levels:

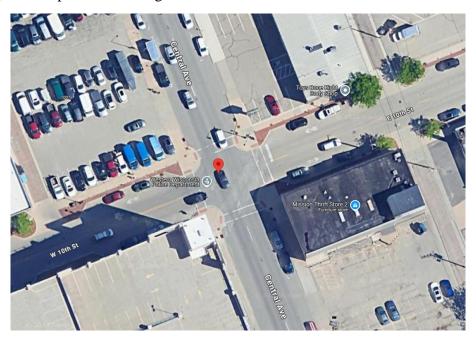
Figure 82: Intersection of Central Avenue and 10th Street

This site is a four-legged, undivided, low speed, partial stop controlled intersection (Google Maps Link). It has a high PCR level for KABCO crashes, highlighting the need for attention and potential countermeasures. The intersection is located in a predominantly commercial area and features well-defined curbs, curb ramps, sidewalks, and marked crosswalks. The intersection is illuminated, and the pavement is in good condition.

Based on the crash history, contributing factors, and performance data, the following safety improvements are recommended along with their associated cost levels:

- Install additional One Way signing as needed (Low)
- Install retroreflective tape on poles for conspicuity (Low)
- Provide left-turn lanes at intersection and install lane assignment pavement markings on north approach (Moderate)
- Implement safety recommendations made in Central and White Corridor Study (Varies)

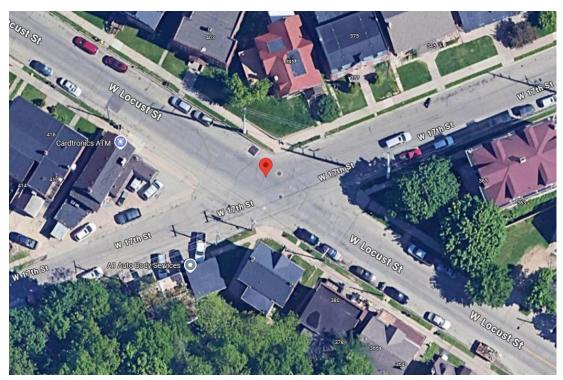
Figure 86: Intersection of Locust Street and West 17th Street

This site is a four-legged, undivided, low speed, partial stop controlled intersection (Google Maps Link). It has a high PCR level for KABCO crashes, indicating the need for immediate attention and potential countermeasures. The intersection is located in a predominantly residential area and features well-defined curbs, curb ramps, and sidewalks to support pedestrian access. The intersection is illuminated, and the pavement is in good condition. However, there are no marked crosswalks present.

manner of collision includes both broadside (front-to-side) and rear-end (front-to-rear) collisions, as well as non-collision, sideswipe, and miscellaneous, indicating diverse traffic conflict patterns. The primary contributing factors to KABCO crashes are loss of control of the vehicle and failure to yield right-of-way from stop signs, as well as running stop signs. The single KAB crash occurred due to loss of control. Other contributing factors include improper turning and FTYROW to pedestrians and from parking maneuvers. The KAB Annual PCR for the intersection is 0.026379, indicating a low severity level, while the KABCO Annual PCR is 1.305985, which is considered high. Based on statewide rankings, this intersection is ranked 3,404th for KAB crashes and 877th for KABCO crashes out of 115,274 intersections statewide, highlighting its significance as a high-risk location for non-severe crashes.

Based on the crash history, contributing factors, and performance data, the following safety improvements are recommended along with their associated cost levels:

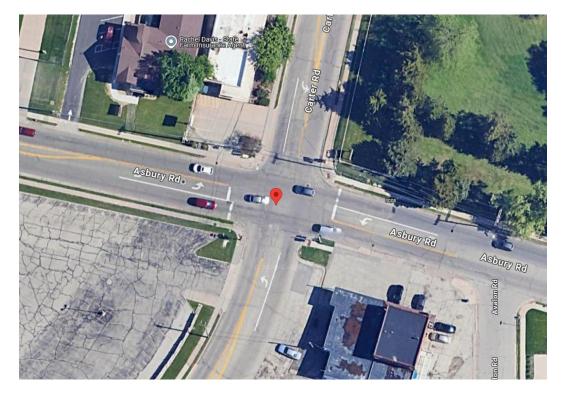
Figure 87: Intersection of Asbury Road and Avalon Road

This site is a four-legged, undivided, low speed, signalized intersection (<u>Google Maps Link</u>). It has a high PCR level for KABCO crashes, indicating the need for attention and potential countermeasures. The intersection is located in a predominantly commercial area and features well-defined curbs, curb ramps, and sidewalks. While pedestrian signals are present, there are no marked crosswalks. The intersection is illuminated, and the pavement is in good condition.

Crash reports indicate that a total of 28 crashes have occurred at this intersection over a five-year period (2018–2022), including two KAB crashes and 26 CO crashes. The predominant manner of collision is broadside (front-to-side, followed by rear-end and angle crashes, suggesting potential issues with driver attentiveness, right-of-way violations, and intersection navigation. The primary contributing factor to KAB crashes is running a traffic signal, which led to one of the two severe crashes. The other KAB crash was attributed to a left-turn failure to yield, which is also one of the leading causes of all crashes at this intersection. Other contributing factors include loss of control, driver distraction, and following too closely. The KAB Annual PCR for the intersection is -0.015001, indicating no severity level, while the KABCO Annual PCR is 1.298078, which is considered high. Based on statewide rankings, this intersection is ranked 110,446th for KAB crashes and 880th for KABCO crashes out of 115,274 intersections statewide, highlighting its importance as a high-risk location for overall crash frequency.

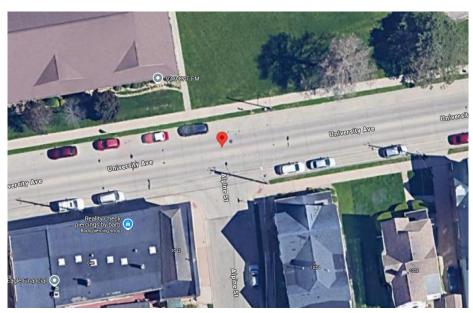
Figure 89: Intersection of University Avenue and Alpine Street

This site is a three-legged, undivided, low speed, partial stop controlled intersection (Google Maps Link). It has a high PCR level for KABCO crashes, indicating the need for immediate attention and potential countermeasures. The intersection is located in a mixture of commercial and residential area and features well-defined curbs, curb ramps, and sidewalks. The intersection is illuminated, and road pavement is in good condition. There are no marked crosswalks present.

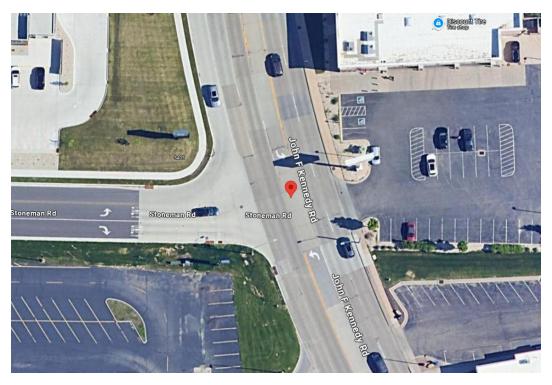
Figure 90: Intersection of Kennedy Road and Stoneman Road

This site is a three-legged, undivided, low speed, partial stop controlled intersection (Google Maps Link). It has a high PCR level for KABCO crashes, indicating the need for attention and potential countermeasures. The intersection is located in a predominantly commercial area and features well-defined curbs, curb ramps, sidewalks, and is illuminated by overhead lighting. The pavement is in good condition; however, there are no marked crosswalks present. Additionally, a driveway is located at the intersection approach, which could influence traffic flow and conflict points.

Crash reports indicate that 14 crashes have occurred at this intersection over a five-year period (2018–2022), including one KAB crash and thirteen CO crashes. The predominant manner of collision is broadside (front-to-side), as well as angle crashes (oncoming left turn), rear-end, rear-to-rear, sideswipe, head-on, and various other non-collision types, reflecting a diverse range of conflict scenarios. The primary contributing factors to the KABCO crashes are failure to yield right-of-way from a stop sign, and running stop sign. Other contributing factors for KABCO crashes include FTYROW from driveway, improper or erratic lane usage, FTYROW while making left turns, and loss of control. The KAB Annual PCR for the intersection is 0.010559, indicating a low severity level, while the KABCO Annual PCR is 1.196721, which is considered high. Based on statewide rankings, this intersection is ranked 5748th for KAB crashes and 966th for KABCO crashes out of 115,274 intersections statewide, reinforcing its status as a location with elevated crash potential.

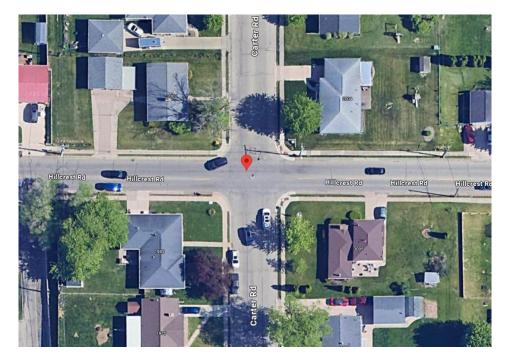
Figure 91: Intersection of Carter Road and Hillcrest Road

This site is a four-legged, undivided, low speed, all way stop controlled intersection (Google Maps link). It has a high PCR level for KABCO crashes, indicating the need for attention and potential countermeasures. The intersection is located in a predominantly residential area and features well-defined curbs, curb ramps, sidewalks, and overhead lighting. The road pavement is in good condition, but there are no marked crosswalks present.

Crash reports indicate that 13 crashes have occurred at this intersection over a five-year period (2018–2022), including one KAB crash and twelve CO crashes. The predominant manner of collision is broadside (front-to-side), as well as head-on collisions and unknown. The primary contributing factors to KABCO crashes are running a stop sign and failure to yield right-of-way at stop signs. Other contributing factors include improper turning movements, and failing to yield from parking and driveways. The KAB Annual PCR for the intersection is 0.034265, indicating a low severity level, while the KABCO Annual PCR is 1.177539, which is considered high. Based on statewide rankings, this intersection is ranked 1,951st for KAB crashes and 987th for KABCO crashes out of 115,274 intersections statewide, highlighting its relative significance in terms of crash frequency and risk.

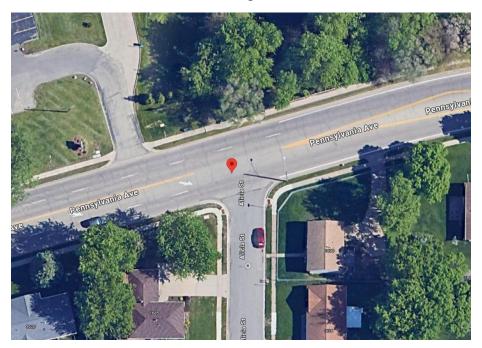
Figure 93: Intersection of Pennsylvania Avenue and Alicia Street

This site is a three-legged, undivided, low speed, partial stop controlled intersection (Google Maps Link). It has a high PCR level for KABCO crashes, indicating the need for immediate attention and potential countermeasures. The area is predominantly residential and features well-defined curbs, curb ramps, and sidewalks. Overhead lighting is present, and the pavement is in good condition. There are no marked crosswalks present.

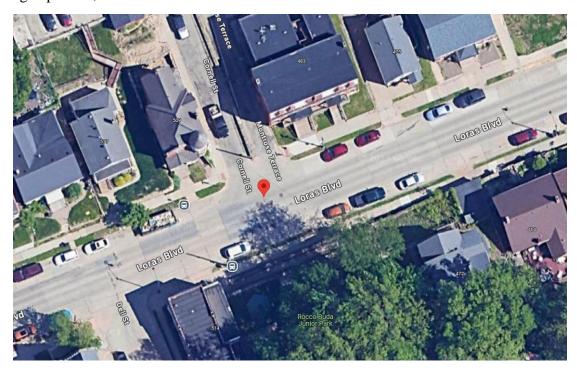
Figure 94: Intersection of Cornell Street and Pickett Street

This site is a three-legged, undivided, low speed, partial stop controlled intersection (Google Maps Link). It has a high KABCO PCR level that suggests the need for attention and potential countermeasures. The intersection is located in a predominantly residential area and features well-defined curbs, curb ramps, and sidewalks. The pavement is in good condition, and overhead lighting is present, but there are no marked crosswalks.

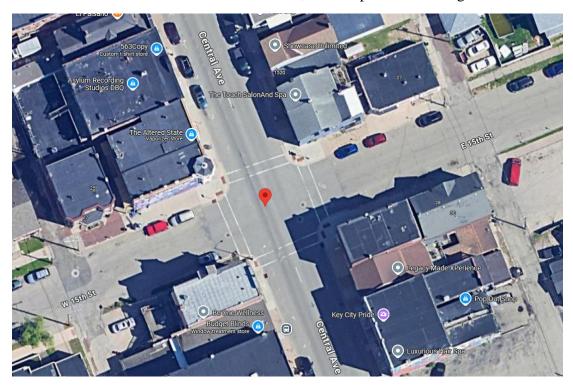
Figure 95: Intersection of Central Avenue and 15th Street

This site is a four-legged, undivided, low speed, signalized intersection (<u>Google Maps Link</u>). It has a low PCR level for KAB crashes but a high PCR level for KABCO crashes, indicating the need for immediate attention and potential countermeasures. The intersection is located in a predominantly commercial area and features well-defined curbs, curb ramps, sidewalks, and marked crosswalks. The intersection is illuminated, and the pavement is in good condition.

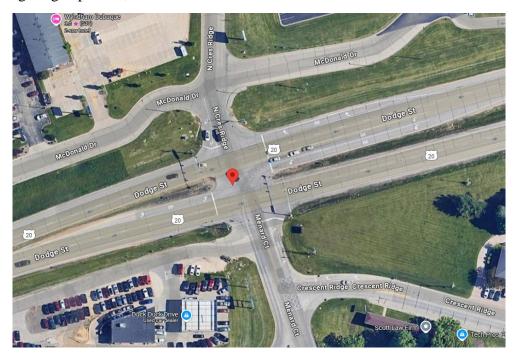
Figure 96: Intersection of US 20 and Menard Court

This site is a four-legged, divided, high speed, signalized intersection (<u>Google Maps Link</u>). It has a high PCR level for KABCO crashes, indicating the need for immediate attention and potential countermeasures. The intersection is located in a predominantly commercial area and does not feature curbs, curb ramps, or sidewalks. While the pavement is in good condition and overhead lighting is present, there are no marked crosswalks.

Crash reports indicate that a total of 60 crashes have occurred at this intersection over a five-year period (2018–2022), including five KAB crashes and fifty-five CO crashes. The predominant manner of collision is rear end (front-to-rear), as well as sideswipe (same direction) and broadside (front-to-side), reflecting a mix of congestion-related and right-of-way issues. The primary contributing factor to KABCO crashes is loss of control, running a traffic signal and following too closely. The KAB Annual PCR for the intersection is -0.102433, indicating no severity level, while the KABCO Annual PCR is 1.018033, which is considered high. Based on statewide rankings, this intersection is ranked 114,328th for KAB crashes and 1,163rd for KABCO crashes out of 115,274 intersections statewide, highlighting its significance in terms of overall crash frequency despite fewer severe outcomes.

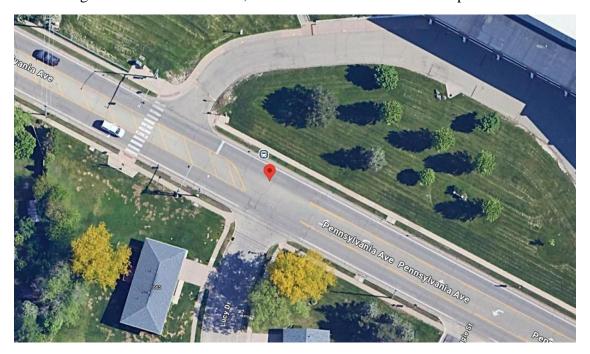
Figure 98: Intersection of Pennsylvania Avenue and Lucy Drive

This site is a three-legged, undivided, low speed, partial stop controlled intersection (Google Maps Link). It has a high PCR level for KABCO crashes, indicating the need for attention and potential countermeasures. The intersection is located in a predominantly residential area and features well-defined curbs, curb ramps, and sidewalks. The intersection is illuminated, and the pavement is in good condition. However, there are no marked crosswalks present.

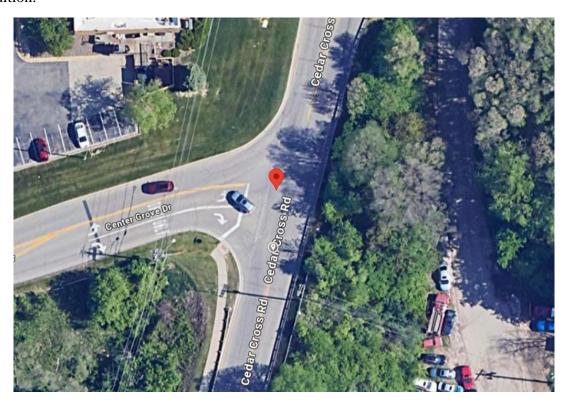
Figure 99: Intersection of Cedar Cross Road and Center Grove Drive

This site is a three-legged, undivided, low speed, partial stop controlled intersection (Google Maps Link). It has a medium PCR level for KABCO crashes, indicating the need for attention and potential countermeasures. The area surrounding the intersection is predominantly commercial. Although sidewalks exist on one side, the intersection lacks well-defined curbs, curb ramps or marked crosswalks. Overhead lighting is present, and the pavement is in good condition.

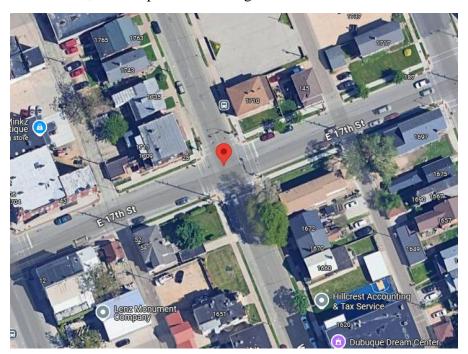
Figure 100: Intersection of White Street and East 17th Street

This site is a four-legged, undivided, low speed, signalized intersection (<u>Google Maps Link</u>). It has a medium PCR level for KABCO crashes, indicating the need for attention and potential countermeasures. The intersection is located in a predominantly residential area and features well-defined curbs, curb ramps, sidewalks, and marked crosswalks with pedestrian signals. The intersection is illuminated, and the pavement is in good condition.

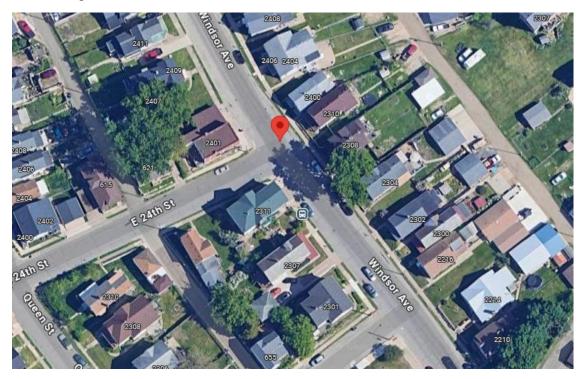
Figure 101: Intersection of East 24th Street and Windsor Avenue

This site is a three-legged, undivided, low speed, partial stop controlled intersection (Google Maps Link). It has a medium PCR level for KABCO crashes, indicating the need for attention and potential countermeasures. The intersection is located in a predominantly residential area and features well-defined curbs, curb ramps, and sidewalks. Although a bus stop is located near the approach, there are no marked crosswalks present. The intersection is illuminated, and the pavement is in good condition.

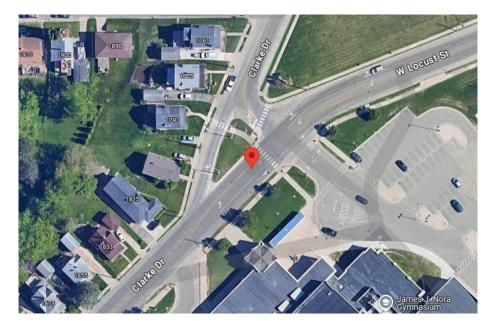
Figure 102: Intersection of Locust Street and Clarke Drive

This site is a three-legged, undivided, low speed, yield controlled intersection (Google Maps Link). It has a medium PCR level for KABCO crashes, indicating the need for attention and potential countermeasures. The intersection is located in a predominantly residential area with a high school located nearby. It features well-defined curbs, curb ramps, sidewalks, and marked crosswalks. The intersection is illuminated, and the pavement is in good condition.

Crash reports indicate that nine crashes have occurred at this intersection over a five-year period (2018-2022), including one KAB crash and eight CO crashes. The predominant manners of collision are rear end (front-to-rear) and sideswipe (same direction), each accounting for one-third of all crashes. Non-collision events and head-on crashes also occurred, though less frequently, suggesting a mix of crash types. The primary contributing factor to the KAB crash is failure to yield right-of-way to pedestrians, highlighting a concern for pedestrian safety near the high school. For CO crashes, the primary contributing factor to the crashes is lost control. Other contributing factors to crashes include following too closely, failure to yield the right of way from parking and from yielding, and improper or erratic lane changes. The KAB Annual PCR for the intersection is 0.031876, indicating a low severity level, while the KABCO Annual PCR is 0.925414, which is considered medium. Based on statewide rankings, this intersection is ranked 2,640th for KAB crashes and 1,284th for KABCO crashes out of 115,274 intersections statewide.

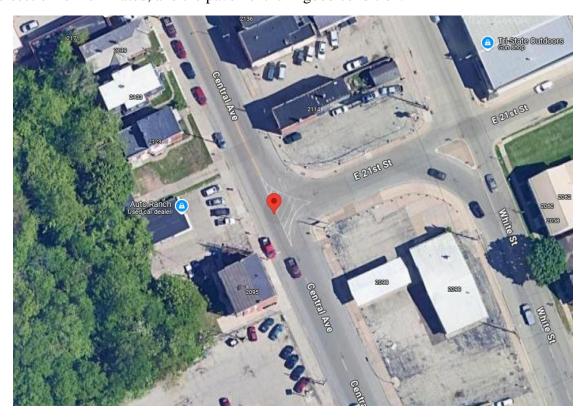
Figure 103: Intersection of Central Avenue and East 21st Street

This site is a three-legged, undivided, low speed, uncontrolled intersection (<u>Google Maps Link</u>). It has a medium PCR level for KABCO crashes, indicating the need for attention and potential countermeasures. The intersection is located in a predominantly commercial area and features well-defined curbs, curb ramps, and sidewalks, although no crosswalks are present. The intersection is illuminated, and the pavement is in good condition.
