Appendix A: Dubuque MPO Sites

Intersections

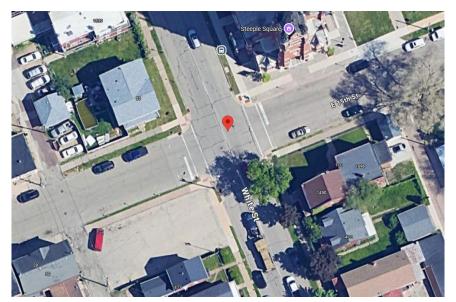
Figure 104: Intersection of White Street and East 15th Street

This site is a four-legged, undivided, low speed, partial stop controlled intersection (Google Maps Link). It has a medium PCR level for KABCO crashes, indicating the need for attention and potential countermeasures. The intersection is located in a predominantly residential area and features well-defined curbs, curb ramps, sidewalks, and marked crosswalks on two sides of the road. The intersection is illuminated, and the pavement is in good condition.

Crash reports indicate that 12 crashes have occurred at this intersection over a five-year period (2018–2022), including one KAB crash and eleven CO crashes. The predominant manner of collision is sideswipe (same direction), accounting for half of the total crashes. Additionally, broadside (front-to-side), angle crashes (oncoming left turn) and non-collision (single vehicle) were also reported, which may reflect issues with lane discipline and turning behavior. The primary contributing factor to the KABCO crash is improper or erratic lane changing. Other contributing factors include failure to yield right-of-way from stop sign, making improper turns, driver distraction, and loss of vehicle control. The KAB Annual PCR for the intersection is 0.024120, indicating a low severity level, while the KABCO Annual PCR is 0.903271, which is considered medium. Based on statewide rankings, this intersection is ranked 3,719th for KAB

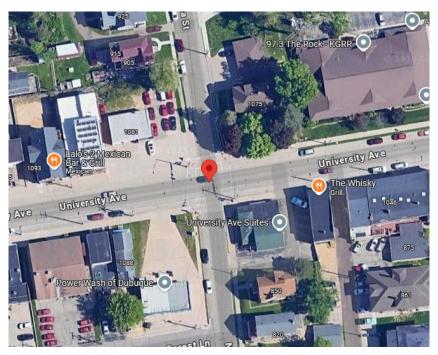
Figure 105: Intersection of University Avenue and Nevada Street

This site is a four-legged, undivided, low speed, signalized intersection (<u>Google Maps Link</u>). It has a medium PCR level for KABCO crashes, indicating the need for attention and potential countermeasures. The intersection is located in a mixed commercial and residential area and features well-defined curbs, curb ramps, sidewalks, and marked crosswalks with pedestrian signals. The intersection is illuminated, and the pavement is in good condition.

factor to the KABCO crash is loss of control, followed by driver distraction, improper backing, and multiple instances of failure to yield right-of-way, both at driveways and uncontrolled locations. The KAB Annual PCR for the intersection is 0.0323, indicating a low severity level, while the KABCO Annual PCR is 0.898463, which is considered medium. Based on statewide rankings, this intersection is ranked 2,553rd for KAB crashes and 1,331st for KABCO crashes out of 115,274 intersections statewide, highlighting it as a moderately high-risk location.

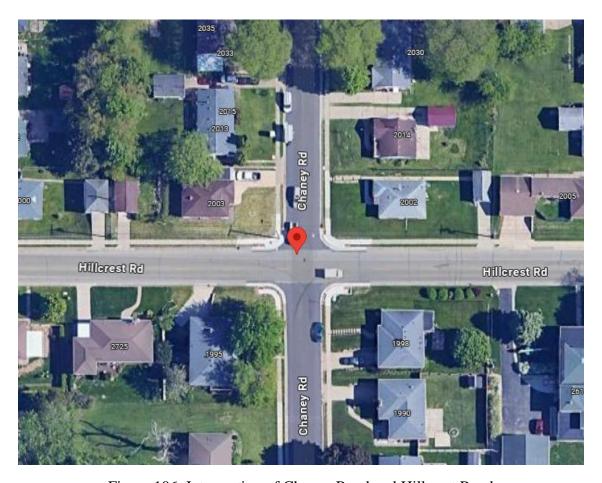
Figure 106: Intersection of Chaney Road and Hillcrest Road

This site is a four-legged, undivided, low speed, signalized intersection (<u>Google Maps Link</u>). It has a medium PCR level for KABCO crashes, indicating the need for attention and potential countermeasures. The intersection is located in a predominantly residential area and features well-defined curbs, curb ramps, and sidewalks, although there are no crosswalks. The intersection is illuminated, and the pavement is in good condition.

Crash reports indicate that 10 crashes have occurred at this intersection over a five-year period (2018–2022), all of which were classified as CO crashes, with no KAB crashes reported. The predominant manner of collision is broadside (front-to-side), rear-end collisions (front-to-rear), angle crashes (oncoming left turn), and sideswipes in the opposite direction. While there were no severe (KAB) crashes, the most frequent contributing factor to the CO crashes was running a stop sign, which led to multiple broadside collisions. Other contributing factors included loss of control, failure to yield right-of-way from a stop sign, improper backing, and making improper turns. The KAB Annual PCR is -0.021749 (low), while the KABCO Annual PCR is 0.889651, placing it in the medium range of severity level. Based on statewide rankings, this intersection is ranked 111,574th for KAB crashes and 1,355th for KABCO crashes out of 115,274 intersections statewide.

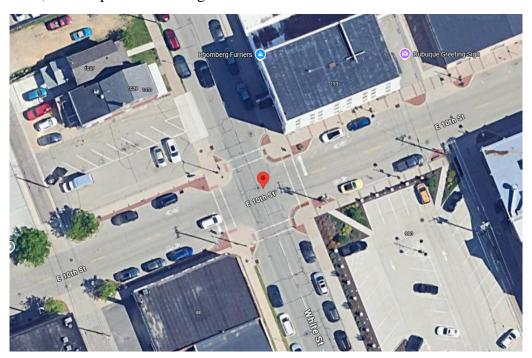
Figure 107: Intersection of White Street and East 10th Street

This site is a four-legged, undivided, low speed, partial stop controlled intersection (Google Maps Link). It has a medium PCR level for KABCO crashes, indicating the need for attention and potential countermeasures. The intersection is located in a predominantly commercial area and features well-defined curbs, curb ramps, sidewalks, and marked crosswalks. The intersection is illuminated, and the pavement is in good condition.

Crash reports indicate that 10 crashes have occurred at this intersection over a five-year period (2018-2022), including zero KAB crashes and ten CO crashes. The predominant manner of collision is broadside (front-to-side), angle crashes (oncoming left turn), sideswipes, and non-collision crashes. The major contributing factors to these crashes include running a stop sign, improper turning movements, driving too fast for conditions, lost control, and failure to yield right-of-way from stop control. The KAB Annual PCR for the intersection is -0.020226, indicating no severity level, while the KABCO Annual PCR is 0.888885, which is considered medium. Based on statewide rankings, this intersection is ranked 111,372nd for KAB crashes and 1,359th for KABCO crashes out of 115,274 intersections statewide.

- Add red pennants to stop signs to increase conspicuity (Low)
- Restrict or eliminate parking (Low)
- Implement safety recommendations made in Central and White Corridor Study (Varies)

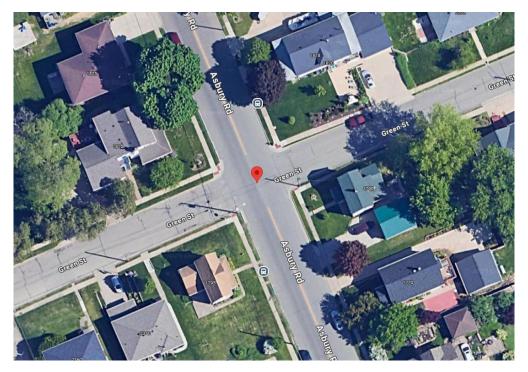
Figure 108: Intersection of Asbury Road and Green Street

This site is a four-legged, undivided, low speed, partial stop controlled intersection (Google Maps Link). It has a medium PCR level for KABCO crashes, indicating the need for attention and potential countermeasures. The intersection is located in a predominantly residential area and features well-defined curbs, curb ramps, and sidewalks, but crosswalks are not present. The intersection is illuminated, and the pavement is in good condition.

Crash reports indicate that 12 crashes have occurred at this intersection over a five-year period (2018–2022), all of which were classified as CO (property damage only), with zero severe (KAB) crashes reported. The predominant manner of collision is rear end (front-to-rear), followed by broadside collisions, and sideswipe in the same direction. The primary contributing factors to the KABCO crashes at this location are varied. These include driver distraction (external and adjacent), loss of control, making improper turns, following too closely, and failure to yield right-of-way from parking maneuvers. The KAB Annual PCR for this intersection is -0.059742, indicating no severity level, while the KABCO Annual PCR is 0.824203, which is considered medium. Based on statewide rankings, this intersection is ranked 113,624th for KAB crashes and 1,447th for KABCO crashes out of 115,274 intersections statewide.

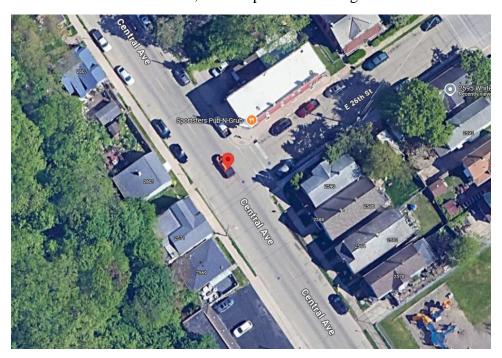
Figure 109: Intersection of Central Avenue and East 26th Street

This site is a three-legged, undivided, low speed, partial stop controlled intersection (Google Maps Link). It has a medium PCR level for KABCO crashes, indicating the need for attention and potential countermeasures. The intersection is located in a predominantly residential area and features well-defined curbs, curb ramps, sidewalks, and marked crosswalks on one side of the road. The intersection is illuminated, and the pavement is in good condition.

Crash reports indicate that nine crashes have occurred at this intersection over a five-year period (2018–2022), including one KAB crash and eight CO crashes. The predominant manner of collision include broadside (front-to-side), rear-end, angle, non-collision, and sideswipe crashes. This variety in crash types suggests potential concerns with turning movements, signal timing, and vehicle control. The primary contributing factors to KABCO crashes is loss of control, failure to yield right-of-way from a stop sign, running a stop sign, and failing to maintain proper

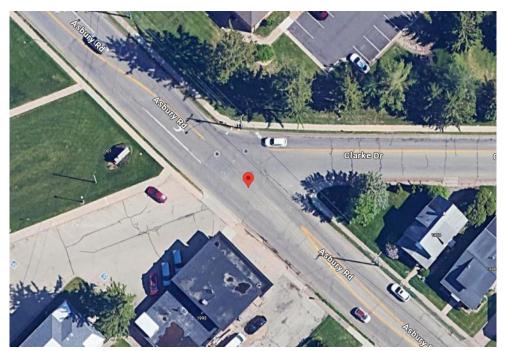
Figure 110: Intersection of Asbury Road and Clarke Drive

This site is a three-legged, undivided, low speed, partial stop controlled intersection (Google Maps Link). It has a medium PCR level for KABCO crashes, indicating the need for attention and potential countermeasures. The intersection is located in a predominantly residential area and is located near a medical center. It features well-defined curbs, curb ramps, and sidewalks, but no marked crosswalks. Overhead lighting is present at the intersection, and the pavement is in good condition.

Crash reports indicate that nine crashes have occurred at this intersection over a five-year period (2018–2022), including one KAB crash and eight CO crashes. The predominant manner of collision is rear end (front-to-rear), followed by broadside (front-to-side), angle (oncoming left turn), non-collision (single vehicle), and sideswipe crashes. The primary contributing factor to KABCO crashes is loss of control. Other contributing factors for all KABCO crashes include failure to yield right-of-way from a driveway, FTYROW from a stop sign and while making an improper left turn, and running stop sign. The KAB Annual PCR for the intersection is 0.011394, indicating a low severity level, while the KABCO Annual PCR is 0.780894, which is considered medium. Based on statewide rankings, this intersection is ranked 5,500th for KAB crashes and 1,537th for KABCO crashes out of 115,274 intersections statewide, suggesting that it is a location with moderate crash risk but notable concerns due to its crash frequency and variety of contributing factors.

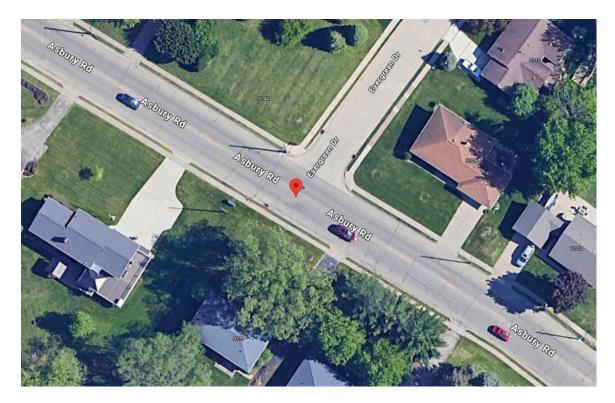
Figure 111: Intersection of Asbury Road and Evergreen Street

This site is a three-legged, undivided, low speed, partial stop controlled intersection (Google Maps Link). It has a medium PCR level for KABCO crashes, indicating the need for attention and potential countermeasures. The intersection is located in a predominantly residential area and features well-defined curbs, curb ramps, and sidewalks. Although overhead lighting is present and the pavement is in good condition, there are no marked crosswalks present.

Crash reports indicate that nine crashes have occurred at this intersection over a five-year period (2018–2022), including zero KAB crashes and nine CO crashes. The predominant manner of collision is rear end (front-to-rear), although broadside collisions were also reported. The primary contributing factor to CO crashes is following too closely, which resulted in a significant number of rear-end crashes. Other contributing factors include loss of control, running a stop sign, and various forms of driver distraction. The KAB Annual PCR for the intersection is - 0.005726, indicating no severity level, while the KABCO Annual PCR is 0.778823, which is considered medium. Based on statewide rankings, this intersection is ranked 106,240th for KAB crashes and 1,543rd for KABCO crashes out of 115,274 intersections statewide.

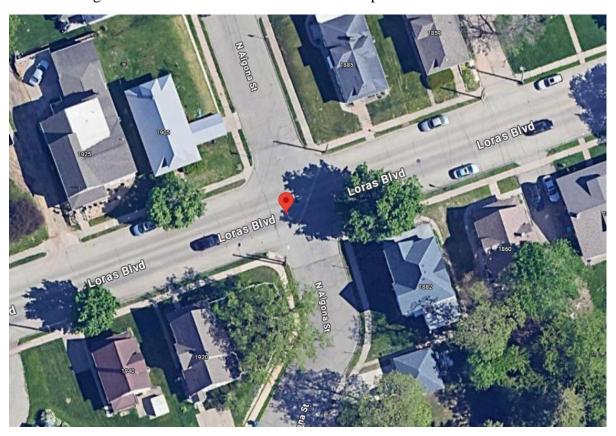
Figure 112: Intersection of Loras Boulevard and Algona Street

This site is a four-legged, undivided, low speed, partial stop controlled intersection (Google Maps Link). It has a medium PCR level for KABCO crashes, indicating the need for attention and potential countermeasures. The intersection is located in a predominantly residential area and features well-defined curbs, curb ramps, and sidewalks. Overhead lighting is present, and the pavement is in good condition. No marked crosswalks are present.

Crash reports indicate that nine crashes have occurred at this intersection over a five-year period (2018–2022), with no KAB crashes and nine CO crashes. The predominant manner of collision is angle (oncoming left turn), as well as broadside (front-to-side), sideswipe (same direction), rear-end (front to rear) and sideswipe (opposite direction). The primary contributing factors to CO crashes include loss of control, failure to yield right-of-way from stop sign and while making left turns, inattentive driving, and running stop signs. These behaviors indicate potential concerns regarding driver attentiveness and stop compliance at this intersection. The KAB Annual PCR for the intersection is -0.015206, indicating no severity level, while the KABCO Annual PCR is 0.776076, categorized as medium. Based on statewide rankings, this intersection is ranked 110,489th for KAB crashes and 1,547th for KABCO crashes out of 115,274 intersections, highlighting its relative risk level in terms of overall crash frequency.

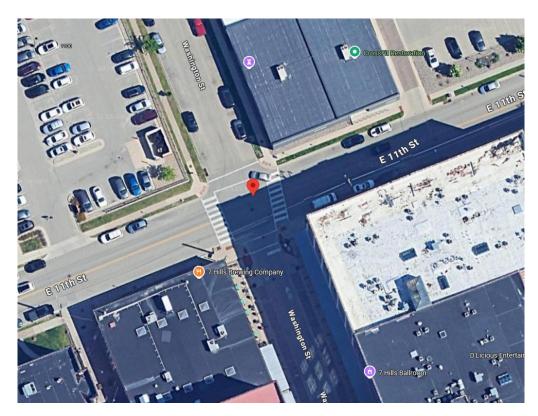
Figure 113: Intersection of East 11th Street and Washington Street

This site is a four-legged, undivided, low speed, partial stop controlled intersection (Google Maps Link). It has a medium PCR level for KABCO crashes, indicating the need for attention and potential countermeasures. The intersection is located in a predominantly commercial area and features well-defined curbs, curb ramps, sidewalks, and marked crosswalks. The intersection is illuminated, and the pavement is in good condition.

(single vehicle) crashes. The primary contributing factors to KABCO crashes include lost control and failure to yield right-of-way from stop sign. Other crashes were associated with a vehicle running stop sign, and failing to yield right-of-way while making left turn. The KAB Annual PCR for the intersection is 0.005298, indicating a low severity level, while the KABCO Annual PCR is 0.771192, which is considered medium. Based on statewide rankings, this intersection is ranked 7,071st for KAB crashes and 1,556th for KABCO crashes out of 115,274 intersections statewide, indicating a moderate risk profile.

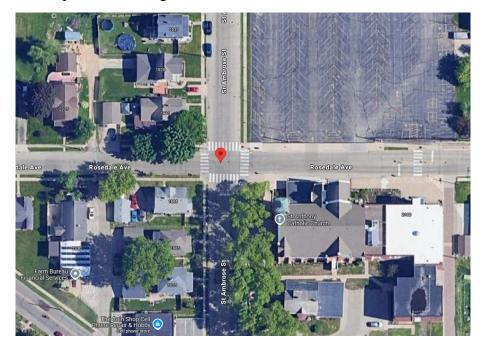
Figure 114: Intersection of Rosedale Avenue and Saint Ambrose Street

This site is a four-legged, undivided, low speed, partial stop controlled intersection (Google Maps Link). It has a medium PCR level for KABCO crashes, indicating the need for attention and potential countermeasures. The intersection is located in a predominantly residential area. It features well-defined curbs, curb ramps, sidewalks, and marked crosswalks. The intersection is illuminated, and the pavement is in good condition.

Crash reports indicate that eight crashes have occurred at this intersection over a five-year period (2018–2022), with no KAB crashes and eight CO crashes. The predominant manner of collision is broadside (front-to-side), followed by angle crashes (oncoming left turn) and rear-end collisions, suggesting potential issues with right-of-way compliance and driver attentiveness. The primary contributing factors to the CO crashes include running stop sign, failing to yield right-of-way from a stop sign or while making a left turn, and lost vehicle control. The KAB Annual PCR for the intersection is -0.01096, indicating a low severity level, while the KABCO Annual PCR is 0.760304, which is considered medium. Based on statewide rankings, this intersection is ranked 109,249th for KAB crashes and 1,593rd for KABCO crashes out of 115,274 intersections statewide.

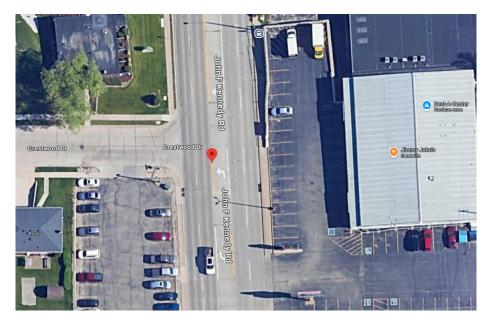
Figure 115: Intersection of Kennedy Road and Crestwood Drive

This site is a three-legged, undivided, low speed, partial stop controlled intersection (Google Maps Link). It has a medium PCR level for KABCO crashes, indicating the need for attention and potential countermeasures. The intersection is located in a mixed-use area with both commercial and residential. It features well-defined curbs, curb ramps, sidewalks, and is illuminated. The pavement is in good condition, however, there are no marked crosswalks present.

Crash reports indicate that nine crashes have occurred at this intersection over a five-year period (2018–2022), including one KAB crash and eight CO crashes. The manner of collision include rear end (front-to-rear), and broadside (front-to-side), reflecting potential visibility or yielding issues during turning maneuvers. The primary contributing factor to the KABCO crash is loss of control. Other contributing factors to the KABCO crashes include following too closely, failure to yield right-of-way from driveway and while making left-turn, and driver distraction. The KAB Annual PCR for the intersection is 0.011154, indicating a low severity level, while the KABCO Annual PCR is 0.754132, which is considered medium. Based on statewide rankings, this intersection is ranked 5,574th for KAB crashes and 1,612th for KABCO crashes out of 115,274 intersections statewide.

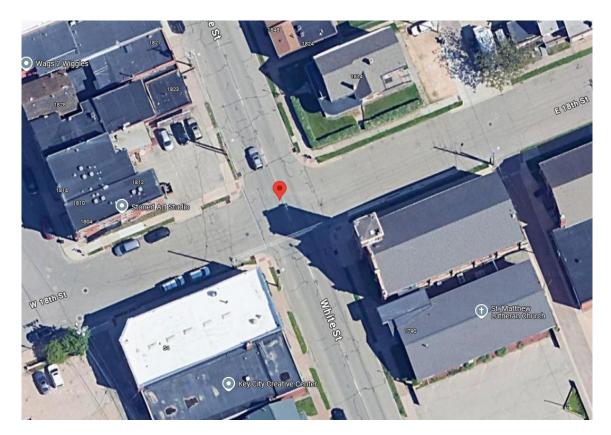
Figure 116: Intersection of White Street and East 18th Street

This site is a four-legged, undivided, low speed, partial stop controlled intersection (Google Maps Link). It has a medium PCR level for KABCO crashes, indicating the need for attention and potential countermeasures. The intersection is located in a mixed-use area, combining commercial and residential land uses. It features well-defined curbs, curb ramps, and sidewalks, but there are no marked crosswalks present. Overhead lighting is present, and the pavement is in good condition.

Crash reports indicate that nine crashes have occurred at this intersection over a five-year period (2018–2022), including one KAB crash and eight CO crashes. The predominant manner of collision is rear end (front-to-rear), as well as broadside (front-to-side) and sideswipe (same direction) collisions. The primary contributing factors to KABCO crashes are loss of control, driver distraction (passenger-related), failure to yield right-of-way at uncontrolled approaches, and improper turning movements. The KAB Annual PCR for the intersection is 0.034309, indicating a low severity level, while the KABCO Annual PCR is 0.724685, which is considered medium. Based on statewide rankings, the intersection is ranked 1,889th for KAB crashes and 1,664th for KABCO crashes out of 115,274 intersections statewide.

- Add crosswalks if needed (Low)
- Implement safety recommendations made in Central and White Corridor Study (Varies)

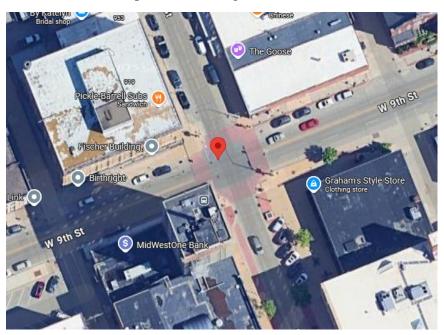
Figure 117: Intersection of Main Street and West 9th Street

This site is a four-legged, undivided, low speed, signalized intersection (<u>Google Maps Link</u>). It has a medium PCR level for KABCO crashes, indicating the need for attention and potential countermeasures. The intersection is located in a predominantly commercial area and features well-defined curbs, curb ramps, sidewalks, and marked crosswalks with pedestrian signals. The intersection is illuminated, and the pavement is in good condition.

Crash reports indicate that 15 crashes have occurred at this intersection over a five-year period (2018–2022), with no reported KAB crashes and fifteen CO crashes. The predominant manner of collision is broadside (front-to-side), followed closely by rear-end (front-to-rear) and sideswipe (same direction) crashes, suggesting issues with driver attentiveness, signal compliance, and lane discipline. Although there were no KAB crashes, the contributing factors to all CO crashes reveal that a significant number were due to running a traffic signal, lost control, failure to yield right-of-way while making a left turn, following too closely, failure to yield right-of-way from parking, and improper backing. These behaviors indicate poor compliance with traffic control devices and operational errors at the intersection. The KAB Annual PCR for the intersection is -0.107938, indicating no level, while the KABCO Annual PCR is 0.709189, which is considered medium. Based on statewide rankings, this intersection is ranked 114,388th for KAB crashes and 1,697th for KABCO crashes out of 115,274 intersections statewide, highlighting its moderate crash risk status.

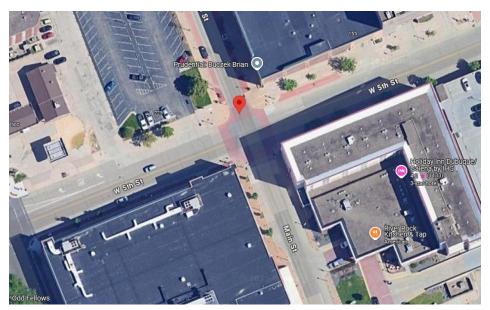
Figure 118: Intersection of Main Street and West 5th Street

This site is a four-legged, undivided, low speed, partial stop controlled intersection (Google Maps Link). It has a medium PCR level for KABCO crashes, indicating the need for attention and potential countermeasures. The intersection is located in a predominantly commercial area and features well-defined curbs, curb ramps, sidewalks, and marked crosswalks. The intersection is illuminated, and the pavement is in good condition.

Crash reports indicate that eight crashes have occurred at this intersection over a five-year period (2018-2022), including one KAB crash and seven CO crashes. The predominant manner of collision is broadside (front-to-side), followed by non-collision (single-vehicle) and rear-end collisions, indicating potential issues with intersection control and driver behavior. The primary contributing factor to KABCO crashes is running stop sign. Other contributing factors include driver loss of control and failure to yield right-of-way to pedestrians. The KAB Annual PCR for the intersection is 0.033827, indicating a low severity level, while the KABCO Annual PCR is 0.697395, which is considered high. Based on statewide rankings, this intersection is ranked 2,188th for KAB crashes and 1,717th for KABCO crashes out of 115,274 intersections statewide, highlighting its importance as a location needing safety improvements.

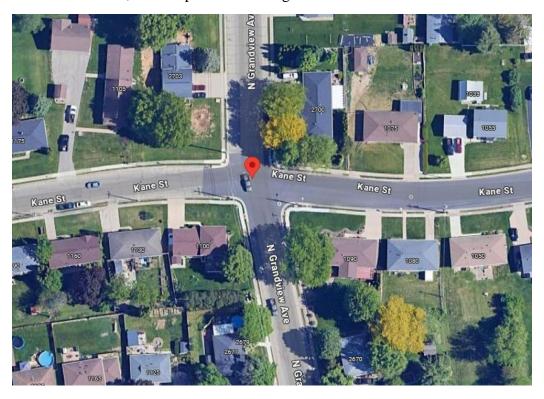
Figure 119: Intersection of Grandview Avenue and Kane Street

This site is a four-legged, undivided, low speed, partial stop controlled intersection (Google Maps Link). It has a medium PCR level for KABCO crashes, indicating the need for attention and potential countermeasures. The intersection is located in a predominantly residential area and features well-defined curbs, curb ramps, and sidewalks, but no marked crosswalks. The intersection is illuminated, and the pavement is in good condition.

Crash reports indicate that eight crashes have occurred at this intersection over a five-year period (2018-2022), all of which were classified as CO, with no reported KAB (severe injury or fatal) crashes. The predominant manner of collision is broadside (front-to-side), as well as rear-end collisions, suggesting potential issues with intersection control compliance and following distances. The primary contributing factor to CO crashes is drivers running stop signs, with other contributing factors including failure to yield right-of-way from stop position and driver distraction. The KAB Annual PCR for the intersection is -0.017985, indicating no severity level,

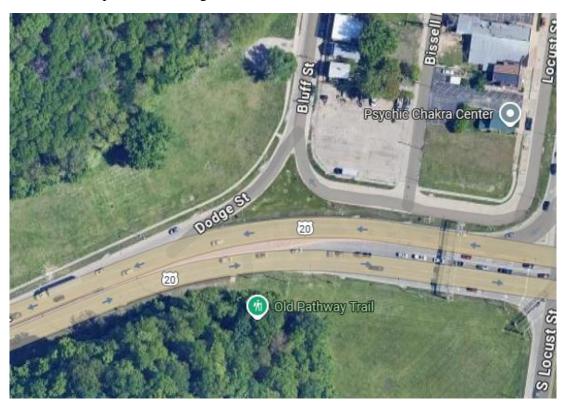
Figure 120: Intersection of Bluff Street and Connector Roadway

This site is a three-legged, undivided, low speed, partial stop controlled intersection (Google Maps Link). The southwest leg of the intersection serves as an entrance rap onto US 20 and is one-way. It has a medium PCR level for KABCO crashes, indicating the need for attention and potential countermeasures. The intersection is located in a mixed land use area and features sidewalks only on one side of the intersection, but lacks crosswalks. The intersection is illuminated, and the pavement is in good condition.

Crash reports indicate that eight crashes have occurred at this intersection over a five-year period (2018–2022), including one KAB crash and seven CO crashes. The predominant manner of collision is rear end (front-to-rear), along with sideswipe (same direction) and non-collision (single vehicle) crashes, suggesting possible driver behavior and control issues. The primary contributing factor to the KABCO crash is loss of control, while other major contributing factors to KABCO crashes include improper or erratic lane changing and improper starting maneuvers. The KAB Annual PCR for the intersection is 0.002425, indicating a low severity level, while the KABCO Annual PCR is 0.686839, which is considered medium. Based on statewide rankings, this intersection is ranked 7,850th for KAB crashes and 1,749th for KABCO crashes out of 115,274 intersections statewide.

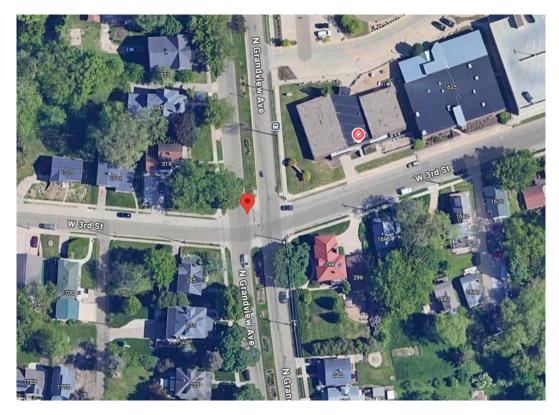
Figure 121: Intersection of Grandview Avenue and West 3rd Street

This site is a four-legged, semi-divided, low speed, partial stop controlled intersection (Google Maps Link). It has a medium PCR level for KABCO crashes, indicating the need for attention and potential countermeasures. The intersection is located in a predominantly residential area, with a medical center located in the northeast quadrant. It features well-defined curbs, curb ramps, and sidewalks, with overhead lighting ensuring adequate visibility. The pavement is in good condition, and marked crosswalks are present on two sides of the intersection.

Crash reports indicate that 11 crashes have occurred at this intersection over a five-year period (2018–2022), including one KAB crash and ten CO crashes. The predominant manners of collision are broadside (front-to-side) and rear-end (front-to-rear), as well as an angle collision (oncoming left turn). The primary contributing factor to the KABCO crash was loss of control along with failure to yield right-of-way from a stop sign, driver distraction, running a stop sign, following too closely, FTYROW during left-turn maneuvers, loss of control, and running off the road. The KAB Annual PCR for this intersection is 0.012491, indicating a low severity level, while the KABCO Annual PCR is 0.658028, which is considered medium. Based on statewide rankings, this intersection is ranked 5,174th for KAB crashes and 1,829th for KABCO crashes out of 115,274 intersections, identifying it as a notable location for potential safety improvements.

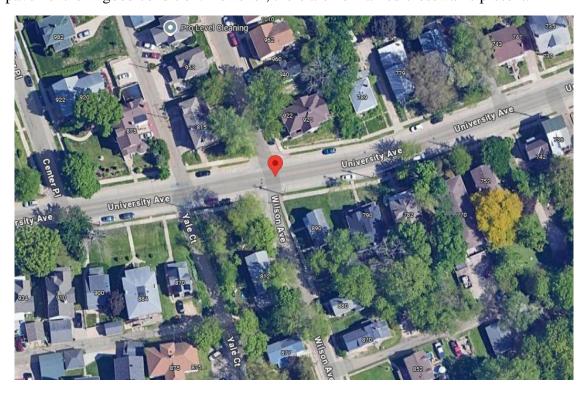
Figure 122: Intersection of University Avenue and Wilson Street

This site is a four-legged, undivided, low speed, partial stop controlled intersection (Google Maps Link). It has a medium PCR level for KABCO crashes, indicating the need for attention and potential countermeasures. The intersection is located in a predominantly residential area and features well-defined curbs, curb ramps, and sidewalks. The intersection is illuminated, and the pavement is in good condition. However, there are no marked crosswalks present.

Crash reports indicate that eight crashes have occurred at this intersection over a five-year period (2018–2022), including one KAB crash and seven CO crashes. The predominant manner of collision is broadside (front-to-side), with other crashes being non-collision and sideswipe (same direction). The primary contributing factor to the KABCO crash is loss of control, which led to a broadside collision. Other contributing factors for the KABCO crashes include failure to yield right-of-way from stop signs, from uncontrolled approaches, and from driveways, along with instances of running stop signs. The KAB Annual PCR for the intersection is 0.032357, indicating a low severity level, while the KABCO Annual PCR is 0.65349, which is considered medium. Based on statewide rankings, this intersection is ranked 2,543rd for KAB crashes and 1,841st for KABCO crashes out of 115,274 intersections statewide.

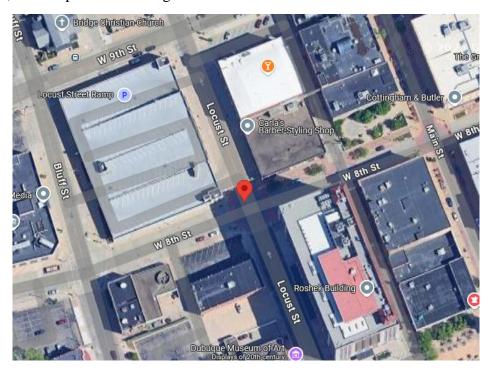
Figure 123: Intersection of Locust Street and West 8th Street

This site is a four-legged, undivided, low speed, signalized intersection (Google Maps Link). It has a medium PCR level for KABCO crashes, indicating the need for attention and potential countermeasures. The intersection is located in a predominantly commercial area and features well-defined curbs, curb ramps, sidewalks, and marked crosswalks. The intersection is illuminated, and the pavement is in good condition.

Crash reports indicate that 10 crashes have occurred at this intersection over a five-year period (2018-2022), including zero KAB crashes and ten CO crashes. The predominant manner of collision is broadside (front-to-side), followed by rear-end collisions, sideswipes, and non-collision crashes, indicating a variety of contributing risk factors. For KABCO crashes, the primary contributing factor was lost control, as well as running a traffic signal, improper or erratic lane changes, making improper turns, and traveling the wrong way. The KAB Annual PCR for the intersection is -0.035877, indicating no severity level, while the KABCO Annual PCR is 0.648296, which is considered medium. Based on statewide rankings, this intersection is ranked 112,732nd for KAB crashes and 1,856th for KABCO crashes out of 115,274 intersections statewide.

Based on the crash history, contributing factors, and performance data, the following safety improvements are recommended along with their associated cost levels:

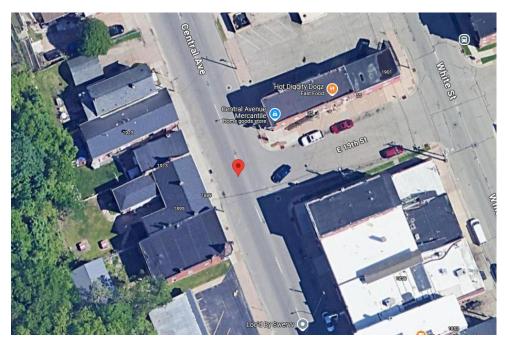
Figure 124: Intersection of Central Avenue and East 19th Street

This site is a three-legged, undivided, low speed, partial stop controlled intersection (Google Maps Link). It has a medium PCR level for KABCO crashes, indicating the need for attention and potential countermeasures. The intersection is located in a predominantly commercial area and features well-defined curbs, curb ramps, and sidewalks to support pedestrian safety. The intersection is illuminated, and the pavement is in good condition. No marked crosswalks are provided at this location.

Crash reports indicate that eight crashes have occurred at this intersection over a five-year period (2018–2022), all of which were CO crashes. The predominant manner of collision is sideswipe (same direction), while other reported crash types include angle (oncoming left turn), broadside (front-to-side), and rear-end collisions, pointing to potential issues related to lane discipline, turning maneuvers, and signal compliance. The primary contributing factors to crashes at this location are failure to yield right-of-way during left-turn movements and making improper turns. Additional contributing factors include improper or erratic lane changes, making improper turns,

and FTYROW violations from stop signs. The KAB Annual PCR for the intersection is - 0.001145, indicating no severity level, while the KABCO Annual PCR is 0.645573, which is considered medium. Based on statewide rankings, this intersection is ranked 94,703rd for KAB crashes and 1,862nd for KABCO crashes out of 115,274 intersections statewide, suggesting it may require operational improvements.

- Install lane assignment pavement markings on north approach (Low)
- Provide left-turn channelization on north approach (Moderate)
- Install Stay in Lane and No Weaving signage (Low)
- Relocate the utility poles; if relocation is not feasible, install retro-reflective tape to poles (Moderate)
- Implement safety recommendations made in Central and White Corridor Study (Varies)

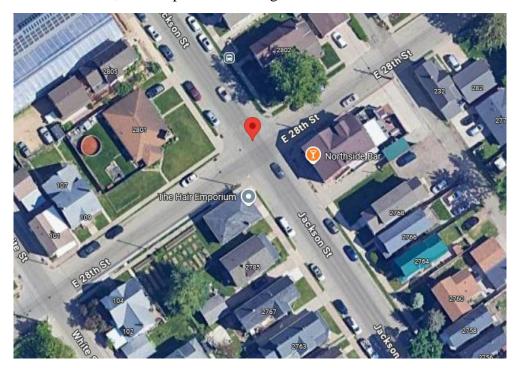
Figure 125: Intersection of Jackson Street and East 28th Street

This site is a four-legged, undivided, low speed, partial stop controlled intersection (Google Maps Link). It has a medium PCR level for KABCO crashes, indicating the need for attention and potential countermeasures. The intersection is located in a predominantly residential area and features well-defined curbs, curb ramps, and sidewalks, but lacks crosswalks. The intersection is illuminated, and the pavement is in good condition.

Crash reports indicate that eight crashes have occurred at this intersection over a five-year period (2018–2022), including one KAB crash and seven CO crashes. The predominant manner of collision is broadside (front-to-side), as well as sideswipe (same direction) and rear-end collisions, indicating a range of contributing factors and potential conflicts at the intersection. The primary contributing factor to the KABCO crash is failure to yield the right-of-way from a stop sign, which led to broadside crashes. Other contributing factors to KABCO crashes include loss of control, running stop sign, and swerving/evasive maneuvers. The KAB Annual PCR for the intersection is 0.025711, indicating a low severity level, while the KABCO Annual PCR is 0.642280, which is considered medium. Based on statewide rankings, this intersection is ranked 3,505th for KAB crashes and 1,877th for KABCO crashes out of 115,274 intersections statewide.

Based on the crash history, contributing factors, and performance data, the following safety improvements are recommended along with their associated cost levels:

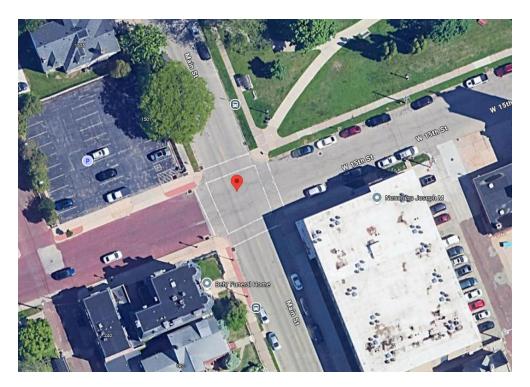
Figure 126: Intersection of Main Street and West 15th Street

This site is a four-legged, undivided, low speed, partial stop controlled intersection (Google Maps Link). It has a medium PCR level for KABCO crashes, indicating the need for attention and potential countermeasures. The area is a mixture of commercial and residential land use. The intersection features well-defined curbs, curb ramps, and sidewalks, but no crosswalks are present. Overhead lighting ensures good visibility, and the pavement is in good condition.

Crash reports indicate that seven crashes occurred at this intersection over a five-year period (2018–2022), including one KAB crash and six CO crashes. The predominant manners of collision were broadside (front-to-side) and rear-end (front-to-rear). The primary contributing factor to the KABCO crash was failure to yield right-of-way (FTYROW) at a stop sign. Other contributing factors to overall crashes include driver distraction and driving too fast for conditions. The KAB Annual PCR for the intersection is 0.020983, which is considered low, while the KABCO Annual PCR is 0.641883, indicating a medium severity level. Based on statewide rankings, this intersection is ranked 4,142nd for KAB crashes and 1,879th for KABCO crashes out of 115,274 intersections statewide.

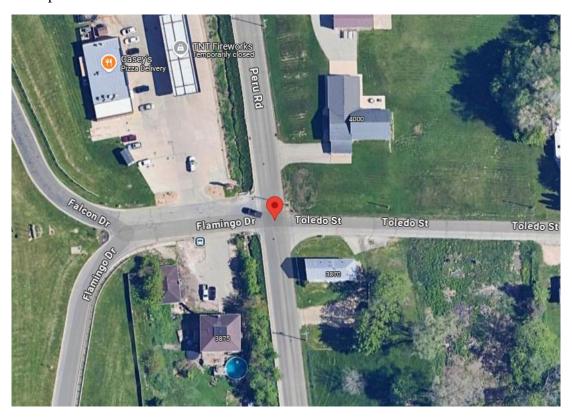
Figure 127: Intersection of Peru Road and Toledo Street

This site is a four-legged, undivided, low speed, partial stop controlled intersection (Google Maps Link). It has a medium PCR level for KABCO crashes, indicating the need for attention and potential countermeasures. The intersection is located in a predominantly residential area and features well-defined curbs, curb ramps, and sidewalks to support pedestrian movement. The intersection is illuminated, and the pavement is in good condition. However, there are no marked crosswalks present.

Crash reports indicate that eight crashes have occurred at this intersection over a five-year period (2018–2022), including one KAB crash and seven CO crashes. The predominant manner of collision include broadside (front-to-side), rear-end collisions, non-collision single-vehicle crashes and rear to rear crashes, highlighting varied driver behaviors and situational hazards. The primary contributing factor to the KABCO crashes is running stop sign indicating possible issues related to rules violation. Other contributing factors for KABCO crashes include driving too fast for conditions, loss of control, improper turns, running off road on right side, and driver inexperience. The KAB Annual PCR for the intersection is 0.025355, indicating a low severity level, while the KABCO Annual PCR is 0.640616, which is considered medium. Based on statewide rankings, this intersection is ranked 3,548th for KAB crashes and 1,885th for KABCO crashes out of 115,274 intersections statewide, reflecting a need for moderate attention.

Based on the crash history, contributing factors, and performance data, the following safety improvements are recommended along with their associated cost levels:

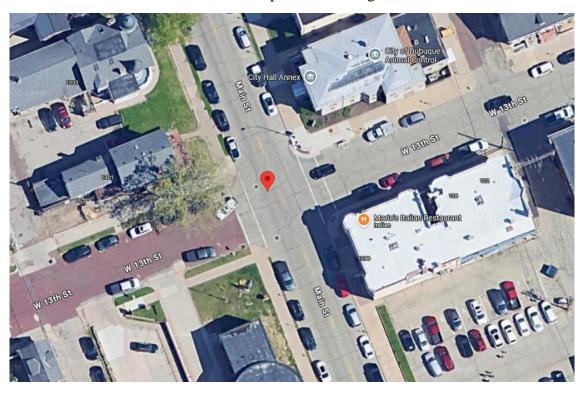
Figure 128: Intersection of Main Street and West 13th Street

This site is a four-legged, undivided, low speed, partial stop controlled intersection (Google Maps Link). It has a medium PCR level for KABCO crashes, indicating the need for attention and potential countermeasures. The intersection is located in a predominantly commercial area and features well-defined curbs, curb ramps, sidewalks, and marked crosswalks on the minor road. The intersection is illuminated, and the pavement is in good condition.

Crash reports indicate that eight crashes have occurred at this intersection over a five-year period (2018–2022), with no KAB crashes and eight CO crashes. The predominant manner of collision is broadside (front-to-side), as well as one non-collision crash (single vehicle). The primary contributing factors to KABCO crashes include failure to yield right-of-way from stop signs, and running stop signs. The KAB Annual PCR for the intersection is -0.024464, indicating no

Based on the crash history, contributing factors, and performance data, the following safety improvements are recommended along with their associated cost levels:

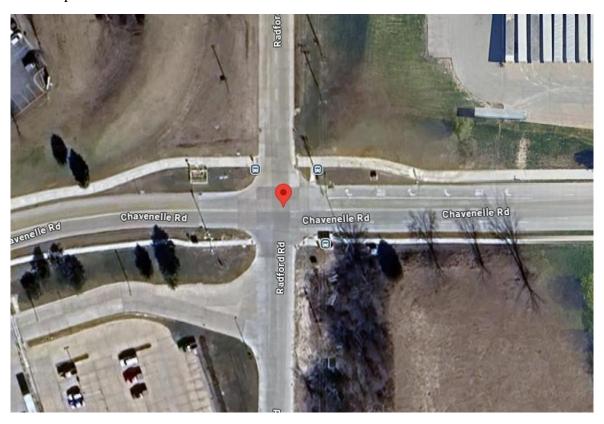
Figure 129: Intersection of Chavenelle Road and Radford Road

This intersection in the city of Dubuque is a four-legged, undivided, low speed, partial stop controlled intersection (Google Maps Link). It has a medium PCR level for KABCO crashes, indicating the need for attention and potential countermeasures. The area features a mixture of land uses and includes well-defined curbs, curb ramps, and sidewalks. The intersection is well-lit by overhead lighting, and the pavement is in good condition. However, there are no marked crosswalks present.

Crash reports indicate that nine crashes have occurred at this intersection over a five-year period (2018–2022), all of which were classified as CO crashes, with no severe (KAB) crashes reported. The predominant manner of collision is broadside (front-to-side), with other types of collisions including rear-end crashes, angle crashes (oncoming left turn), non-collision single-vehicle events, and sideswipe crashes in the same direction. This variety indicates potential concerns related to lane discipline, turning movements, and yielding behavior. The major contributing factors to these crashes include failure to yield right-of-way from driveways and stop signs, vehicles following too closely, loss of control, and improper driving actions. The KAB Annual PCR for the intersection is -0.040756, indicating no severe crash activity, while the KABCO Annual PCR is 0.625863, placing the site at a medium severity level. Based on statewide rankings, this intersection is ranked 112,966th for KAB crashes and 1,935th for KABCO crashes out of 115,274 intersections statewide.

Based on the crash history, contributing factors, and performance data, the following safety improvements are recommended along with their associated cost levels:

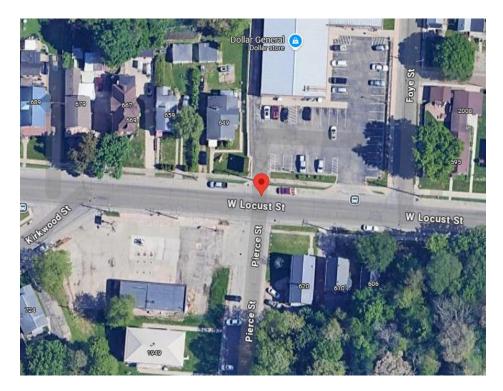
Figure 130: Intersection of Locust Street and Pierce Street

This site is a three-legged, Undivided, undivided, low speed, partial stop controlled intersection (Google Maps Link). It has a medium PCR level for KABCO crashes, indicating the need for attention and potential countermeasures. The intersection is located in a mixed commercial and residential area and features well-defined curbs, curb ramps, and sidewalks. However, no marked crosswalks are present. The intersection is illuminated, and the pavement is in good condition.

Crash reports indicate that 10 crashes have occurred at this intersection over a five-year period (2018–2022), including zero KAB crashes and ten CO crashes. The predominant manners of collision are broadside (front-to-side) and rear-end (front-to-rear), as well as angle crashes (oncoming left turn), head-on collisions, sideswipe (same direction), and non-collision crashes, suggesting diverse crash patterns and driver errors. The variety in crash types highlights multiple contributing behaviors. The primary contributing factors to CO crashes include failure to yield right-of-way from driveways and while making left turns, loss of control, and improper backing. The KAB Annual PCR for the intersection is -0.000331, indicating no severity level, while the KABCO Annual PCR is 0.617902, which is considered medium. Based on statewide rankings, this intersection is ranked 73,389th for KAB crashes and 1,955th for KABCO crashes out of 115,274 intersections statewide.

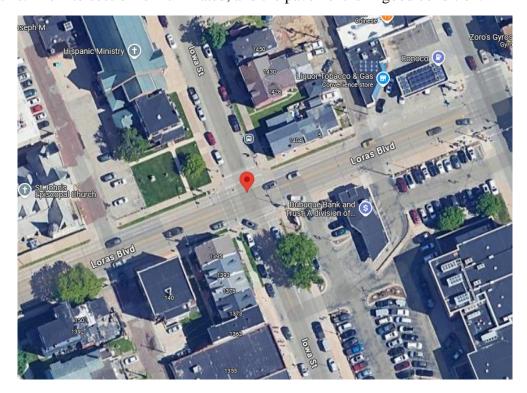
Figure 131: Intersection of Iowa Street and West 14th Street

This site is a four-legged, undivided, low speed, signalized intersection (Google Maps Link). It has a medium PCR level for KABCO crashes, indicating the need for attention and potential countermeasures. The intersection is located in a mixed-use area with both commercial and residential land-use. It features well-defined curbs, curb ramps, sidewalks, and marked crosswalks. The intersection is illuminated, and the pavement is in good condition.

Crash reports indicate that 14 crashes have occurred at this intersection over a five-year period (2018–2022), with no KAB crashes and 14 CO crashes. The predominant manner of collision is broadside (front-to-side), followed by sideswipe (same direction), angle (oncoming left turn), rear-end, and non-collision (single-vehicle), suggesting a variety of issues including turn conflicts, lane departure, and inattentive driving. The primary contributing factors to the CO crashes include running traffic signals, improper or erratic lane usage, failure to yield right-of-way while making left turns, and loss of control. The KAB Annual PCR for the intersection is -0.109186, indicating no severity level, while the KABCO Annual PCR is 0.601914, which is considered medium. Based on statewide rankings, this intersection is ranked 114,399th for KAB crashes and 2,000th for KABCO crashes out of 115,274 intersections statewide.

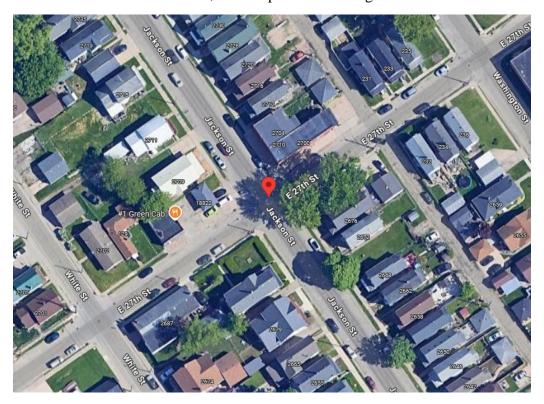
Figure 132: Intersection of East 27th Street and Jackson Street

This site is a four-legged, undivided, low speed, partial stop controlled intersection (Google Maps Link). It has a medium PCR level for KABCO crashes, indicating the need for attention and potential countermeasures. The intersection is located in a predominantly residential area and features well-defined curbs, curb ramps, and sidewalks, but no marked crosswalks are present. The intersection is illuminated, and the pavement is in good condition.

Crash reports indicate that seven crashes have occurred at this intersection over a five-year period (2018–2022), including one KAB crash and six CO crashes. The predominant manner of collision is broadside (front-to-side), as well as rear-end and sideswipe (same direction), suggesting potential issues with stop compliance and maneuvering behavior at the intersection. The primary contributing factor to KABCO crashes is failure to yield right-of-way from a stop sign, which led to broadside collisions. Other contributing factors include failure to yield from parked position, loss of control, running stop sign, and vehicles running off the road to the right. The KAB Annual PCR for the intersection is 0.022446, indicating a low severity level, while the KABCO Annual PCR is 0.599315, which is considered medium. Based on statewide rankings,

Based on the crash history, contributing factors, and performance data, the following safety improvements are recommended along with their associated cost levels:

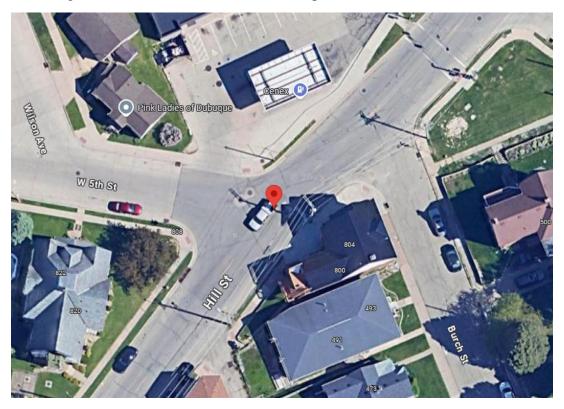
Figure 133: Intersection of West 5th Street and Wilson Street

This site is a three-legged, undivided, low speed, partial stop controlled intersection (Google Maps Link). It has a medium PCR level for KABCO crashes, indicating the need for attention and potential countermeasures. The intersection is located in a predominantly residential area and features well-defined curbs, curb ramps, and sidewalks. Overhead lighting is present, and the pavement is in good condition. There are no marked present.

end (front-to-rear), angle (oncoming left turn), broadside (front-to-side), and head-on (front-to-front), suggesting a variety of conflict points at the intersection. The primary contributing factor to these crashes is loss of control, failing to keep in proper lane, and several types of failure to yield right-of-way (FTYROW), including from parked positions, from stop signs, and during left-turn maneuvers. These factors point to driver behavior and decision-making errors as key safety concerns. The KAB Annual PCR for the intersection is -0.000762, indicating no severe injury or fatal crashes during the period, while the KABCO Annual PCR is 0.582550, which is considered medium. Based on statewide rankings, this intersection is ranked 88,773rd for KAB crashes and 2,054th for KABCO crashes out of 115,274 intersections statewide.

Based on the crash history, contributing factors, and performance data, the following safety improvements are recommended along with their associated cost levels:

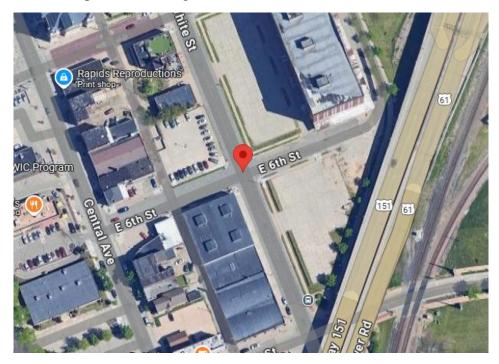
Figure 134: Intersection of White Street and East 6th Street

This site is a four-legged, undivided, low speed, partial stop controlled intersection (Google Maps Link). It has a medium PCR level for KABCO crashes, indicating the need for attention and potential countermeasures. The intersection is located in a predominantly commercial area and features well-defined curbs, curb ramps, and sidewalks, but no crosswalks. The intersection is illuminated, and the pavement is in good condition.

Crash reports indicate that eight crashes have occurred at this intersection over a five-year period (2018-2022), including zero KAB crashes and eight CO crashes. The predominant manner of collision is sideswipe (same direction), as well as broadside (front-to-side) and angle (oncoming left turn), suggesting potential issues with lane discipline and turning behavior. The primary contributing factors to CO crashes include improper or erratic lane changes, improper turns, driver distraction, and running a stop sign. These behaviors highlight concerns around driver attentiveness and compliance with traffic control. The KAB Annual PCR for the intersection is -0.025439, indicating no recorded severe injury or fatal crashes, while the KABCO Annual PCR is 0.575354, which is considered medium. Based on statewide rankings, this intersection is ranked 112,002nd for KAB crashes and 2,071st for KABCO crashes out of 115,274 intersections statewide.

Based on the crash history, contributing factors, and performance data, the following safety improvements are recommended along with their associated cost levels:

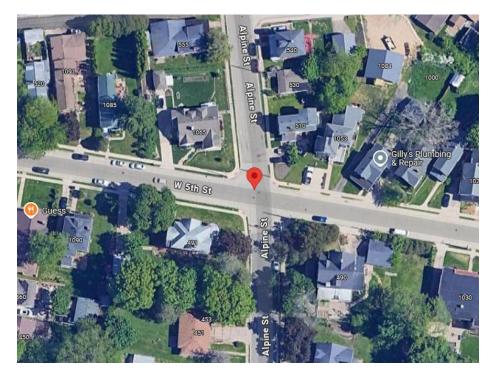
Figure 135: Intersection of Alpine Street and Carlotta Street

This site is a four-legged, undivided, low speed, partial stop controlled intersection (Google Maps Link). It has a medium PCR level for KABCO crashes, indicating the need for attention and potential countermeasures. The intersection is located in a predominantly residential area and features well-defined curbs, curb ramps, and sidewalks. The intersection is illuminated, and the pavement is in good condition. However, there are no marked crosswalks present.

Crash reports indicate that seven crashes have occurred at this intersection over a five-year period (2018–2022), including one KAB crash and six CO crashes. The predominant manner of collision is broadside (front-to-side), as well as head-on and rear-end collisions, suggesting concerns with lane discipline, stop compliance, and driver attentiveness. The primary contributing factor to KABCO crashes is running a stop sign, which led to broadside collisions at the intersection. Other contributing factors include driver loss of control and failure to yield right-of-way from stop signs. The KAB Annual PCR for the intersection is 0.014341, indicating a low severity level, while the KABCO Annual PCR is 0.574584, which is considered medium. Based on statewide rankings, this intersection is ranked 4,948th for KAB crashes and 2,075th for KABCO crashes out of 115,274 intersections statewide, highlighting its moderate risk profile.

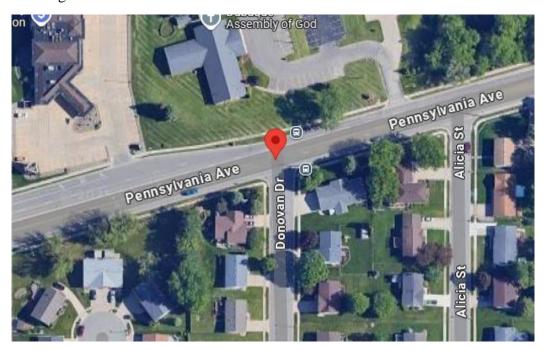
Figure 136: Intersection of Pennsylvania Avenue and Donovan Drive

This site is a three-legged, undivided, low speed, partial stop controlled intersection (Google Maps Link). It has a medium PCR level for KABCO crashes, indicating the need for attention and potential countermeasures. The intersection is located in a predominantly residential area and features well-defined curbs, curb ramps, and sidewalks. There are bus stops near the intersection, however, there are no marked crosswalks. Overhead lighting is present, and the pavement is in good condition.

Based on the crash history, contributing factors, and performance data, the following safety improvements are recommended along with their associated cost levels:

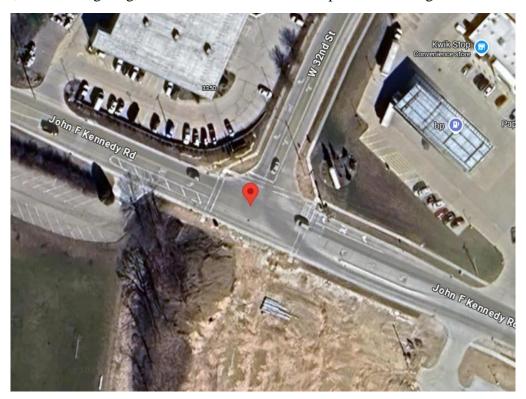
Figure 137: Intersection of Kennedy Road and West 32nd Street

This site is a three-legged, undivided, low speed, partial stop controlled intersection (Google Maps Link). It has a medium PCR level for KABCO crashes, indicating the need for attention and potential countermeasures. The intersection is located in a mixed-use area with both commercial and undeveloped surroundings. It features well-defined curbs, curb ramps, sidewalks, overhead lighting, and marked crosswalks. The pavement is in good condition.

Crash reports indicate that eight crashes have occurred at this intersection over a five-year period (2018–2022), including two KAB crashes and six CO crashes. The predominant manners of collision are broadside (front-to-side) and head-on (front-to-front), followed by rear-end and angle (oncoming left turn) crashes, suggesting issues with traffic flow and yielding behavior. The primary contributing factor to the KABCO crashes is running a stop sign. Other contributing factors include failure to yield right-of-way from a stop sign, and driver distraction. The KAB Annual PCR for the intersection is 0.032964, indicating a low severity level, while the KABCO Annual PCR is 0.572018, which is considered medium. Based on statewide rankings, this intersection is ranked 2,435th for KAB crashes and 2,092nd for KABCO crashes out of 115,274 intersections, highlighting its relevance for safety improvements.

Based on the crash history, contributing factors, and performance data, the following safety improvements are recommended along with their associated cost levels:

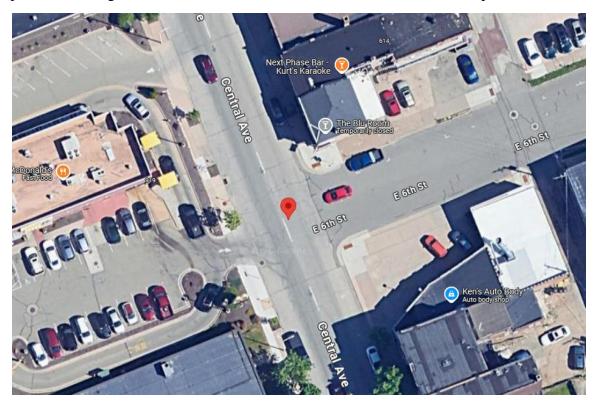
Figure 138: Intersection of Central Avenue and East 6th Street

This site is a three-legged, undivided, low speed, partial stop controlled intersection (Google Maps Link). It has a medium PCR level for KABCO crashes, indicating the need for attention and potential countermeasures. The intersection is located in a predominantly commercial area and features well-defined curbs, curb ramps, and sidewalks. The intersection is illuminated, and the pavement is in good condition; however, there are no marked crosswalks present.

Crash reports indicate that seven crashes have occurred at this intersection over a five-year period (2018–2022), including zero KAB crashes and seven CO crashes. The predominant manner of collision are sideswipe (same direction), rear-end (front-to-rear), and other unspecified crashes were also reported. The contributing factors to CO crashes include improper turning movements, driver distraction (both inattentive and manual), failure to yield right-of-way from parking areas, erratic lane changes, and lost control. The KAB Annual PCR for the

- Restrict or eliminate parking (Low)
- Provide left-turn lanes on north approach (Moderate)
- Implement safety recommendations made in Central and White Corridor Study (Varies)
