Appendix A: Dubuque MPO Sites

Intersections

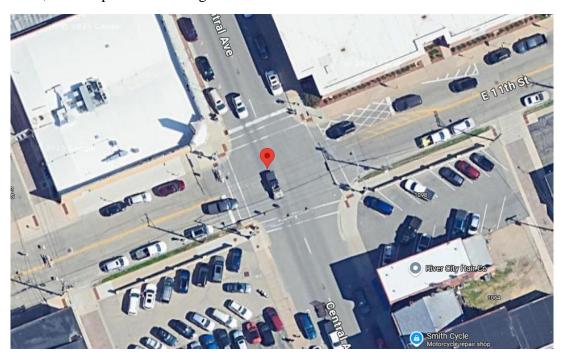
Figure 139: Intersection of Central Avenue and 11th Street

This site is a four-legged, undivided, low speed, signalized intersection (Google Maps Link). It has a medium PCR level for KABCO crashes, indicating the need for immediate attention and potential countermeasures. The intersection is located in a predominantly commercial area and features well-defined curbs, curb ramps, sidewalks, and marked crosswalks. The intersection is illuminated, and the pavement is in good condition.

side), angle crashes (oncoming left turn), and non-collision crashes, suggesting potential issues with lane changing behavior, inadequate gap acceptance, or visibility constraints at the intersection. The major contributing factors to CO crashes include improper turning movements, failure to yield right-of-way from driveways and stop signs, lost control, and driver distraction. The KAB Annual PCR for the intersection is -0.069227, indicating no severity level, while the KABCO Annual PCR is 0.567857, which is considered medium. Based on statewide rankings, this intersection is ranked 113,854th for KAB crashes and 2,106th for KABCO crashes out of 115,274 intersections statewide.

- Employ multiphase signal operation (Moderate)
- Provide left-turn channelization (Moderate)
- Relocate the utility poles; if relocation is not feasible, install retroreflective tape (Moderate)
- Install push button activation for pedestrian crossing (Moderate)
- Implement safety recommendations made in Central and White Corridor Study (Varies)

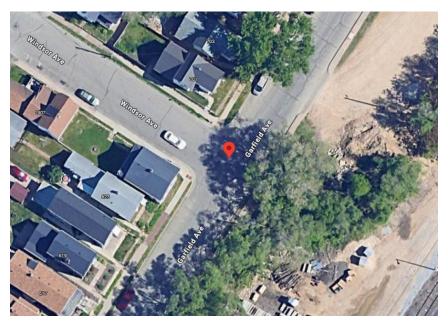
Figure 140: Intersection of Garfield Avenue and Windsor Avenue

This site is a three-legged, undivided, low speed, partial stop controlled intersection (Google Maps Link). It has a medium PCR level for KABCO crashes, indicating the need for attention and potential countermeasures. The intersection is located in a predominantly residential area and features well-defined curbs, curb ramps, and sidewalks, but no crosswalks. The intersection is illuminated, and the pavement is in good condition.

Crash reports indicate that six crashes have occurred at this intersection over a five-year period (2018–2022), including one KAB crash and five CO crashes. The predominant manner of collision include non-collision (single vehicle), rear-end (front to rear), angle crashes (oncoming left turn) and sideswipe collisions in the opposite direction, highlighting a variety of crash types. The primary contributing factor to KABCO crashes at this location is driver distraction, with one crash linked to external distraction and others associated with internal or other forms of distraction. Additional contributing factors include driving too fast for conditions, and failure to keep in proper lane. The KAB Annual PCR for the intersection is 0.003495, indicating a low severity level, while the KABCO Annual PCR is 0.566759, which is considered medium. Based on statewide rankings, this intersection is ranked 7,547th for KAB crashes and 2,109th for KABCO crashes out of 115,274 intersections statewide.

Based on the crash history, contributing factors, and performance data, the following safety improvements are recommended along with their associated cost levels:

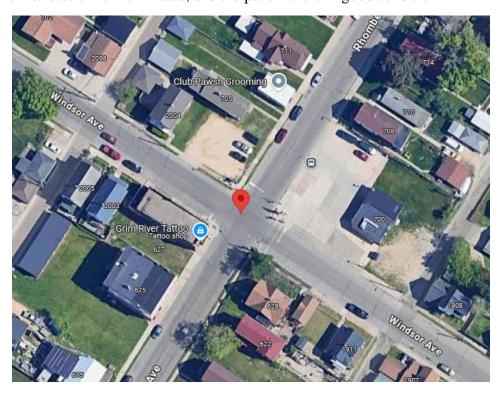
Figure 142: Intersection of Rhomberg Avenue and Windsor Avenue

This site is a four-legged, undivided, low speed, signalized intersection (<u>Google Maps Link</u>). It has a medium PCR level for KABCO crashes, indicating the need for immediate attention and potential countermeasures. The intersection is located in a predominantly residential area and features well-defined curbs, curb ramps, sidewalks and marked crosswalks. A bus stop is located nearby. The intersection is illuminated, and the pavement is in good condition.

Crash reports indicate that 12 crashes have occurred at this intersection over a five-year period (2018–2022), including one KAB crash and eleven CO crashes. The manner of collision include broadside (front-to-side), rear-end (front-to-rear), sideswipe (same and opposite direction), angle (oncoming left turn), head-on, and non-collision single vehicle events. The primary contributing factor to KABCO crashes is lost control, as well as running a traffic signal, failure to yield right-of-way while making a left turn, aggressive driving, improper turning, driver distraction, and failure to dim lights. The KAB Annual PCR for the intersection is 0.02223, indicating a low severity level, while the KABCO Annual PCR is 0.562214, which is considered medium. Based on statewide rankings, this intersection is ranked 3,977th for KAB crashes and 2,116th for KABCO crashes out of 115,274 intersections statewide.

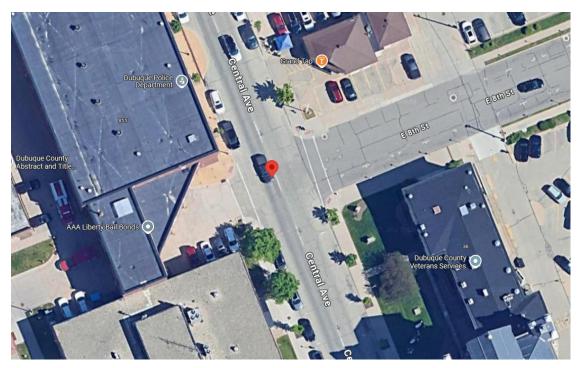
Figure 143: Intersection of Central Avenue and East 8th Street

This site is a three-legged, undivided, low speed, partial stop controlled intersection (Google Maps Link). It has a medium PCR level for KABCO crashes, indicating the need for attention and potential countermeasures. The intersection is located in a predominantly commercial area and features well-defined curbs, curb ramps, sidewalks, and marked crosswalks on the minor road. The intersection is illuminated, and the pavement is in good condition.

Crash reports indicate that seven crashes have occurred at this intersection over a five-year period (2018-2022), including one KAB crash and six CO crashes. The predominant manner of collision is sideswipe (same direction), followed by angle (oncoming left turn), rear-to-side, and non-collision crashes, highlighting a variety of crash behaviors at this location. The major contributing factors across all crashes include failure to yield right-of-way from driveways and parking positions, improper or erratic lane changes, lost control, and improper turning movements. The KAB Annual PCR for the intersection is 0.007374, indicating a low severity level, while the KABCO Annual PCR is 0.560051, which is considered medium. Based on statewide rankings, this intersection is ranked 6,547th for KAB crashes and 2,125th for KABCO crashes out of 115.274 intersections statewide.

- Install rectangular rapid flashing beacon (RRFB) for pedestrian crossing (Moderate)
- Provide marked crosswalks on the major road (Low)
- Restrict or eliminate parking (Low)
- Provide left-turn lanes on north approach (Moderate)
- Implement safety recommendations made in Central and White Corridor Study (Varies)

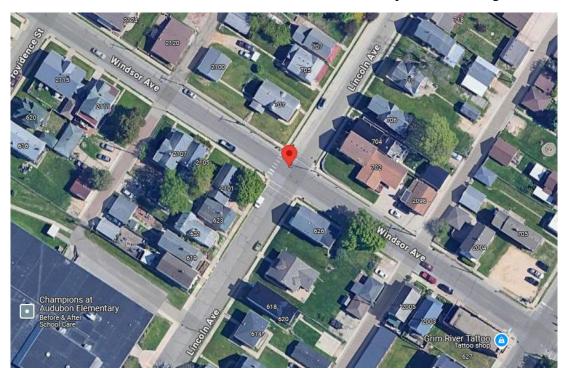
Figure 145: Intersection of Lincoln Avenue and Windsor Avenue

This site is a four-legged, undivided, low speed, partial stop controlled intersection (Google Maps Link). It has a medium PCR level for KABCO crashes, indicating the need for immediate attention and potential countermeasures. The intersection is located in a predominantly residential area and features well-defined curbs, curb ramps, sidewalks, and marked crosswalks on three sides of the road. The intersection is illuminated, and the pavement is in good condition.

Crash reports indicate that nine crashes have occurred at this intersection over a five-year period (2018–2022), including one KAB crash and eight CO crashes. The predominant manner of collision is broadside (front-to-side), accounting for the majority of crashes. Additionally, angle crashes (oncoming left turn) were also reported, suggesting potential concerns with turning movements and failure to comply with traffic control devices. The primary contributing factor to KABCO crashes is running a stop sign, which led to broadside collisions. Other contributing factors for overall crashes include failure to yield right-of-way during left turns and operating a vehicle in an erratic manner. The KAB Annual PCR for the intersection is 0.030102, indicating a low severity level, while the KABCO Annual PCR is 0.552215, which is considered medium. Based on statewide rankings, this intersection is ranked 2,908th for KAB crashes and 2,143rd for KABCO crashes out of 115,274 intersections statewide, highlighting it as a location warranting safety improvements.

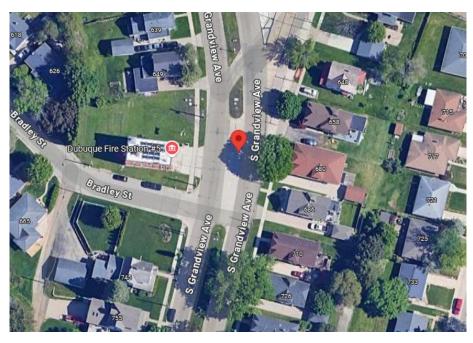
Figure 146: Intersection of Grandview Avenue and Bradley Street

This site is a three-legged, semi-divided, low speed, partial stop controlled intersection (Google Maps Link). It has a medium PCR level for KABCO crashes, indicating the need for immediate attention and potential countermeasures. The intersection is located in a predominantly residential area. It features well-defined curbs, curb ramps, and sidewalks. Overhead lighting is present and the pavement is in good condition. Marked crosswalks are not present.

Crash reports indicate that six crashes have occurred at this intersection over a five-year period (2018–2022), including one KAB crash and five CO crashes. The predominant manner of collision is non-collision (single vehicle), followed by angle (oncoming left turn), broadside (front-to-side), and sideswipe (same direction). The primary contributing factors across all crashes include driver distraction (manual), excessive speed for conditions, improper turning movements, failure to yield right-of-way from a stop sign and traveling the wrong way. The KAB Annual PCR for the intersection is 0.03108, indicating a low severity level, while the KABCO Annual PCR is 0.534437, which falls within the medium range. Based on statewide rankings, this intersection is ranked 2,763rd for KAB crashes and 2,217th for KABCO crashes out of 115,274 intersections, identifying it as a moderate-risk site.

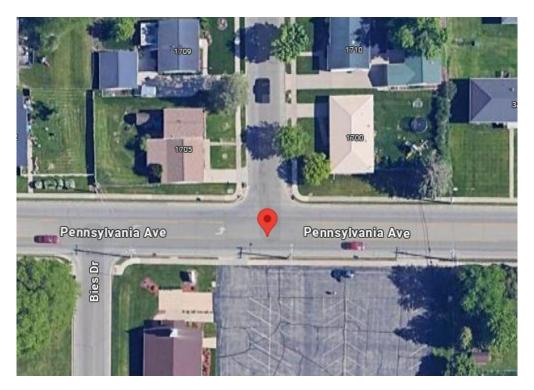
Figure 147: Intersection of Pennsylvania Avenue and Key Way

This site is a three-legged, undivided, low speed, partial stop controlled intersection (Google Maps Link). It has a medium PCR level for KABCO crashes, indicating the need for immediate attention and potential countermeasures. The intersection is located in a predominantly residential area with a church nearby. It features well-defined curbs, curb ramps, and sidewalks. The road is not illuminated. In addition, there are no marked crosswalks present.

Crash reports indicate that eight crashes have occurred at this intersection over a five-year period (2018–2022), including one KAB crash and seven CO crashes. The predominant manner of collision is rear end (front-to-rear), accounting for the largest share of crashes. Angle crashes (oncoming left turn), broadside (front-to-side), and non-collision (single vehicle) incidents were also reported, indicating a mix of failure to maintain safe following distances and right-of-way errors. The primary contributing factor to the total crash was loss of control, followed by running a stop sign, failure to yield right-of-way (both from stop sign and during left turns), and running off the road. The KAB Annual PCR for the intersection is 0.011819, indicating a low severity level, while the KABCO Annual PCR is 0.516913, which is considered medium. Based on statewide rankings, this intersection is ranked 5,275th for KAB crashes and 2,289th for KABCO crashes out of 115,274 intersections statewide.

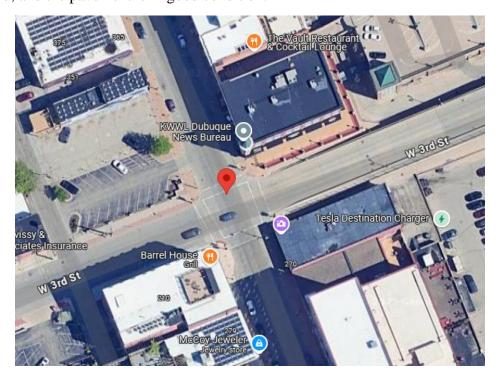
Figure 148: Intersection of Main Street and West 3rd Street

This site is a four-legged, undivided, low speed, signalized intersection (Google Maps Link). It has a medium PCR level for KABCO crashes, indicating the need for attention and potential countermeasures. The intersection is located in a predominantly commercial area and features well-defined curbs, curb ramps, sidewalks, and marked crosswalks. The intersection is illuminated, and the pavement is in good condition.

Crash reports indicate that 12 crashes have occurred at this intersection over a five-year period (2018–2022), with no reported KAB crashes and all 12 being classified as CO crashes. The predominant manners of collision are broadside (front-to-side), rear-end (front-to-rear), sideswipe (same and opposite directions) and angle crashes (oncoming left turn), which suggest potential conflicts of different type of crashes at the location. The major contributing factors for the KABCO crashes include running a traffic signal, and lost control. Other causes noted were failure to yield right-of-way while making left turns, improper backing, and improper turning. The KAB Annual PCR for the intersection is -0.077443, indicating no severity level, while the KABCO Annual PCR is 0.514341, which falls into the medium range. Based on statewide rankings, the intersection is ranked 113,978th for KAB crashes and 2,302nd for KABCO crashes out of 115,274 intersections statewide.

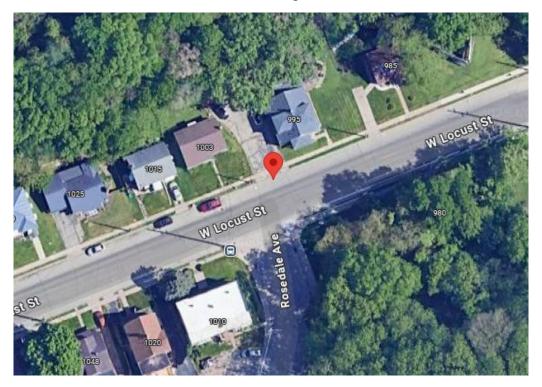
Figure 149: Intersection of Rosedale Avenue and Locust Street

This site is a three-legged, undivided, low speed, partial stop controlled intersection (Google Maps Link). It has a medium PCR level for KABCO crashes, indicating the need for attention and potential countermeasures. The intersection is located in a predominantly residential area. It features well-defined curbs, curb ramps, sidewalks, and overhead lighting. The pavement is in good condition, but there are no marked crosswalks present.

Crash reports indicate that seven crashes have occurred at this intersection over a five-year period (2018–2022), with no KAB crashes and seven CO crashes. The predominant manner of collision is rear end (front-to-rear), as well as sideswipe (same direction) and non-collision incidents (such as running off-road). These crash types suggest possible issues with driver attentiveness. The primary contributing factor to these crashes is loss of control, followed by driver distraction and exceeding the authorized speed limit. Other causes include improper passing and vehicles running off the road. The KAB Annual PCR for the intersection is -0.000871, indicating no severity level, while the KABCO Annual PCR is 0.511944, which is considered medium. Based on statewide rankings, this intersection is ranked 91,269th for KAB crashes and 2,317th for KABCO crashes out of 115,274 intersections statewide.

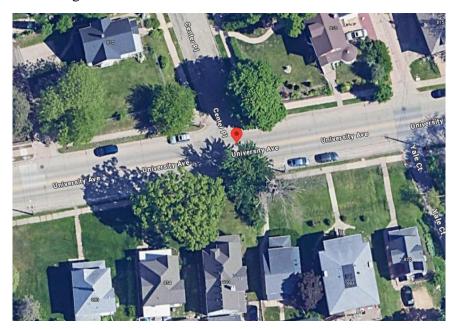
Figure 150: Intersection of University Avenue and Center Place

This site is a three-legged, undivided, low speed, partial stop controlled intersection (Google Maps Link). It has a medium PCR level for KABCO crashes, indicating the need for attention and potential countermeasures. The intersection is located in a predominantly residential area and features well-defined curbs, curb ramps, and sidewalks. It is illuminated, and the pavement is in good condition. However, there are no marked crosswalks present, and roadside trees are obstructing the line of sight at the intersection.

Crash reports indicate that seven crashes have occurred at this intersection over a five-year period (2018–2022), including zero KAB crashes and seven CO crashes. The most frequent manner of collision is rear end (front-to-rear), followed by angle crashes (oncoming left turn), broadside (front-to-side), sideswipe (same direction), and single-vehicle crashes (non-collision). The primary contributing factor to these crashes is loss of control, which led to a variety of collision types. Other contributing factors include failure to yield right-of-way from driveways and while making left turns, improper backing, and driver distraction. The KAB Annual PCR for the intersection is -0.000758, indicating no severity level, while the KABCO Annual PCR is 0.508485, which is considered medium. Based on statewide rankings, this intersection is ranked

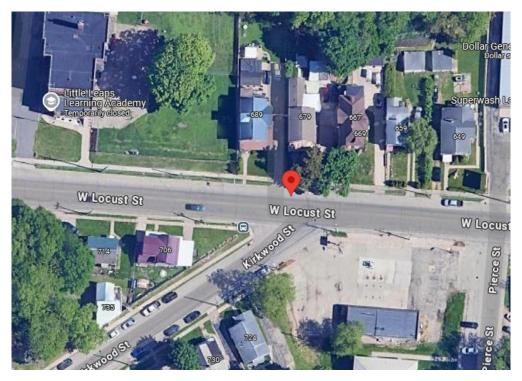
Figure 151: Intersection of Locust Street and Kirkwood Street

This site is a three-legged, undivided, low speed, yield controlled intersection (Google Maps Link). It has a medium PCR level for KABCO crashes, indicating the need for attention and potential countermeasures. The intersection is located in a predominantly residential area and features well-defined curbs, curb ramps, and sidewalks but no crosswalks. A bus stop is located at the intersection. The area is illuminated and the road pavement is in good condition.

Crash reports indicate that six crashes have occurred at this intersection over a five-year period (2018–2022), all of which were CO (property damage or minor injury) crashes. The predominant manners of collision are rear end (front-to-rear) and angle crashes (oncoming left turn), with a

sideswipe was also observed, suggesting various types of conflicts at the intersection. The primary contributing factor to these crashes is failure to yield right-of-way (FTYROW) from yield signs, which accounted for half of all reported crashes. Other contributing factors include loss of control, improper passing, and running off the road. The KAB Annual PCR for the intersection is -0.002493, indicating no severity, while the KABCO Annual PCR is 0.507776, which falls within the medium range. Based on statewide rankings, this intersection is ranked 101,173rd for KAB crashes and 2,342nd for KABCO crashes out of 115,274 intersections statewide, pointing to a moderate crash frequency but low severity.

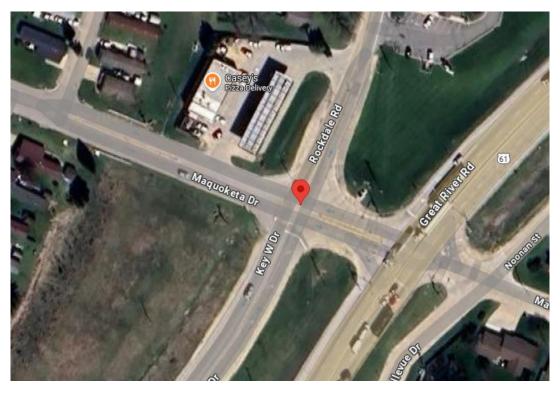
Figure 152: Intersection of Maquoketa Street and Rockdale Road

This site is a four-legged, undivided, low speed, partial stop controlled intersection (Google Maps Link). It has a medium PCR level for KABCO crashes, indicating the need for immediate attention and potential countermeasures. The intersection is surrounded by residential area with some commercial present. It lacks well-defined curbs, curb ramps, and sidewalks. Overhead lighting is present, and the pavement is in good condition.

Crash reports indicate that eight crashes have occurred at this intersection over a five-year period (2018–2022), with all being classified as CO (property damage or complaint of pain), and none being classified as KAB (severe crashes). The predominant manner of collision is broadside (front-to-side), with other reported collision types including head-on (front-to-front), rear-end (front-to-rear), sideswipe (same direction), and rear-to-side collisions. The major contributing factor to KABCO crashes at this location is running a stop sign, followed by failure to yield right-of-way from parking or stop sign, improper backing, and traveling the wrong way on a divided highway. These behaviors suggest issues with compliance, and visibility at the intersection. The KAB Annual PCR for the intersection is -0.044013, indicating no severity level for serious injuries. However, the KABCO Annual PCR is 0.494769, which is considered medium. Based on statewide rankings, this intersection is ranked 113,114th for KAB crashes and 2,405th for KABCO crashes out of 115,274 intersections statewide, highlighting it as a location with frequent non-severe but recurring crash patterns.

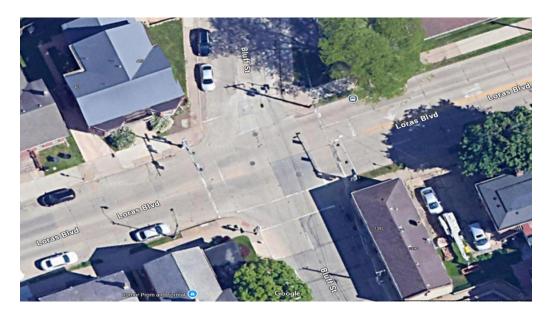
Figure 153: Intersection of Loras Boulevard and Bluff Street

This site is a four-legged, undivided, low-speed, signalized intersection (<u>Google Maps Link</u>). It has a moderate KABCO PCR level, indicating the need for potential safety improvements. The intersection is located in a mixed residential and commercial area and features well-defined curbs, curb ramps, and sidewalks. It is illuminated, and the pavement is in fair condition. Marked crosswalks are present at the intersection.

Crash data from 2018 to 2024 indicate 13 crashes occurred at this intersection. The manner of collisions includes broadside, sideswipe, and rear-end crashes. Reported contributing factors include loss of control, running a traffic signal, improper lane changing, and wet and darklighted conditions. This intersection has a KABCO Annual PCR of 0.494132, indicating a moderate crash frequency.

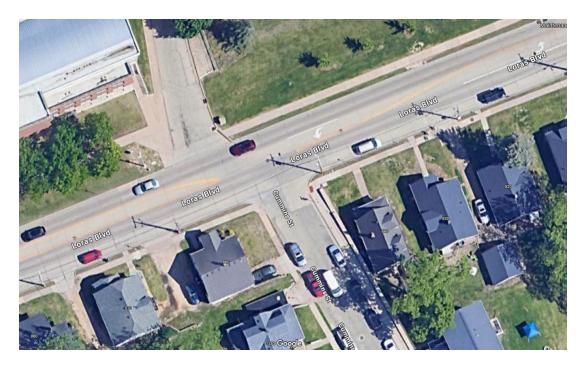
Figure 154: Intersection of Loras Boulevard and Cummins Street

This site is a three-legged, undivided, low-speed, partial stop-controlled intersection (Google Maps Link). It has a moderate KABCO PCR level, indicating potential safety concerns. The surrounding area includes a mix of residential and commercial properties. The intersection has poor pavement markings on the northbound and eastbound approaches, and visibility issues have been reported. Additionally, a driveway is located approximately 60 feet from the intersection on the eastbound approach, which may contribute to access-related conflicts.

Crash reports indicate that seven crashes have occurred at this intersection over a five-year period (2018–2022), including two KAB crashes and five CO crashes. The manner of collisions includes sideswipe (same direction), rear-end, and broadside crashes. Reported contributing factors include loss of control, speeding, improper backing, and vision obstruction. This intersection has a KABCO Annual PCR of 0.487632, suggesting a moderate frequency of crashes requiring attention.

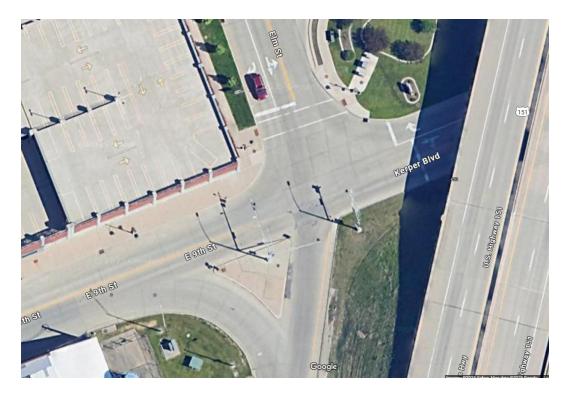
Figure 155: Intersection of East 9th Street-Kerper Boulevard and Elm Street

This site is a four-legged, undivided, low-speed, signalized intersection (<u>Google Maps Link</u>). It has a moderate KABCO PCR level, indicating potential safety concerns. The area surrounding the intersection includes a mix of commercial and residential properties. The intersection has worn pavement markings on the eastbound approach, and there are dedicated right-turn lanes on the southbound and westbound approaches. Crosswalk markings are present.

Crash reports indicate that 11 crashes have occurred at this intersection over a five-year period (2018–2022), including zero KAB crashes and eleven CO crashes. The manner of collisions includes rear-end, two angle, and broadside crashes. Contributing factors include loss of control, improper turning while making a left turn, and running a traffic signal. This intersection has a KABCO Annual PCR of 0.486721, suggesting a moderate frequency of crashes requiring attention.

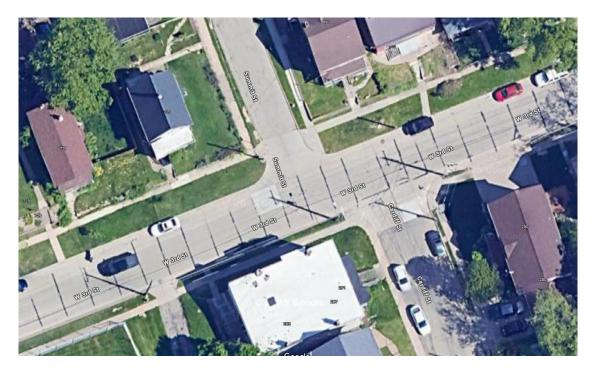
Figure 156: Intersection of Cardiff Street, Summit Street and West 3rd Street

This site is a four-legged, undivided, low-speed, partial stop-control intersection (<u>Google Maps Link</u>). It has a moderate KABCO PCR level, indicating potential safety concerns. The intersection has household driveways in close proximity, and both Cardiff and Summit Streets have downgrade slopes. On-street parking is present, which may impact visibility. There are no crosswalk markings, but

Crash data from 2018 to 2024 indicates a total of six crashes occurred at this intersection. There were no reported fatal or severe injury crashes. The manner of collision includes broadside, sideswipe, and rear-end crashes. Reported contributing factors include failure to yield right-of-way from a stop, improper backing, and loss of control. This intersection has a KABCO Annual PCR of 0.481226, indicating a moderate crash frequency.

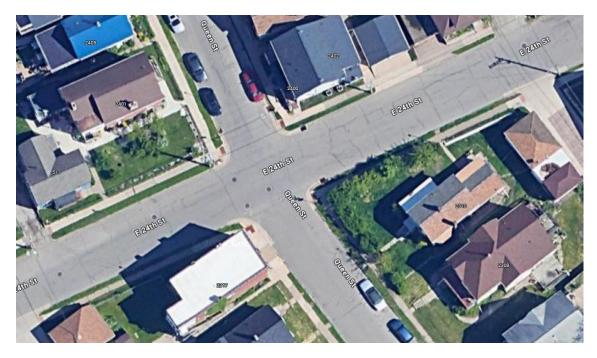
Figure 157: Intersection of East 24th Street and Queen Street

This is a four-legged, undivided, low-speed, partial stop-control intersection (Google Maps Link). It has a moderate KABCO PCR level, indicating potential safety concerns. The intersection is located in a residential area and features well-defined curbs, curb ramps, and sidewalks. It is illuminated, and the pavement is in good condition. Marked crosswalks are not present at the intersection, but there are well-defined curbs, curb ramps, and sidewalks.

Crash data from 2018 to 2022 indicates a total of six crashes occurred at this intersection. One crash resulted in a severe injury (KAB), while the remaining five were classified as property damage or minor injury crashes (CO). The most common crash type was broadside, followed by angle, rear-end, single-vehicle/non-motorist, and sideswipe collisions. The primary contributing factors include running a stop sign and loss of control. This intersection has a KABCO Annual PCR of 0.474161, indicating a moderate crash frequency.

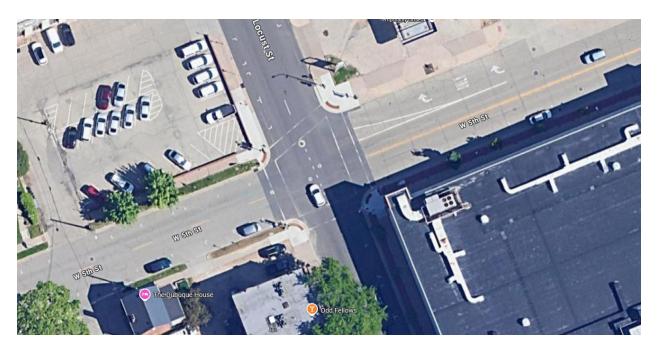
Figure 158: Intersection of Locust Street South and West 5th Street (Google Maps)

This is a four-legged, undivided, low-speed, signalized intersection in Dubuque. On-street parking is present on the northbound, southbound, and westbound approaches. The westbound approach includes a dedicated right-turn lane. Marked crosswalks are present at the intersection.

Crash data from 2018 to 2022 indicates that 11 crashes occurred at this intersection, including 1 severe injury (KAB) crash and 10 other crashes (CO). The manner of collision includes broadside, sideswipe, and rear-end. Contributing factors include running the traffic signal, improper lane changing, and one loss of control. Adverse roadway conditions were also reported. This intersection has a KABCO Annual PCR of 0.472482, indicating a moderate crash frequency.

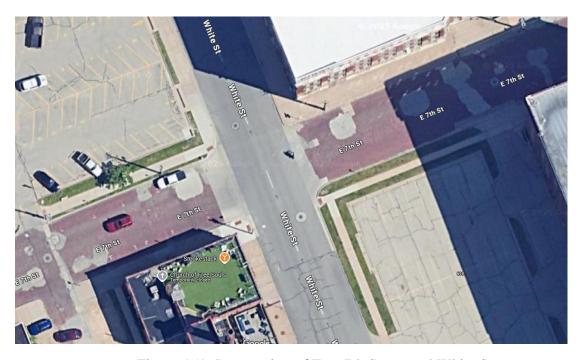
Figure 159: Intersection of East 7th Street and White Street

This site is a four-legged, undivided, low-speed, partial stop-control intersection (Google Map Link). The intersection has sight distance limitations for the northbound and southbound approaches, which may impact driver visibility and reaction time. Marked crosswalks are not present at the intersection.

Crash data from 2018 to 2022 indicates that seven crashes occurred at this intersection. No fatal or severe injury crashes were reported. The manner of collision included sideswipe, broadside and angle crashes. Contributing factors included improper lane changing, loss of control, reckless/negligent driving, and failure to yield right-of-way. This intersection has a KABCO Annual PCR of 0.471676, indicating a moderate crash frequency.

- Enhance intersection signage and lane markings (Low)
- Implement safety recommendations made in Central and White Corridor Study (Varies)

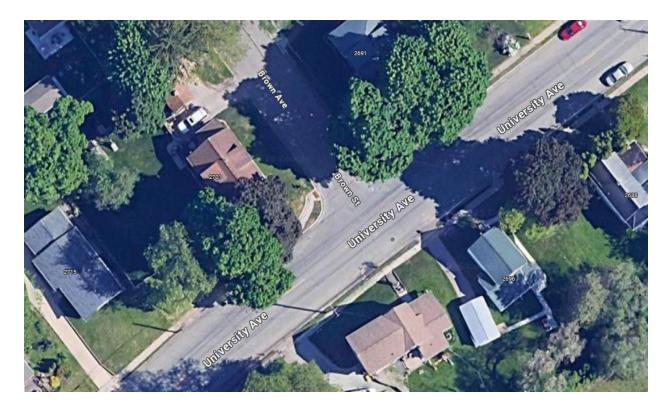
Figure 160: Intersection of Brown Street and University Avenue

This site is a three-legged, undivided, low-speed, partial stop-control intersection (Google Maps Link). The eastbound approach appears to have insufficient sight distance, which may impact driver decision-making. Pavement markings may be in marginal condition, and there are no marked crosswalks at the intersection.

Crash data from 2018 to 2022 indicates that six crashes occurred at this intersection. No fatal or severe injury crashes were reported. The manner of collision includes rear-end, broadside, failure to yield right-of-way and improper turning. Contributing factors include **loss** of control, driver distraction, following too close, failure to yield right-of-way, and improper turning. This intersection has a KABCO Annual PCR of 0.460694, indicating a moderate crash frequency.

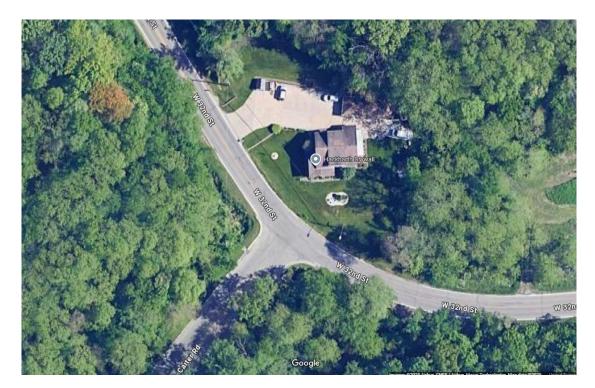
Figure 161: Intersection of West 32nd Street and Carter Road

This site is a three-legged, undivided, low-speed, partial stop-control intersection (Google Maps Link). The northbound approach may have limited visibility due to overgrown bushes, which may obstruct sightlines for drivers. There is no pedestrian infrastructure present. There is curbing present on Carter Road, and an overhead light is present.

Crash data from 2018 to 2022 indicates a total of six crashes occurred at this intersection, including one severe injury (KAB) crash and five other crashes (CO). The manner of collision includes rear-end, broadside crash, head-on crash, sideswipe crash, and non-collision incidents due to animal presence, loss of control, and running off the road. This intersection has a KABCO Annual PCR of 0.45899, indicating a moderate crash frequency.

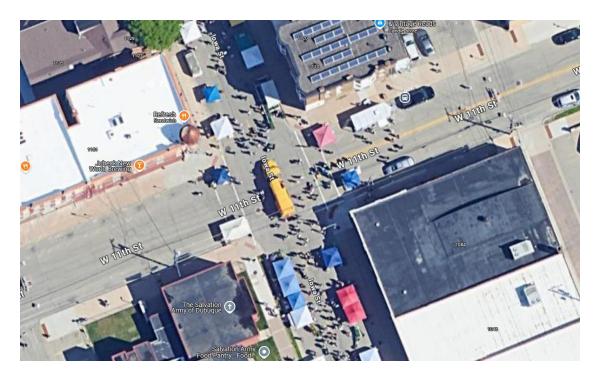
Figure 162: Intersection of 11th Street and Iowa Street

This is a four-legged, undivided, low-speed intersection with partial stop control (Google Maps Link). The intersection is located in a commercial area. On-street parking is present on all approaches, which may contribute to limited sight distance. Pedestrian infrastructure is present, including marked crosswalks on the east and west approaches. Overhead lighting is also present.

Crash reports indicate that seven crashes have occurred at this intersection over a five-year period (2018–2022), including zero KAB crashes and seven CO crashes. The manner of collision includes broadside, failure to yield right-of-way, running stop sign, sideswipe, non-collision, loss of control and alcohol involvement. This intersection has a KABCO Annual PCR of 0.458771, indicating a moderate crash frequency.

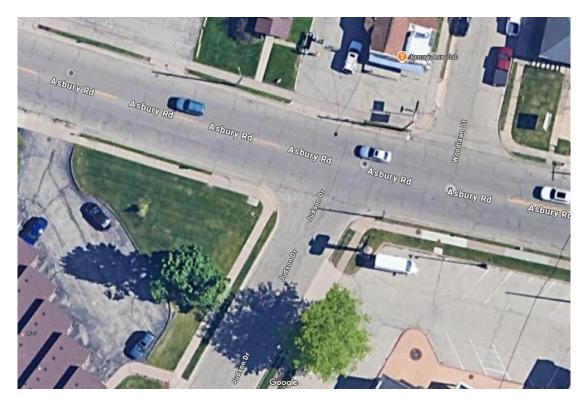
Figure 163: Intersection of Asbury Road and Judson Drive

This site is a three-legged, undivided, low-speed intersection with partial stop control (Google Maps Link). The intersection is near multiple driveways, which may impact visibility and driver decision-making. On-street parking is present. Sidewalks and curb ramps are present, but there are no crosswalks. Limited overhead lighting is also present.

Crash data from 2018 to 2022 indicates a total of six crashes occurred at this intersection. The manner of collision includes rear-end and broadside crashes. Contributing factors include following too close, driver fatigue, loss of control, failure to yield right-of-way, and running a stop sign. This intersection has a KABCO Annual PCR of 0.45802.

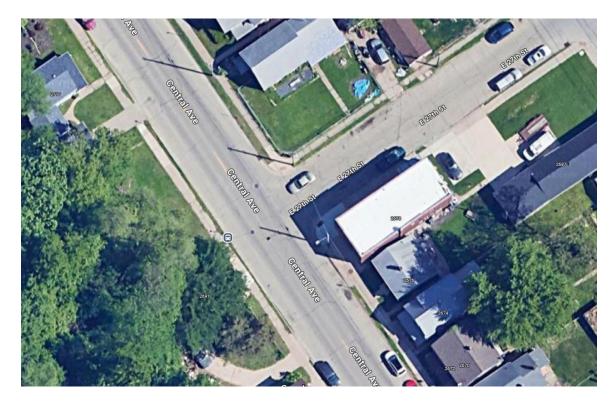
Figure 164: Intersection of Central Avenue and East 27th Street

This site is a three-legged, undivided, low-speed intersection with partial stop control (Google Maps Link). On-street parking is present, and there are possible sight distance issues that may impact driver decision-making. Pedestrian infrastructure and overhead lighting are present at the intersection. However, there are no crosswalks present.

Crash data from 2018 to 2022 indicates a total of six crashes occurred at this intersection. The manner of collision included four rear-end and two broadside crashes. Crash causes included following too close, driver distraction, loss of control failure to yield right-of-way, running a stop sign, and driver distraction. This intersection has a KABCO Annual PCR of 0.454103.

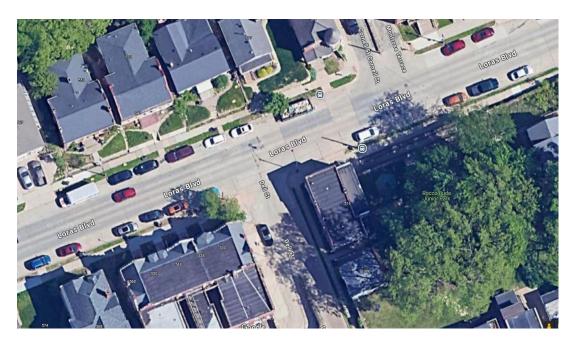
Figure 165: Intersection of Loras Boulevard and Dell Street

This site is a three-legged, undivided, low-speed, partial stop-control intersection (Google Maps Link). Dell Street is on a downgrade into the intersection. On-street parking is present, which may impact visibility. Pedestrian infrastructure includes sidewalks and curb ramps, but no crosswalks are present. Overhead lighting is also present.

Crash reports indicate that six crashes have occurred at this intersection over a five-year period (2018–2022), including zero KAB crashes and six CO crashes. The manner of collision included broadside, rear-to-rear, sideswipe, and head-on crashes. Reported contributing factors included collision with a parked vehicle, running a stop sign, and loss of control. Three crashes occurred under adverse weather conditions (one in snow, one in slush, and one in both snow and slush). This intersection has a KABCO Annual PCR of 0.453406, indicating a moderate crash frequency.

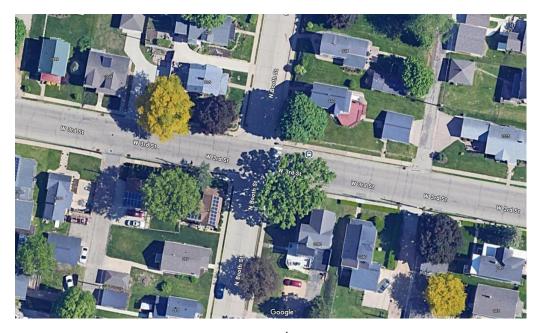
Figure 166: Intersection of West 3rd Street and North Booth Street

This site is a four-legged, undivided, low-speed, partial stop-control intersection (Google Maps Link). The intersection has on-street parking and may have sight distance issues. The north approach is on a downgrade into the intersection. Pedestrian infrastructure includes sidewalks, curb ramps and a marked crosswalks with signage on the east approach. Overhead lighting is present above the crosswalk.

Crash data from 2018 to 2022 indicates a total of six crashes occurred at this intersection. There were no reported fatal or severe injury crashes. The manner of collision included broadside and non-collision crashes. Reported contributing factors included failure to yield right-of-way and driver distraction. This intersection has a KABCO Annual PCR of 0.447542, indicating a moderate crash frequency.

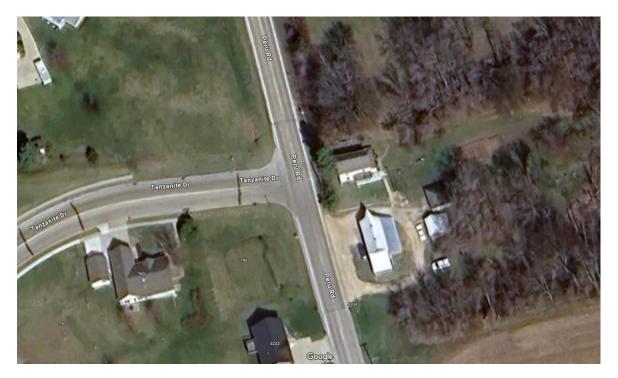
Figure 167: Intersection of Peru Road and Tanzanite Drive

This site is a three-legged, undivided, low-speed, partial stop-control intersection (Google Maps Link). Peru Road is on a grade through the intersection. Tanzanite Drive has curb and gutter installed, but there is no pedestrian infrastructure present along either roadway. Overhead lighting is present.

Crash data from 2018 to 2022 indicates a total of six crashes occurred at this intersection. There were no reported fatal or severe injury crashes. The manner of collision includes rear-end (front to rear), non-collision (single vehicle), and one other types of crashes. Reported contributing factors included loss of control, distraction, inattentiveness, being under the influence, and following too closely. This intersection has a KABCO Annual PCR of 0.444711, indicating a moderate crash frequency.

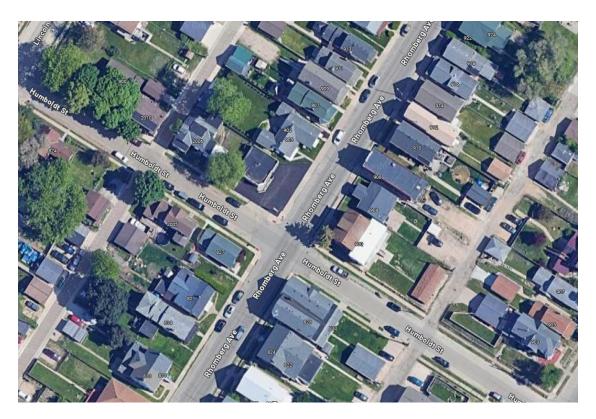
Figure 168: Intersection of Humboldt Street and Rhomberg Avenue

This site is a four-legged, undivided, low-speed, partial stop-control intersection (<u>Google Maps Link</u>). The intersection may have sight distance issues. It is located in a residential area, and pedestrian infrastructure includes sidewalks and curb ramps. There are no marked crosswalks present. There is an overhead light present.

Crash data from 2018 to 2022 indicates a total of 6 crashes occurred at this intersection. There was one crash with a KAB severity and five crashes with CO severity. The manner of collision includes sideswipe (same direction), rear-end (front to rear), broadside (front to side) crashes, and rear-to-side crashes. Reported contributing factors include driver distraction, loss of control, being under the influence, over-correcting/over-steering, inattentiveness, failure to yield right-of-way while making a left turn, and improper backing. This intersection has a KABCO Annual PCR of 0.439299, indicating a moderate crash frequency.

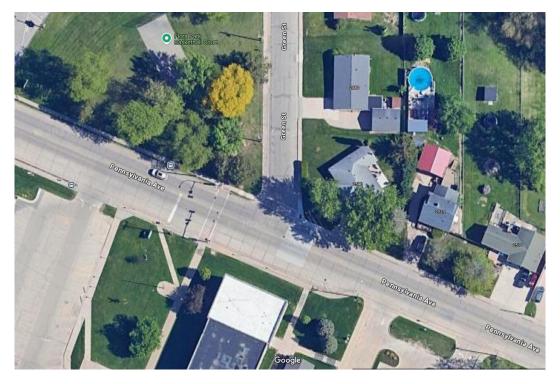
Figure 169: Intersection of Pennsylvania Avenue and Green Street

This site is a three-legged, undivided, low-speed, partial stop-control intersection (Google Maps Link). It is located in a residential area, with a school located directly to the south. Extensive pedestrian infrastructure is present, including sidewalks, curb ramps, and a pedestrian traffic

signal on the west approach. Overhead lighting is also present in the vicinity of the intersection. Although not at the intersection itself.

Crash data from 2018 to 2022 indicates a total of 6 crashes occurred at this intersection. There were no reported fatal or severe injury crashes. The manner of collision includes rear-end (front to rear) and angle (oncoming left turn) crashes. Reported contributing factors include loss of control, following too closely, and making improper turns. This intersection has a KABCO Annual PCR of 0.437121, indicating a moderate crash frequency.

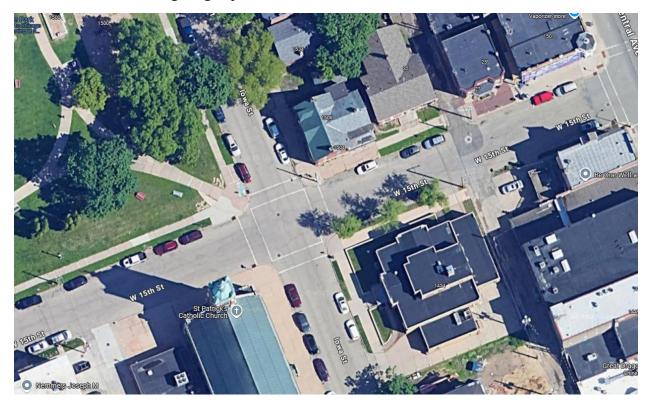
Figure 170: Intersection of 15th Street and Iowa Street

This site is a four-legged, undivided, low-speed, all-way stop intersection (<u>Google Map Link</u>). The intersection may have sight distance issues. The site is in a residential area, and on street

parking is present. Pedestrian infrastructure includes sidewalks, curb ramps and marked crosswalks. Overhead lighting is present.

Crash data from 2018 to 2022 indicates a total of five crashes occurred at this intersection. There were no reported fatal or severe injury crashes. The manner of collision includes "other", sideswipe (same direction), rear-end (front to rear), rear-to-side, non-collision (single vehicle) incidents, and broadside (front to side) crashes. Reported contributing factors include loss of control, starting or backing improperly, being under the influence, failure to yield right-of-way from a stop sign, and emotional factors. This intersection has a KABCO Annual PCR of 0.419135, indicating a moderate crash frequency.

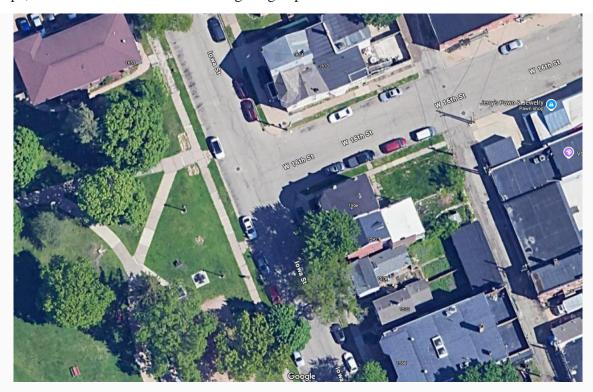
Figure 171: Intersection of Iowa Street and West 16th Street

This site is a three-legged, undivided, low-speed, partial stop-control intersection (Google Maps Link). The intersection may have issues with sight distance. It is located in a residential area and has on street parking. Pedestrian infrastructure is present and consists of sidewalks and curb ramps, but no crosswalks. Overhead lighting is present.

Crash data from 2018 to 2022 indicates a total of six crashes occurred at this intersection. There were no reported fatal or severe injury crashes. The manner of collision includes three rear-end (front to rear), "other", rear-to-side, sideswipe (same direction), angle (oncoming left turn), and non-collision (single vehicle) crashes. Reported contributing factors include unknown, starting or backing improperly, loss of control, making improper turn, and being under the influence. This intersection has a KABCO Annual PCR of 0.417951, indicating a moderate crash frequency.

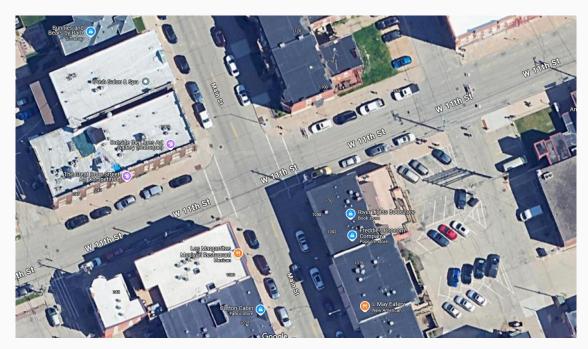
Figure 172: Intersection of West 11th Street and Main Street

This site is a four-legged, undivided, low-speed, partial stop-control intersection (<u>Google Maps Link</u>). It is located in a commercial area and on-street parking is present. There may be a restricted sight distance issue. Pedestrian facilities include sidewalks and curb ramps, along with marked crosswalks on the east and west approaches. Overhead lighting is present.

Crash reports indicate that six crashes have occurred at this intersection over a five-year period (2018–2022), including one KAB crashes and five CO crashes. The manner of collision included broadside (front to side), sideswipe, and rear end crashes. Contributing factors included failure to yield right-of-way from a stop sign, running a stop sign, FTYROW from a parked position, following too closely, reckless/erratic/careless/negligent operation and backing improperly. This intersection has a KABCO Annual PCR of 0.413897, indicating a moderate crash frequency.

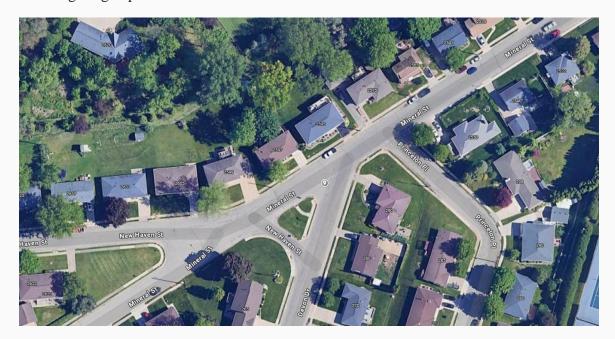
Figure 173: Intersection of Mineral Street and New Haven Street

This site is a three-legged, undivided, low-speed, partial stop-control intersection (Google Maps Link). In reality, this site consists of a complex interaction between the intersections of New Haven Street, Mineral Street, and Devon Drive. It is located in a residential area and has sidewalks and curb ramps present. No marked crosswalks have been installed, and only limited overhead lighting is present in the area of the New Haven Street and Mineral Street intersection.

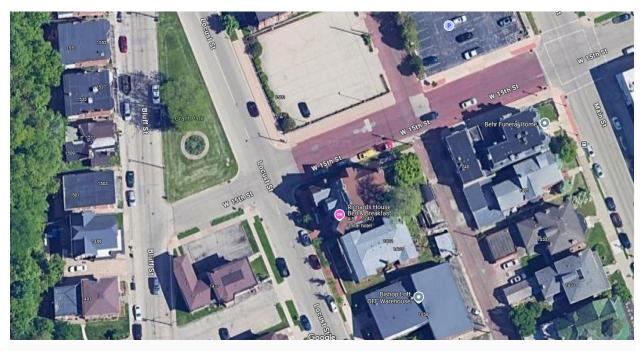
Figure 174: Intersection of Locust Street and West 15th Street

This site is a four-legged, undivided, low-speed, partial stop-control intersection (<u>Google Maps Link</u>). This is a residential area, and on-street parking is present. This may contribute to restricted sight distance. Pedestrian infrastructure includes sidewalks and curb ramps, but not marked crosswalks. No overhead lighting is present.

Crash reports indicate that five crashes have occurred at this intersection over a five-year period (2018–2022), including one KAB crashes and four CO crashes. The manner of collision included rear-end (front to rear), broadside, and sideswipe. Contributing factors included failure to keep in the proper lane, failure to yield right-of-way from a stop sign, improper/erratic lane changing, other interior distractions, and loss of control. This intersection has a KABCO Annual PCR of 0.401537, indicating a moderate crash frequency.

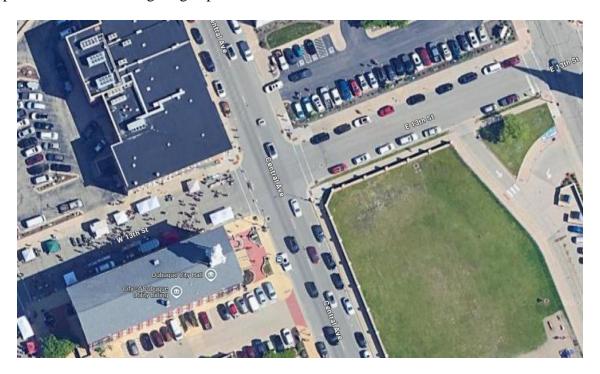
Figure 175: Intersection of Central Avenue and West 13th Street

This site is a four-legged, undivided, low-speed, partial stop-control intersection (<u>Google Maps Link</u>). This location is a commercial area and on-street parking is present. Pedestrian infrastructure includes sidewalks, curb ramps, and marked crosswalks on the east and west approaches. Overhead lighting is present.

Crash reports indicate that ten crashes have occurred at this intersection over a five-year period (2018–2022), including one KAB crashes and nine CO crashes. The manner of collision included broadside (front to side), sideswipe (same direction), angle (oncoming left turn), rear-end (front to rear), and non-collision (single vehicle) crashes. Contributing factors included improper turns, running stop signs, emotional factors, traveling the wrong way/on the wrong side, loss of control, and following too closely. This intersection has a KABCO Annual PCR of 0.400221, indicating a moderate crash frequency.

- Upgrade pedestrian crossings with rectangular rapid flash beacons (Moderate)
- Add red pennants or flashing beacons to stop signs to increase conspicuity (Low)
- Implement safety recommendations made in Central and White Corridor Study (Varies)

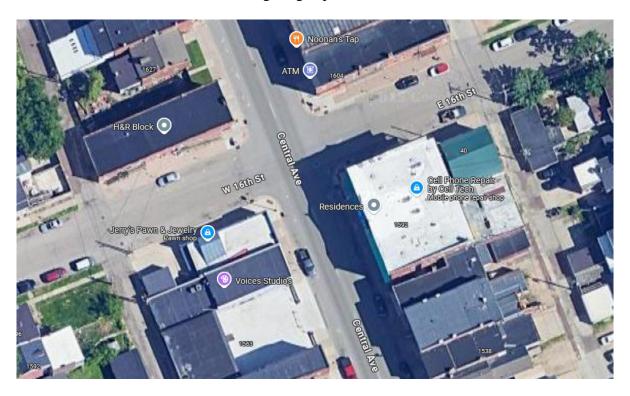
Figure 176: Intersection of Central Avenue and West 16th Street

This site is a four-legged, undivided, low-speed, partial stop-control intersection (<u>Google Maps Link</u>). It is located in a commercial area, and on-street parking is present. This may contribute to restricted sight distance. Pedestrian infrastructure includes sidewalks, curb ramps, but no marked crosswalks. Limited overhead lighting is present.

Crash reports indicate that seven crashes have occurred at this intersection over a five-year period (2018–2022), including one KAB crashes and six CO crashes. The manner of collision included sideswipe (same direction), rear-end (front to rear), broadside (front to side), angle (oncoming left turn), non-collision (single vehicle), and "other" crashes. Contributing factors included improper/erratic lane changing, driver distraction, loss of control, unknown/medical (seizure reaction), starting/backing improperly, vision obstruction, loss of control. running a stop sign, making improper turn, and failure to yield right-of-way while making a left turn. This intersection has a KABCO Annual PCR of 0.400173, indicating a moderate crash frequency.

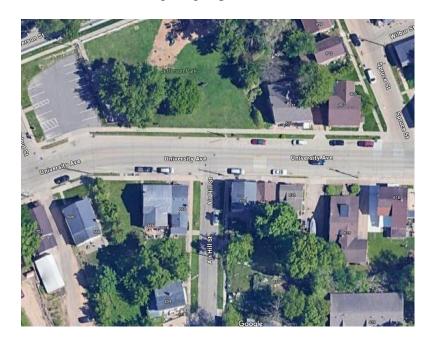
Figure 177: Intersection of University Avenue and Air Hill Street

This site is a three-legged, undivided, low-speed, partial stop-control intersection (Google Maps Link). It is located in a residential area and has on-street parking. The intersection has a steep slope on the northbound approach. Pedestrian infrastructure includes sidewalks, and curb ramps, but no marked crosswalks. Overhead lighting is present.

Crash reports indicate that six crashes have occurred at this intersection over a five-year period (2018–2022), including one KAB crashes and five CO crashes. The manner of collision included rear-end (front to rear), non-collision (single vehicle), and sideswipe (same direction) crashes. Contributing factors included running off the road, improper backing, driving too fast for conditions, emotional factors, loss of control, driver distraction, and starting or backing

improperly. This intersection has a KABCO Annual PCR of 0.399803, indicating a moderate crash frequency.

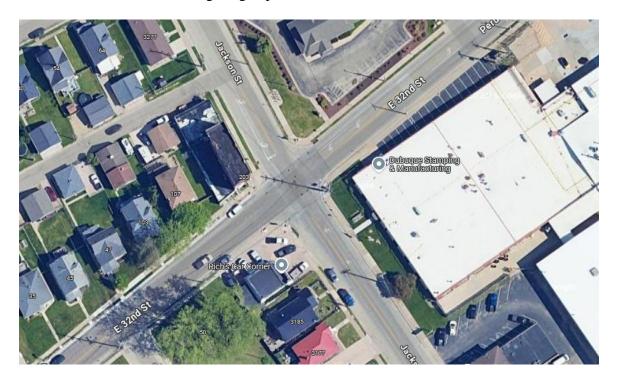
Figure 178: Intersection of Jackson Street and East 32nd Street

This site is a four-legged, undivided, low-speed, signalized intersection (<u>Google Maps Link</u>). It is located in a mixed residential and light industrial area. There is a driveway in the southeast corner of the intersection. Pedestrian infrastructure includes sidewalks, and curb ramps, but no marked crosswalks. Overhead lighting is present.

included sideswipe (same direction), non-collision (single vehicle), angle (oncoming left turn), broadside (front to side), and rear-end (front to rear) crashes. Contributing factors included improper turns, loss of control, failure to yield right-of-way while making left turns, running traffic signals, and improper starting/backing. This intersection has a KABCO Annual PCR of 0.394738, indicating a moderate crash frequency.

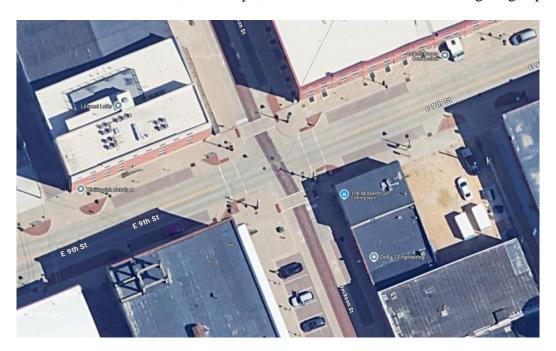
Figure 179: Intersection of East 9th Street and Jackson Street

This site is a four-legged, undivided, low-speed, partial stop-control intersection (Google Maps Link). The intersection is located in a commercial area with on-street parking. Pedestrian infrastructure includes sidewalks, curb ramps, and marked crosswalks. Street lighting is present.

Crash reports indicate that five crashes have occurred at this intersection over a five-year period (2018–2022), including one KAB crashes and four CO crashes. The manner of collision included broadside (front to side) and sideswipe (same direction) crashes. Contributing factors to crashes included running stop signs, failure to yield right-of-way from stop signs, and no improper action. This intersection has a KABCO Annual PCR of 0.394193, indicating a moderate crash frequency.

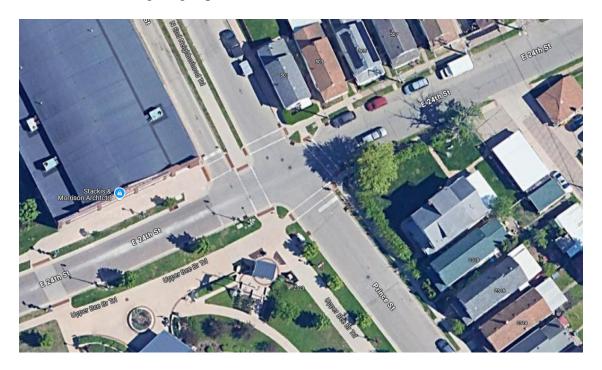
Figure 180: Intersection of Prince Street and East 24th Street

This site is a four-legged, semi-divided, low-speed, partial stop-control intersection (Google Maps Link). The location is a mix of residential and commercial, with on-street parking present on some approaches. There appear to be restricted sight distance issues, particularly for westbound traffic. Pedestrian infrastructure includes sidewalks, curb ramps, and marked crosswalks. Overhead lighting is present.

Crash reports indicate that five crashes have occurred at this intersection over a five-year period (2018–2022), including zero KAB crashes and five CO crashes. The manner of collision included broadside (front to side), angle (oncoming left turn), "other", sideswipe (same direction), and non-collision (single vehicle) crashes. Contributing factors to crashes included running stop signs and failure to yield right-of-way from stop signs, improper backing, loss of control, impairment, and running off the road to the right. This intersection has a KABCO Annual PCR of 0.392788, indicating a moderate crash frequency.

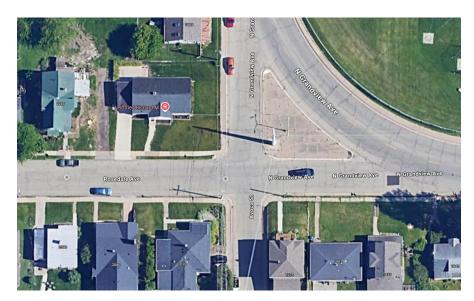
Figure 181: Intersection of Rosedale Avenue, Avoca Street, and Grandview Avenue

This site is a four-legged, undivided, low-speed, partial stop-control intersection (Google Maps Link). A raised island is in the center of the intersection which allows Grandview Avenue traffic to transition from north-south to east-west without stopping. A steel utility pole is located within this island area. Pedestrian infrastructure includes sidewalks and curb ramps, but there are marked crosswalks. Overhead lighting is present.

Crash reports indicate that six crashes have occurred at this intersection over a five-year period (2018–2022), including zero KAB crashes and six CO crashes. The manner of collision included broadside (front to side), "other", and angle (oncoming left turn) crashes. Contributing factors to crashes included running stop signs and failure to yield right-of-way from stop signs or while making left turns. This intersection has a KABCO Annual PCR of 0.392755, indicating a moderate crash frequency.

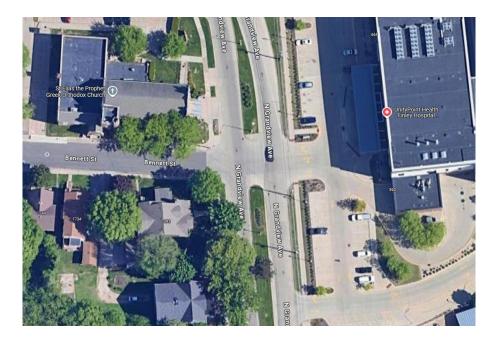
Figure 182: Intersection of Grandview Avenue and Bennett Street

This site is a three-legged, divided, low-speed, partial stop-control intersection (Google Maps Link). The fourth leg of this intersection is an entrance to a hospital. There is restricted sight distance for eastbound traffic. The intersection is located in a mostly residential area. Pedestrian infrastructure includes sidewalks and curb ramps, but there are marked crosswalks. Overhead lighting is present.

Crash reports indicate that five crashes have occurred at this intersection over a five-year period (2018–2022), including one KAB crashes and four CO crashes. The manner of collision included broadside (front to side), non-collision (single vehicle), and rear-end (front to rear) crashes. Contributing factors to crashes included failure to yield right-of-way from a driveway, from a stop sign and to non-motorists, being under the influence, and loss of control. This intersection has a KABCO Annual PCR of 0.382142, indicating a moderate crash frequency.
