Appendix A: Dubuque MPO Sites

Intersections

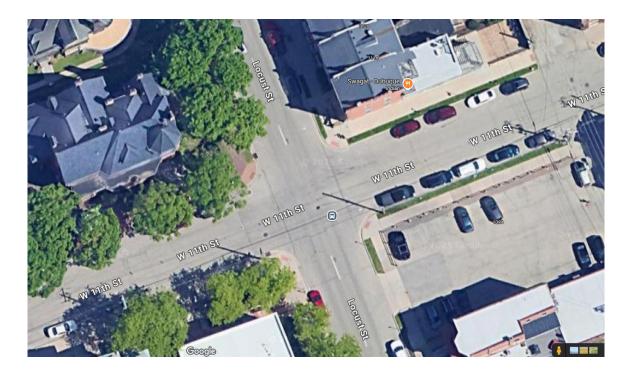
Figure 183: Intersection of Locust Street and West 11th Street

This site is a four-legged, undivided, low-speed, partial stop-control intersection (Google Maps Link). The location is a primarily residential area. On-street parking and driveways are located near the intersection. Pedestrian infrastructure includes sidewalks and curb ramps, but there are marked crosswalks. Overhead lighting is present.

Crash reports indicate that six crashes have occurred at this intersection over a five-year period (2018–2022), including one KAB crashes and five CO crashes. The manner of collision included sideswipe (same direction), angle (oncoming left turn), head-on (front to front), "other", and non-collision (single vehicle). Contributing factors to crashes included loss of control, traveling the wrong way/on the wrong side, failure to yield right-of-way from parked positions or while making left turns, improper lane changing, improper turns, traveling the wrong way/on the wrong side, running stop signs, and being under the influence. This intersection has a KABCO Annual PCR of 0.381347, indicating a moderate crash frequency.

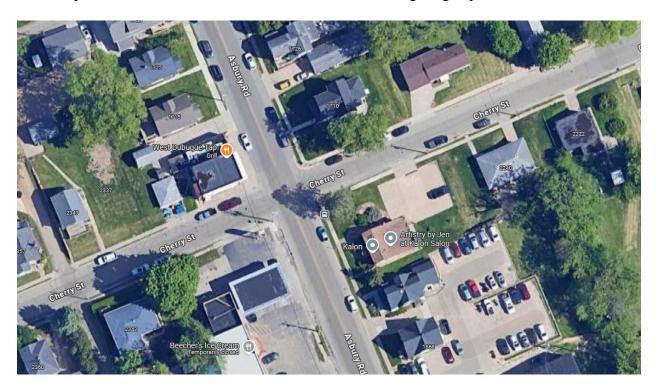
Figure 184: Intersection of Asbury Road and Cherry Street

This site is a four-legged, undivided, low-speed, partial stop-control intersection (Google Maps L ink). The area is a mix of residential and commercial. There is a gas station entrance at the intersection, and on-street parking is present. Pedestrian infrastructure includes sidewalks and curb ramps, but there are marked crosswalks. No overhead lighting is present.

Crash reports indicate that nine crashes have occurred at this intersection over a five-year period (2018–2022), including two KAB crashes and seven CO crashes. The manner of collision included broadside (front to side), rear-end (front to rear), non-collision (single vehicle), "other", head-on (front to front), and sideswipe (same direction) crashes. Contributing factors to crashes included running stop signs and failure to yield right-of-way from stop signs or to non-motorists, loss of control, being under the influence, and traveling the wrong way/on the wrong side. This intersection has a KABCO Annual PCR of 0.378332, indicating a moderate crash frequency.

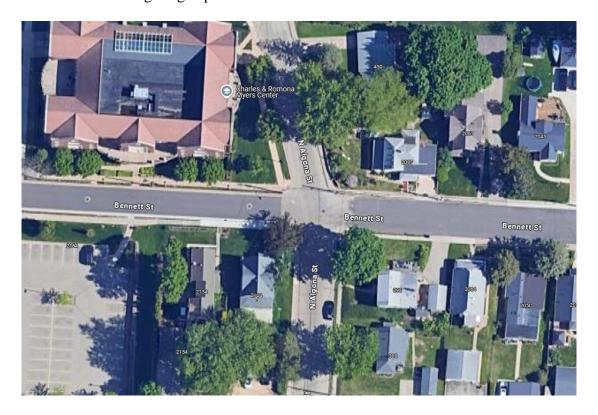
Figure 185: Intersection of Bennet Street and Algona Street

This site is a four-legged, undivided, low-speed, partial stop-control intersection (Google Maps Link). The area is mainly residential, with university-related buildings also located at and near the intersection. On-street parking is present, and there are restricted sight distance and narrow lanes. Pedestrian infrastructure includes sidewalks and curb ramps, but there are marked crosswalks. Overhead lighting is present.

Crash reports indicate that six crashes have occurred at this intersection over a five-year period (2018–2022), including two KAB crashes and four CO crashes. The manner of collision included broadside (front to side), sideswipe (same direction), and non-collision (single vehicle). Contributing factors to crashes included running stop signs and failure to yield right-of-way from stop signs, loss of control, being under the influence, making improper turns, and no improper action. This intersection has a KABCO Annual PCR of 0.368373, indicating a moderate crash frequency.

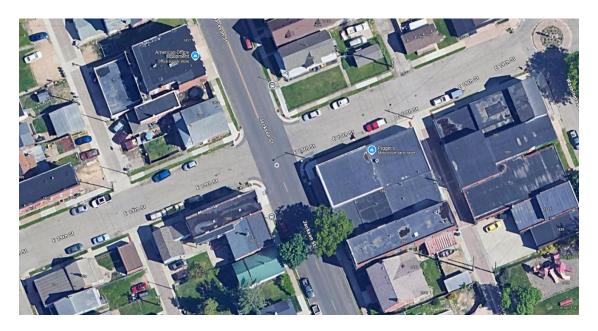
Figure 186: Intersection of Jackson Street and East 19th Street

This site is a four-legged, undivided, low-speed, partial stop-control intersection (<u>Google Maps Link</u>). The location is residential, and on-street parking is present. Pedestrian infrastructure includes sidewalks and curb ramps, but there are marked crosswalks. Overhead lighting is present.

Crash reports indicate that five crashes have occurred at this intersection over a five-year period (2018–2022), including two KAB crashes and three CO crashes. The manner of collision included rear-end (front to rear), head-on (front to front), non-collision (single vehicle), and broadside (front to side) crashes. Contributing factors to crashes included loss of control and reckless/erratic driving, traveling the wrong way/on the wrong side, impairment, and failure to

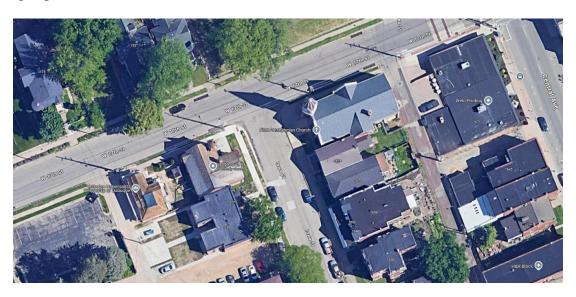
Figure 187: Intersection of West 17th Street and Iowa Street

This site is a three-legged, undivided, low-speed, partial stop-control intersection (Google Maps Link). The area is primarily residential, and on-street parking is present. Pedestrian infrastructure includes sidewalks and curb ramps, but there are marked crosswalks. Overhead lighting is present.

crashes included loss of control, running a stop sign, traveling the wrong way/on the wrong side, and failure to yield right-of-way to non-motorists. This intersection has a KABCO Annual PCR of 0.352506, indicating a moderate crash frequency.

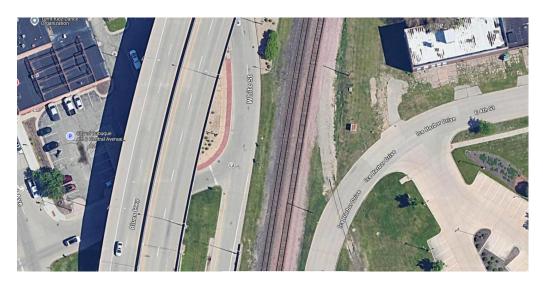
Figure 188: Intersection of White Street and West 4th Street

This site is a three-legged, undivided, low-speed, partial stop-control intersection (Google Maps Link). The south leg of the intersection serves as an entrance ramp to southbound US151. The intersection is located in a commercial area and on-street parking is limited to the north and west approaches. Pedestrian infrastructure consists of sidewalks and curb ramps, and is limited to the north side of the intersection along the north, east and west approaches. Overhead lighting is present.

head-on (front to front), broadside (front to side), and rear end crashes. Contributing factors to crashes included loss of control, failure to yield right-of-way while making a left turn and from a stop sign, and running a stop sign. This intersection has a KABCO Annual PCR of 0.349675, indicating a moderate crash frequency.

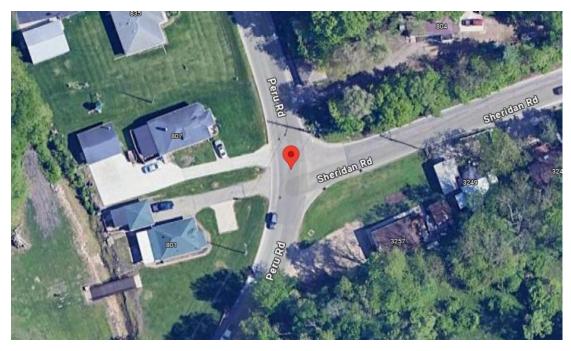
Figure 189: Intersection of Peru Road and Sheridan Road

This site is a three-legged, undivided, low speed, partial stop controlled intersection (Google Maps Link). It has a medium PCR level for KABCO crashes, indicating the need for attention and potential countermeasures. The area is surrounded by residential properties. The intersection lacks curbs, curb ramps, sidewalks and crosswalks. Overhead lighting is present, and the pavement is in good condition.

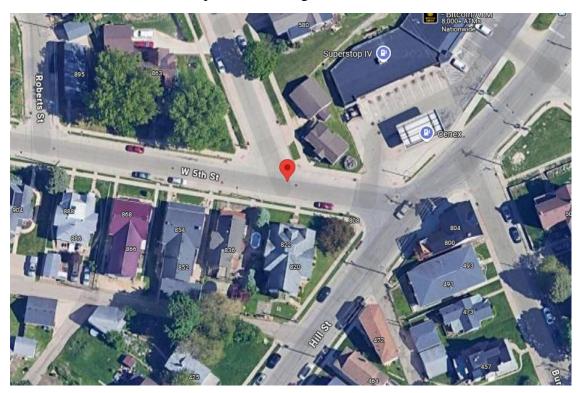
Figure 190: Intersection of Wilson Street and West 5th Street

This site is a three-legged, undivided, low speed, partial stop controlled intersection (Google Maps Link). It has a medium PCR level for KABCO crashes, indicating the need for attention and potential countermeasures. The intersection is located in a predominantly residential area and features well-defined curbs, curb ramps, and sidewalks, but lacks marked crosswalks. The intersection is illuminated, and the pavement is in good condition.

Crash reports indicate that six crashes have occurred at this intersection over a five-year period (2018-2022), including zero KAB crashes and six CO crashes. The predominant manner of collision includes sideswipes in the opposite direction, rear-end, and same-direction sideswipe crashes. The primary contributing factors to crashes are loss of control, driving too fast for conditions, improper backing, and vehicles running off the road to the left. The KAB Annual PCR for the intersection is -0.000432, indicating no severity level, while the KABCO Annual PCR is 0.344316, which is considered medium. Based on statewide rankings, this intersection is ranked 78,717th for KAB crashes and 3,305th for KABCO crashes out of 115,274 intersections statewide.

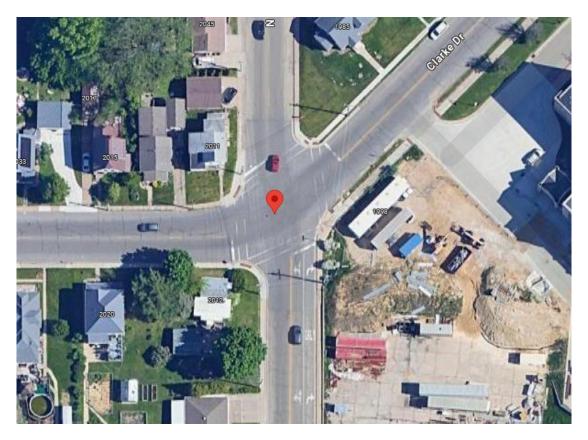
Figure 191: Intersection of Clarke Drive and Grandview Avenue

This site is a four-legged, undivided, low speed, all way stop controlled intersection (Google Maps Link). It has a medium PCR level for KABCO crashes, indicating the need for attention and potential countermeasures. The intersection is located in a predominantly residential area and features well-defined curbs, curb ramps, sidewalks, and marked crosswalks. The intersection is illuminated, and the pavement is in good condition.

Crash reports indicate that 19 crashes have occurred at this intersection over a five-year period (2018-2022), including zero KAB crashes and nineteen CO crashes. The predominant manner of collision is rear end (front-to-rear), broadside (front-to-side), angle (oncoming left turn), head-on (front to front), rear to side, and sideswipe (same direction) crashes, indicating potential issues with driver attention and intersection control. The primary contributing factor to the reported crashes is loss of control, failure to yield right-of-way from stop signs and while making left-turns, running a stop sign, following too closely, and improper backing. The KAB Annual PCR for the intersection is -0.104118, indicating no severity level, while the KABCO Annual PCR is 0.319157, which is considered medium. Based on statewide rankings, this intersection is ranked 114,348th for KAB crashes and 3,472nd for KABCO crashes out of 115,274 intersections statewide.

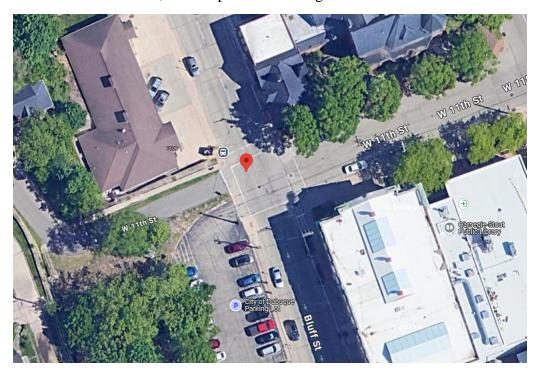
Figure 192: Intersection of Bluff Street and West 11th Street

This site is a four-legged, undivided, low speed, partial stop controlled intersection (Google Maps Link). It has a medium PCR level for KABCO crashes, indicating the need for attention and potential countermeasures. The west approach of the intersection appears to serve more as an alley entrance/exit than a traditional roadway. The intersection is located in a mixed-use area of both residential and commercial land uses. A bus stop is located near the intersection. The intersection features well-defined curbs, curb ramps, sidewalks, and marked crosswalks are present. The area is illuminated, and the pavement is in good condition.

Crash reports indicate that six crashes have occurred at this intersection over a five-year period (2018–2022), all of which were classified as CO crashes. The predominant manner of collision is sideswipe (same direction), head-on, non-collision single vehicle events, and rear-end crashes, suggesting a variety of driver behavior and maneuvering issues. The primary contributing factor to these crashes is lost control, failure to yield right-of-way from parking, and vehicles running off the road to the right. The KAB Annual PCR for the intersection is -0.000706, indicating no severe injury crashes, while the KABCO Annual PCR is 0.317189, which is considered medium. Based on statewide rankings, this intersection is ranked 87,525th for KAB crashes and 3,486th for KABCO crashes out of 115,274 intersections statewide.

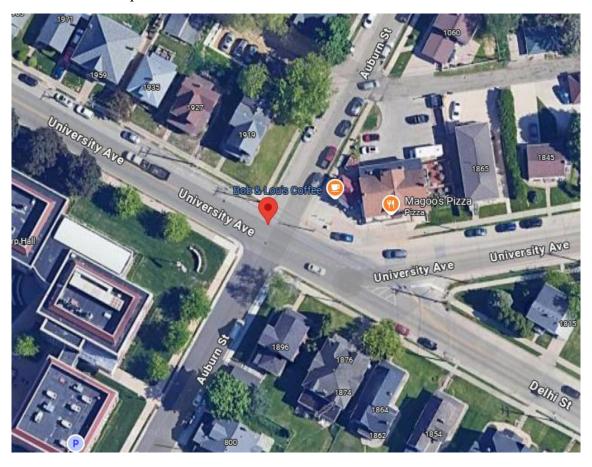
Figure 193: Intersection of University Avenue and Auburn Street

This site is a four-legged, undivided, low speed, partial stop controlled intersection (Google Maps Link). It has a medium PCR level for KABCO crashes, indicating the need for attention and potential countermeasures. The intersection is located in a mixed-use area comprising residential, educational, and commercial land uses. It features well-defined curbs, curb ramps, and sidewalks. Overhead lighting is present, and the pavement is in good condition. There are no marked crosswalks present.

failure to yield right-of-way at stop signs and other yielding conditions, improper backing, and loss of control. The KAB Annual PCR for the intersection is -0.047792, indicating no severity level, while the KABCO Annual PCR is 0.294532, which falls in the medium range. Based on statewide rankings, this intersection is ranked 113,260th for KAB crashes and 3,688th for KABCO crashes out of 115,274 intersections statewide.

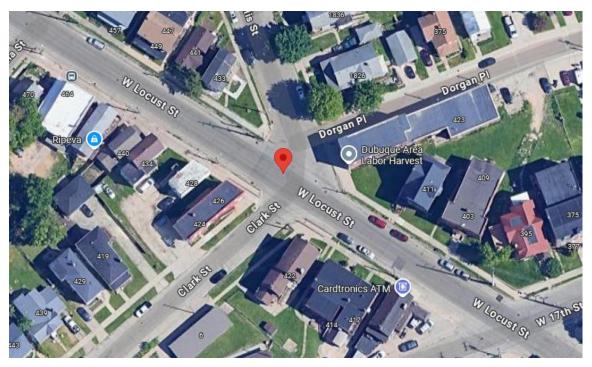
Figure 194: Intersection of Clark Street, Dorgan Street, Ellis Street and West Locust Street

This site is a five-legged, undivided, low speed, partial stop controlled intersection (Google Maps Link). It has a medium PCR level for KABCO crashes, indicating the need for attention and potential countermeasures. The intersection is located in a predominantly residential area and features well-defined curbs, curb ramps, and sidewalks, although there are no marked crosswalks. The intersection is illuminated, and the pavement is in good condition.

Crash reports indicate that six crashes have occurred at this intersection over a five-year period (2018–2022), with no KAB crashes and six CO crashes. The predominant manner of collision is rear end (front-to-rear), broadside (front-to-side), rear-to-side, and sideswipe (same direction) crashes, suggesting a variety of driver errors and potential conflicts at the intersection. The primary contributing factor to these crashes is loss of control, driver distraction, failure to yield right-of-way from stop signs, and improper backing. The KAB Annual PCR for the intersection is -0.002581, indicating no significant severity level, while the KABCO Annual PCR is 0.291461, which is considered medium. Based on statewide rankings, this intersection is ranked 101,415th for KAB crashes and 3,719th for KABCO crashes out of 115,274 intersections statewide.

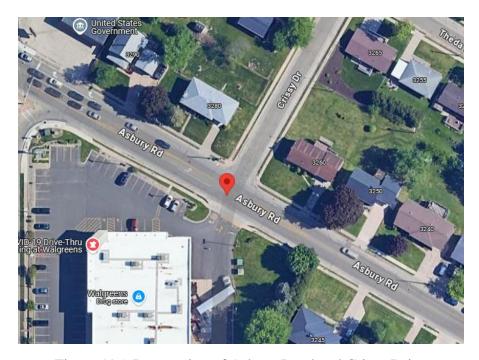
Figure 195: Intersection of Asbury Road and Crissy Drive

This site is a three-legged, undivided, low speed, partial stop controlled intersection (Google Maps Link). It has a medium PCR level for KABCO crashes, indicating the need for attention and potential countermeasures. The intersection is located in a mixed commercial and residential area and features well-defined curbs, curb ramps, and sidewalks. The intersection is illuminated, and the pavement is in good condition. However, there are no marked crosswalks present.

Crash reports indicate that six crashes have occurred at this intersection over a five-year period (2018–2022), all of which were classified as CO. The predominant manner of collision is rear end (front-to-rear) and loss of control crashes. Additional contributing factors include driver distraction, following too closely, and running a stop sign. The KAB Annual PCR for the intersection is -0.007877, indicating no severity level, while the KABCO Annual PCR is 0.291141, which is considered medium. Based on statewide rankings, this intersection is ranked 107,752nd for KAB crashes and 3,725th for KABCO crashes out of 115,274 intersections statewide.

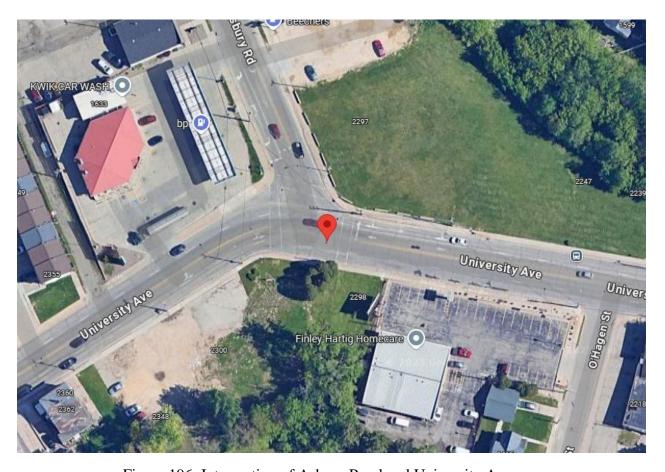
Figure 196: Intersection of Asbury Road and University Avenue

This site is a three-legged, undivided, low speed, all way stop controlled intersection (Google Maps Link). It has a medium PCR level for KABCO crashes, indicating the need for attention and potential countermeasures. The intersection is located in a predominantly commercial area. The pavement is in good condition and overhead lighting is present. The intersection features well-defined curbs, curb ramps, sidewalks and marked crosswalks.

Crash reports indicate that 23 crashes have occurred at this intersection over a five-year period (2018–2022), all of which were classified as CO crashes. The predominant manner of collision is broadside (front-to-side), followed by sideswipe (same direction), head-on (front to front), rearend (front-to-rear), angle (oncoming left turn), and non-collisions (single vehicle). These patterns suggest issues related to yielding and driver attentiveness during turning movements and lane changes. The primary contributing factor to these crashes is failure to yield right-of-way while making a left turn, running a stop sign, making improper turns, loss of control, and failing to maintain proper lane positioning. The KAB Annual PCR for the intersection is -0.400453, indicating no recorded severe crashes. However, the KABCO Annual PCR is 0.271397, which falls in the medium range. The statewide rankings for this intersection are 115,220th for KAB crashes and 4,023rd for KABCO crashes out of 115,274 intersections, emphasizing its relative frequency of non-severe crashes.

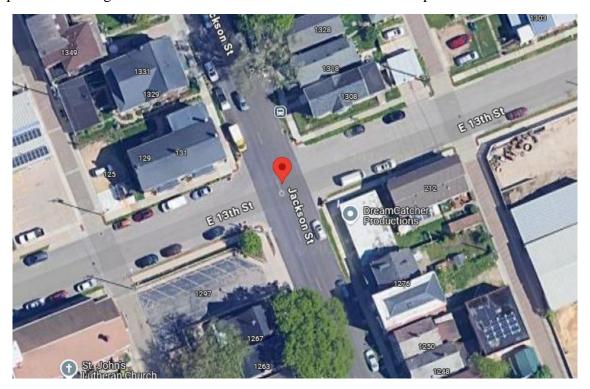
Figure 197: Intersection of East 13th Street and Jackson Street

This site is a four-legged, undivided, low speed, partial stop controlled intersection (Google Maps Link). It has a medium PCR level for KABCO crashes, indicating the need for attention and potential countermeasures. The intersection is located in a predominantly residential area and features well-defined curbs, curb ramps, and sidewalks. The intersection is illuminated, and the pavement is in good condition. There are no marked crosswalks present.

Crash reports indicate that six crashes have occurred at this intersection over a five-year period (2018–2022), including one KAB crash and five CO crashes. The predominant manner of collision is broadside (front-to-side) and sideswipe (same direction) crashes, suggesting potential issues with lane discipline and driver attentiveness. The primary contributing factor to the total crashes is running stop sign, failure to yield right-of-way from a stop sign, FTYROW from parking, and loss of control. The KAB Annual PCR for the intersection is 0.033807, indicating a low severity level, while the KABCO Annual PCR is 0.254509, which is considered medium.

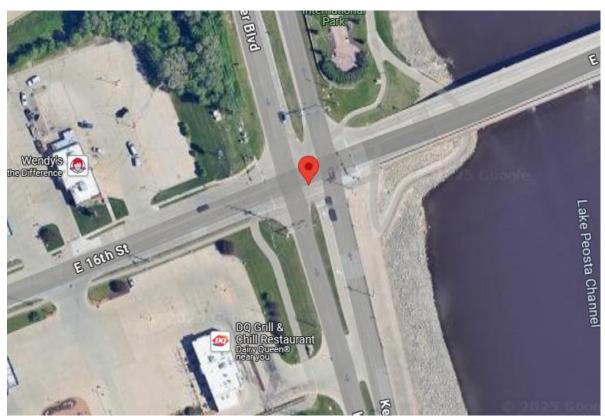
Figure 198: Intersection of East 16th Street and Kerper Boulevard

This site is a four-legged, divided, low speed, signalized intersection (Google Maps Link). It has a medium PCR level for KABCO crashes, indicating the need for attention and potential countermeasures. The intersection is located in a mixed-use area with commercial development and undeveloped land, and a bike trail is located near the intersection approaches. It features well-defined curbs, curb ramps, and sidewalks. The intersection is illuminated, and the pavement is in good condition. There are no marked crosswalks present.

Crash reports indicate that 17 crashes have occurred at this intersection over a five-year period (2018–2022), including two KAB crashes and fifteen CO crashes. The predominant manner of collision is broadside (front-to-side), rear-end, angle (oncoming left turn), and non-collision (single vehicle) crashes, suggesting issues with right-of-way compliance, turning conflicts, and inattentive driving. The primary contributing factors to KABCO crashes are loss of control and running traffic signal, as well as failure to yield right-of-way while making left-turn, running stop signs, driver distraction, and running off road to the left. The KAB Annual PCR for the intersection is 0.027615, indicating a low severity level, while the KABCO Annual PCR is 0.241418, which is considered medium. Based on statewide rankings, this intersection is ranked 3,273rd for KAB crashes and 4,411th for KABCO crashes out of 115,274 intersections statewide, identifying it as a location that warrants attention.

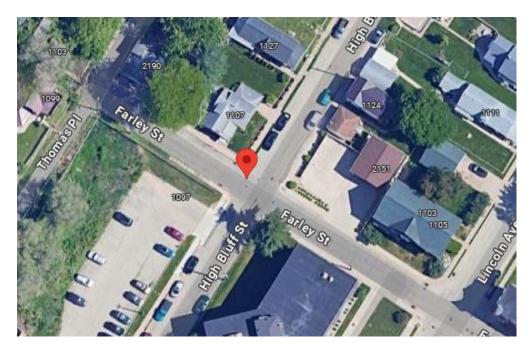
Figure 199: Intersection of Farley Street and Lincoln Avenue

This site is a four-legged, undivided, low speed, uncontrolled intersection (<u>Google Maps Link</u>). It has a medium PCR level for KABCO crashes, indicating the need for attention and potential countermeasures. The intersection is located in a predominantly residential area and features well-defined curbs, curb ramps, and sidewalks. The intersection is illuminated, and the road pavement is in good condition. However, there are no marked crosswalks present.

Crash reports indicate that four crashes have occurred at this intersection over a five-year period (2018–2022), including two KAB crashes and two CO crashes. The predominant manner of collision is broadside (front-to-side), highlighting the risk associated with turning movements or failure to yield at this location. The primary contributing factor to KAB crashes is failure to yield right-of-way at uncontrolled intersections, which led to broadside crashes. The KAB Annual PCR for the intersection is 0.008834, indicating a low severity level, while the KABCO Annual PCR is 0.228186, which is considered medium. Based on statewide rankings, this intersection is ranked 6,205th for KAB crashes and 4,591st for KABCO crashes out of 115,274 intersections statewide.

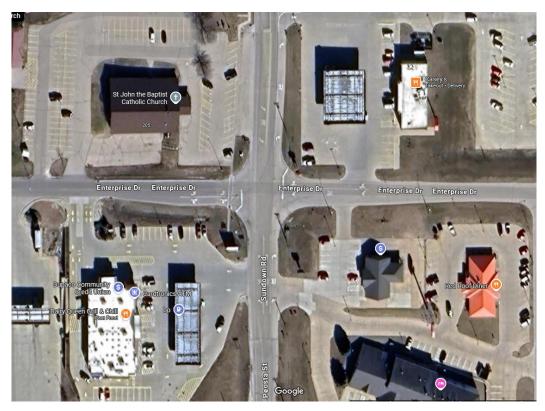
Figure 200: Intersection of Enterprise Drive and Peosta Street (Image: Google Maps)

parking lot entrances nearby may contribute to traffic conflicts and confusion. The latest available street view images are from 2019, and it is likely that roadway conditions and signage may have changed over time. Sidewalks, curb ramps and crosswalks are provided on the west leg of the intersection. An overhead light is present in the southwest quadrant.

This intersection has experienced several crashes in recent years, including one KAB crash and five CO crashes. The primary manner of collision includes sideswipe, broadside, angle, and rearend crashes. A sideswipe crash occurred under wet roadway conditions on the eastbound (EB) approach, attributed to failure to yield right-of-way (FTYROW) from a stop sign. Two broadside crashes were recorded; one between westbound (WB) and southbound (SB) vehicles, and another between eastbound (EB) and southbound (SB) vehicles. Both of these were due to FTYROW from a stop sign. An angle crash between northbound (NB) and southbound (SB) vehicles resulted from FTYROW while making a left turn. Additionally, a rear-end collision occurred on the westbound approach, caused by following too closely.

Based on the crash history and existing roadway conditions, potential safety improvements that have been identified include:

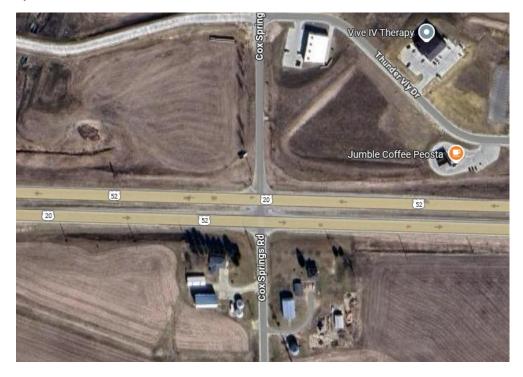
Figure 201: Intersection of US 20 and Cox Springs Road (Image: Google Maps)

This intersection has experienced several crashes in recent years, including four KAB crash and 12 CO crashes. The primary manner of collision includes sideswipe, broadside, angle, rear-end, sideswipe, and single vehicle crashes. Nine crashes involved combinations of southbound and westbound vehicles. At least six of these crashes involved failure to yield right of way by a southbound vehicle. In other instances, no crash cause was reported. Single vehicle crash causes involved loss of control while trying to avoid an object on the roadway, and driver distraction.

Based on the crash history and existing roadway conditions, potential safety improvements that have been identified include:

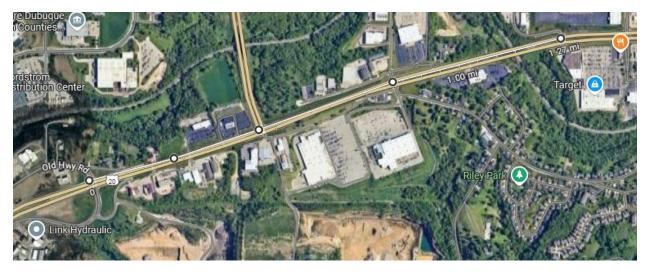
Figure 202: US 20 corridor between Century Drive and Old Highway Road

possible/unknown injuries, and 245 property damage only crashes. The corridor experiences a variety of crash types, including rear-end, sideswipe, broadside, and non-collision single-vehicle crashes. Contributing factors associated with crashes included loss of control, following too closely, running traffic signals and driver distraction. The KAB Annual PCR for this segment is 2.56, which is high, while the KABCO Annual PCR is 0.70, which is considered low. This value was ranked 206 among similar segments statewide. Available speed data for the segment indicates that 18.2 percent of vehicles exceed the speed limit by 10 mph.

- Optimize signal timings to reduce red-light running and prevent rear-end crashes (Moderate)
- Conduct red-light enforcement activities at high-risk intersections to deter violations (Low)
- Add retroreflective backplates to increase conspicuity (Low)
- Install speed feedback signs (permanent or temporary) to encourage speed compliance in the area (Low)
- Implement dedicated left turn phasing at signalized intersections if needed (Moderate)
- Determine friction levels and apply surfacing as needed (Moderate)

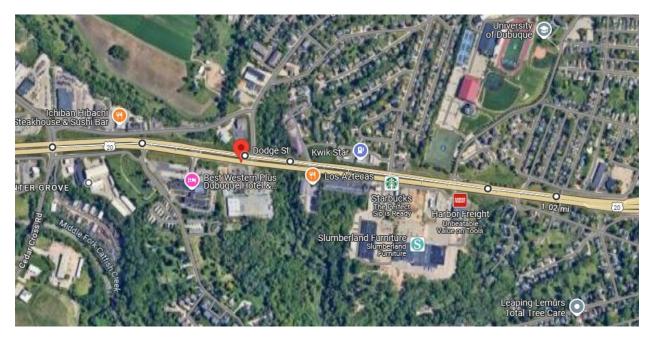
Figure 203: Dodge Street/US 20 between Gandolfo Street and Kennedy Road

A total of 211 crashes were recorded along this corridor from 2018 to 2024. Crash severities included one suspected serious injury crash, 15 suspected minor injury crashes, 40 possible injuries, and 155 property damage only crashes. The corridor experiences a variety of crash types, including rear-end collisions, sideswipe crashes, broadside crashes, and non-collision single-vehicle incidents. Contributing factors to crashes along this corridor include loss of control, following too closely, running traffic signals, and driver distraction. The segment identified ranks 96 out of 5,032 similar segments based on the KABCO Annual PCR of 1.480602. Additionally, the KAB PCR for this segment is 1.042440. Available speed data for the segment indicates that 18.2 percent of vehicles exceed the speed limit by 10 mph.

- Optimize signal timings (Moderate)
- Add backplates with retroreflective borders to improve signal visibility (Low)
- Install speed feedback signs (permanent or temporary) to encourage speed compliance in the area (Low)
- Conduct public awareness campaigns targeting driver distraction (Moderate)
- Add dedicated left-turn phases if necessary (Moderate)
- Evaluate pavement conditions and apply friction material if needed (Moderate)
- Increase targeted enforcement efforts for aggressive driving, following too closely, and signal violations (Low)

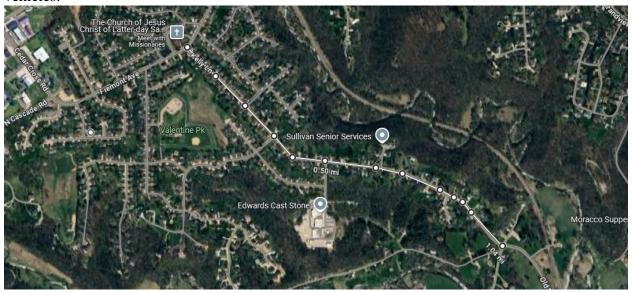
Figure 204: Kelly Lane Corridor (Image: Google Maps)

A total of 31 crashes were recorded along this corridor from 2018-2024. This included one suspected serious injury, three suspected minor injuries, five possible injuries and 22 property damage only. The corridor experiences a variety of crash types, including non-collision single-vehicle, rear-end, sideswipe (same direction), and broadside. It is interesting to note that 10 of total crashes happened on Monday mostly between evening peak periods. Contributing factors in crashes included loss of control, driver distraction, run off the road to the right, and failure to yield the right-of-way from a driveway. This segment ranks 914th out of 5,032 similar segments based on the KABCO Annual PCR of 0.31, while the KAB PCR for the segment is 0.53. Available speed data for the segment indicates that approximately 35.6 percent of vehicles exceed the speed limit by 10 mph.

Based on the crash history, speed trends, and contributing factors, the following safety improvements are recommended:

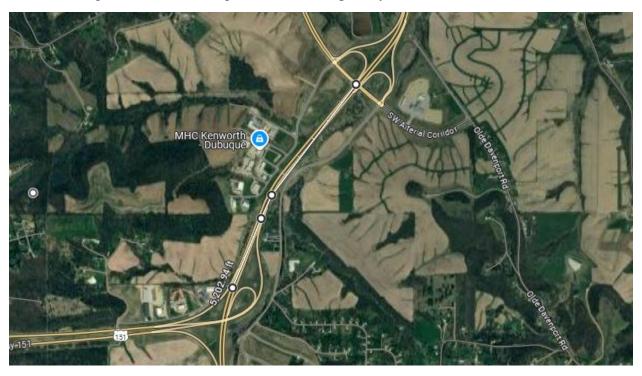
Figure 205: Highway 61 Corridor near Dubuque Regional Airport (Image: Google Maps)

A total of 57 crashes were recorded along this segment from 2018 to 2024. Crash severities included three suspected serious injury crashes, eight suspected minor injury crashes, seven possible or unknown injury crashes, and 39 property damage only crashes. The majority of crashes were non-collision single-vehicle, along with rear-end and broadside (front-to-side) crashes. Contributing factors in crashes included loss of control, run off the road, and animal-vehicle. This segment ranks 541st out of 5,032 similar segments based on the KABCO Annual

Based on the crash history, speed trends, and contributing factors, the following safety improvements are recommended:

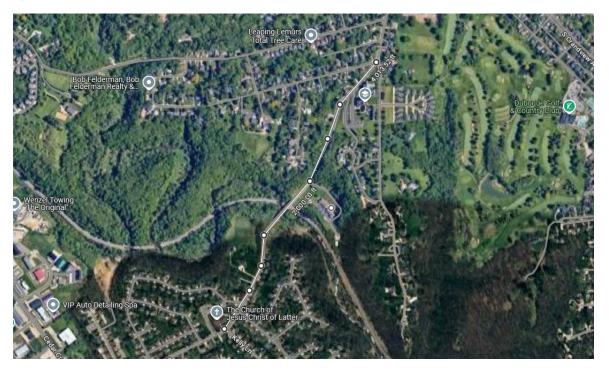
Figure 206: Fremont Avenue Corridor (Image: Google Maps)

A total of 24 crashes were recorded along this segment from 2018 to 2024. Crash severities included two suspected serious injury crashes, two suspected minor injury crashes, three possible or unknown injury crashes, and 17 property damage only crashes. The predominant crash types included non-collision single-vehicle, rear-end, broadside, and angle (oncoming left turn) crash. It is notable that in two crashes, the first harmful event involved a vehicle striking a building after the driver lost control. Contributing factors in crashes included loss of control, run off the road right, driver distraction, and running stop signs. This segment ranks 914th out of 5,032 similar segments based on the KABCO Annual PCR of 0.31, and the KAB PCR for the segment is 0.53. Available speed data for the segment indicates that approximately 21.5 percent of vehicles exceed the speed limit by 10 mph.

Based on the crash history, speed trends, and contributing factors, the following safety improvements are recommended:

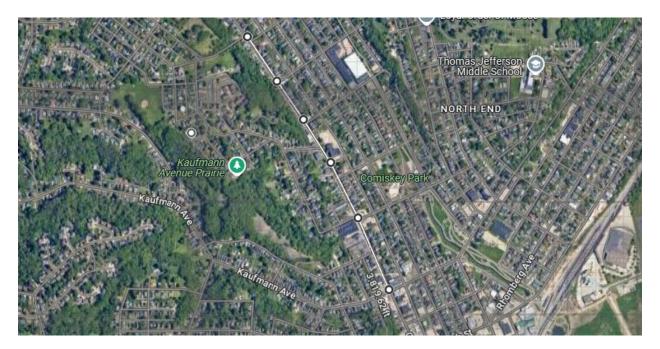
Figure 207: Central Avenue Corridor (Image: Google Maps)

A total of 139 crashes were recorded along this segment from 2018 to 2024. Crash severities included three suspected serious injury crashes, 12 suspected minor injury crashes, 30 possible or unknown injury crashes, and 94 property damage only crashes. The corridor experiences a variety of crash types, including non-collision single-vehicle, head-on (front-to-front), rear-end, angle (oncoming left-turn), broadside (front-to-side), and same-direction sideswipe. Contributing factors included loss of control, improper or erratic lane changes, improper turns, driver distraction, run off the road right, and running stop signs. This segment ranks 91st out of 5,032 similar segments based on the KABCO Annual PCR of -0.04. The KAB PCR for the segment is 0.53.

Based on the crash history, speed trends, and contributing factors, the following safety improvements are recommended:

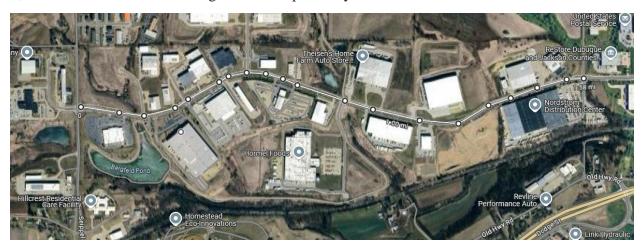
Figure 208: Chanelle Road corridor (Image: Google Maps)

A total of 211 crashes were recorded along this corridor between 2018-2024. Crashes included one suspected serious injury, 15 suspected minor injuries,40 possible injuries and 155 property damage only. Primary crash types in this corridor included rear-end, and sideswipe, broadside and non-collision (single vehicle). Contributing factors in crashes included running stop signs, loss of control, running off the road to the left, of failure to yield right of way from driveways, and driver distraction. This segment ranks 2006th out of 5032 similar intersections based on the KABCO Annual PCR of 0.16 and the KAB PCR for this segment is 0.99. Available speed data for the segment indicates that approximately 18.2 percent of vehicles exceed the speed limit by 10 mph.

- Optimize signal timing to prevent rear-end crashes and determine if changes to the yellow clearance interval are needed to reduce red-light running (Low/Medium).
- Investigate and implement signal coordination if feasible (Medium).
- Employ high visibility traffic enforcement at high-risk intersections to deter violations (Low)

- Add backplates with retroreflective borders to improve traffic signal visibility (Low).
- Deploy speed feedback signs (temporary or permanent) to encourage speed compliance and reduce higher-speed crashes (Low).
- Employ dedicated left-turn phases where applicable to reduce broadside crashes (Medium).
- Evaluate pavement friction conditions and apply skid-resistant surface treatments in high-risk areas to reduce loss-of-control crashes (Medium).

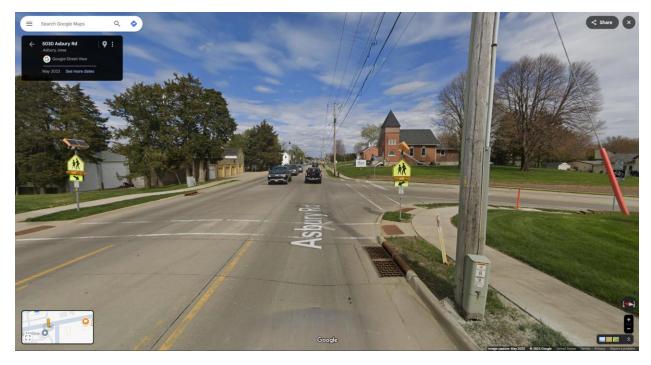
Figure 209: Asbury Road Approach to Radford Road (Image Source: Google)

Several crashes occurred at this intersection during the analysis period. A bicycle crash, involving a northbound vehicle, occurred at/near this intersection in September 2021. A second non-motorist crash happened in August 2021, involving a five-year-old pedestrian (who was seriously injured) and two vehicles (eastbound and westbound). In 2017, multiple pedestrians were struck by a right turning, northbound vehicle that failed to yield to the non-motorists.

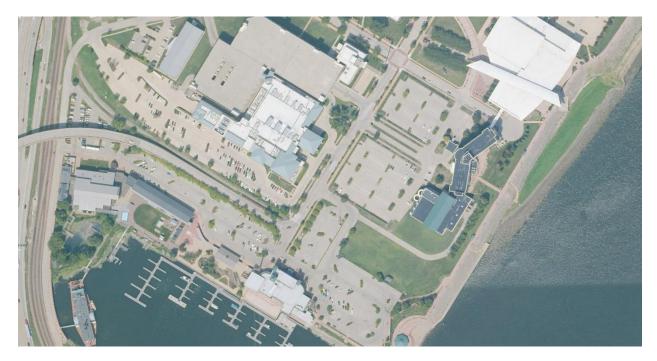
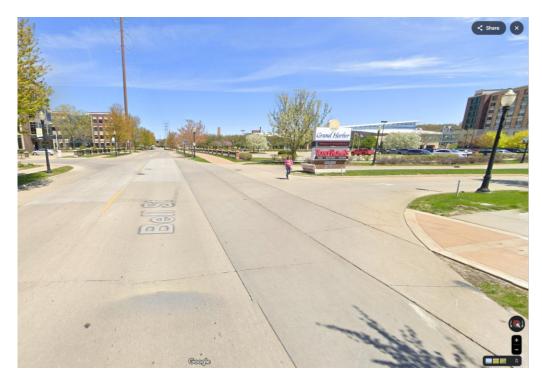
Figure 210: Bell Street at Port of Dubuque (Image Source - <u>Iowa Geographic Map Server</u>)

Two non-motorist crashes occurred along this corridor in recent years — both at driveways. At 11:48, January 21, 2022, a pedestrian was crossing one of the driveways near the parking structure was struck and killed by a right turning vehicle that did not yield right of way. While this crash may have been a random event, the driveways serve high traffic generators. A similar, driveway-related crash happened at 20:02 on October 5, 2021 along Bell Street. Specifically, a left turning vehicle struck a pedestrian crossing a driveway. The figure below shows a pedestrian crossing these driveways.

Figure 211: Bell Street Pedestrian Evidence near Resort Driveway (Image Source: Google)

While the speed limit along Bell Street is generally consistent with safe pedestrian speeds, the high pedestrian and turning vehicle traffic may warrant alerting motorists to pedestrian activity. Potential countermeasures may include the following.

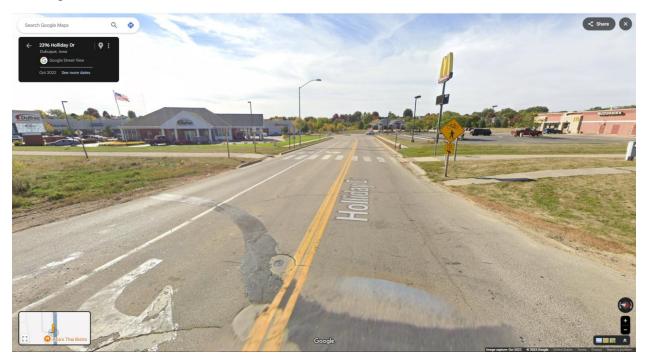
Figure 212: Westbound Holliday Drive at NW Arterial (Image Source: Google)

A shared use trail runs parallel along NW Arterial on the west side of the roadway. The trail crossing on Holliday Drive is approximately 80 feet from the NW Arterial right turn lane edge line. Pedestrian signal heads and activation buttons are located along the west side of NW Arterial, but are more than 60 feet from the shared use trail. Bicycle warning signs are located along the southbound arterial approach. Similar signage is located westbound and eastbound along Holiday Drive in advance of the trail. The crossing is also designated with pavement markings.

A fatal pedestrian crash occurred at this location at 21:02 on July 28, 2018. The vehicle was northbound on NW Arterial turning left onto Holliday Drive. The pedestrian was reported as crossing improperly. This location satisfied five of the evaluation criteria. While crash experience is limited at this location, non-motorist safety improvements are possible.

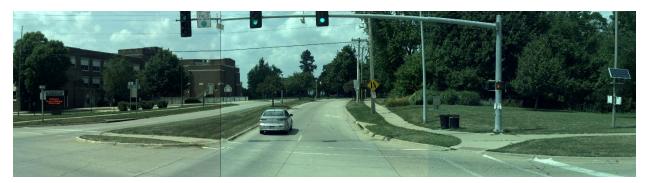
Figure 213. Intersection of Grandview Avenue and Dodge Street Ramp, Northbound (Image Source: Pathweb)

Furthermore, the northbound pedestrian crossing sign is obscured by trees until approximately 85 feet prior to the crossing. Even at this distance, the sign is partially obscured. The southbound pedestrian crossing sign is also obscured by trees, but to a lesser extent.

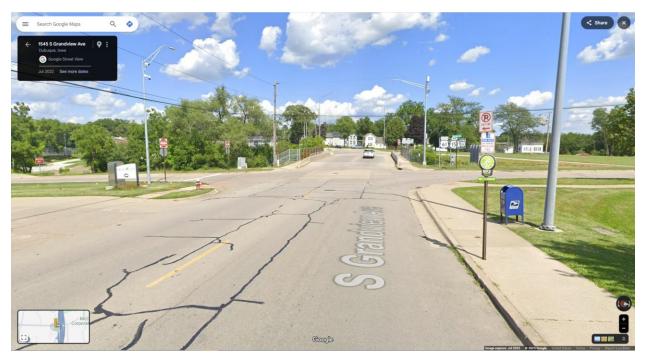
Figure 214: S Grandview Avenue and US 61 Interchange, Eastbound (Image Source: Google)

The area is predominantly residential. Grandview is signed as bike route at this location, but not using standard MUTCD signing, and sidewalks are located on both sides of the road. There are no marked crossings across Grandview or any of the approaches at this location.

Three minor injury crashes occurred at the ramp intersections – two west of the bridge and one east of the bridge – from 2022 to 2023. Two of these crashes involved bicyclists struck by right turning vehicles (northbound and eastbound). The bicyclists were in the travel lane or shoulder and were reported as having no improper actions. A 13-year-old pedestrian was struck at the west ramp intersection by a westbound vehicle. They were crossing the road and reported as having no improper action. In 2014, a crash occurred at the east ramp intersection involving a bicyclist. They were struck by a northbound vehicle turning right that did not yield.

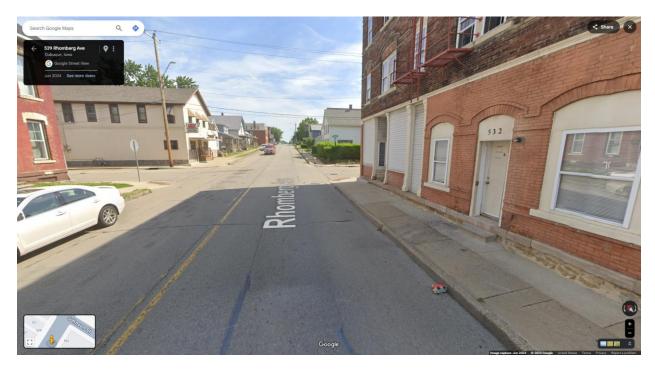
Figure 215. Intersection of Rhomberg Avenue and Johnson Street (Image Source: Google)

This location is a low speed, predominantly residential neighborhood. A bar/restaurant is also located at this intersection. The traffic volume along Rhomberg is approximately 4,700. The intersection is partial stop control from the Johnson Street approaches, which has an AADT of 200 vpd. No crosswalks are marked at the intersection, either by pavement markings or signage. Audubon Elementary School is located approximately 500 feet from this intersection. Sidewalks are immediately adjacent to the roadway along the east side of Rhomberg Avenue, and have a small offset on the west side. Parking is only allowed on the west side of Rhomberg Avenue. Because of the proximity of the buildings to the roadways, sight lines from the uncontrolled approaches of Rhomberg to Johnson Street are limited, particularly for vehicles traveling northbound on Rhomberg.

Most recent crash experience (from 2019-2023) included two pedestrians and bicyclist. One of the pedestrian crashes was reported at the intersection, while the other occurred midblock along Rhomberg south of the intersection. Both of these crashes involved southbound vehicles, and the pedestrians were reported as having no improper actions. The bicyclist crash involved a 10-year-old at approximately 4:00 p.m., who failed to obey the traffic sign and was struck by a westbound vehicle. Another mid-block crash occurred in the same vicinity in 2018, involving an eight-year old crossing improperly at 3:15 p.m. Both of the youth crashes occurred during the month of May. Injury severities included incapacitating, minor (2) and none.

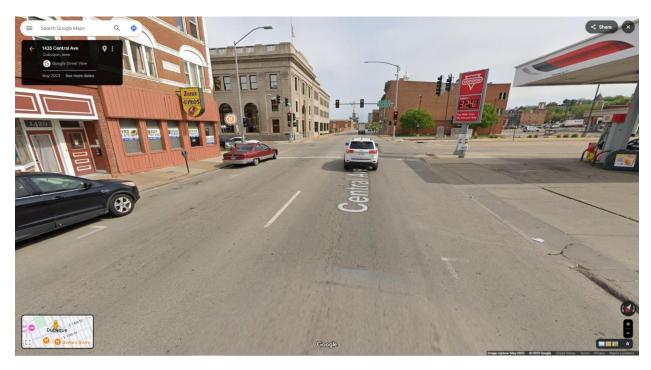
Figure 216. Intersection of Central Avenue and 14th Street/Loras Boulevard (Image Source: Google)

The location was initially identified due to its grouping with eight crashes along Central Avenue between approximately 14th Street and 16th Street. Six of these crashes occurred between 2014 and 2016. However, two crashes occurred in 2019 and 2021 and satisfied all but the private school proximity screening criteria. These crashes involved a ten-year-old (accompanying by 48-year-old), and seven-year-old. Both happened during the school year, January and October at 8:54 a.m. and 4:01 p.m., respectively. The pair were struck by a westbound left turning vehicle that did not yield, while the seven-year-old was struck by a southbound vehicle traveling straight. The seven-year-old did not obey the traffic signal. Injury severities were minor.

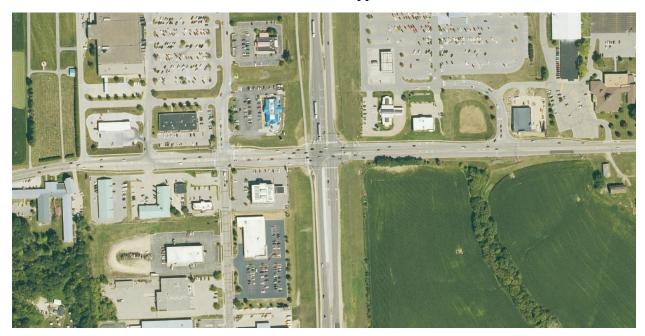
Figure 217. Intersection of Asbury Road and NW Arterial (Image Source: Iowa Geographic Map Server)

This site satisfied eight of the screening criteria, with the exception of school proximity. Two crashes, one involving a pedestrian and one a bicyclist, occurred at this intersection in 2020, resulting in incapacitating and possible injuries. Both non-motorists were struck by vehicles traveling east, one turning left and one turning right, while crossing the road. Improper crossing was reported for both non-motorists (ages 61 and 81). It should be noted that no marked crossing is present. The left turning driver was reported as failing to yield to the non-motorist. Improvements have recently been made to the NW Arterial, and it is unclear whether this may impact crash experience.

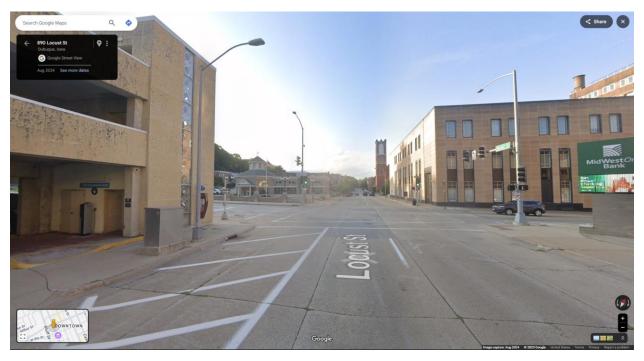
Figure 218. Intersection of Locust Street and 9th Street, Northbound (Image Source: Google)

This site is located in a low speed commercial area. The intersection is signalized and has pedestrian signals present. Activation buttons are located on the southwest and northeast corners. Locust Street is one way from south to north and consists of two lanes. Crosshatch pavement markings are present from the curb to the left lane on the westside of the south Locust Street approach.

This site satisfied eight screening criteria and experienced three crashes since 2017, specifically in 2017, 2020 and 2023. The most recent crash involved a 13-year-old skater who improperly crossed and was struck by a northbound vehicle. The other two crashes involved left turning vehicles that failed to yield to pedestrians crossing the road in the crossing. One vehicle was traveling east while the other was traveling north prior to making the left turn. All crashes occurred during daylight hours. Sight distance does not appear to be an issue at this intersection, including left turning movements from any approach.

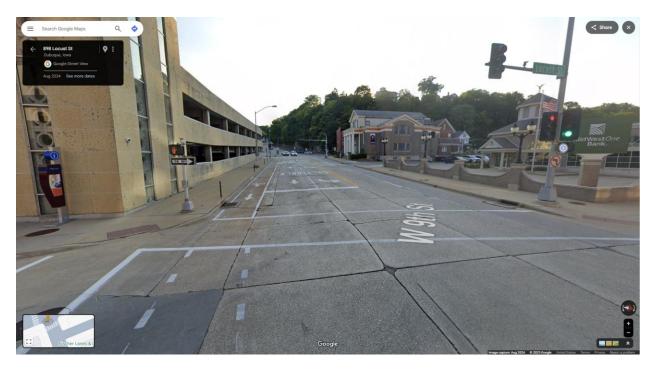
Figure 219. Intersection of Locust Street and 9th Street, West Approach (Image Source: Google)

The west approach of 9th Street has four lanes, with parking allowed on the south side. A marked bike lane is located adjacent to the south curb and shares an edge line with the through lane. The stop bars are offset from the crosswalk. The east approach of 9th Street has two legs, with parking allowed on the north side and a bike lane adjacent to the south curb. The bike lane is separated from the eastbound through lane by solid lines and crosshatch markings. The bike lanes were recent additions (summer 2024), converted from parking.

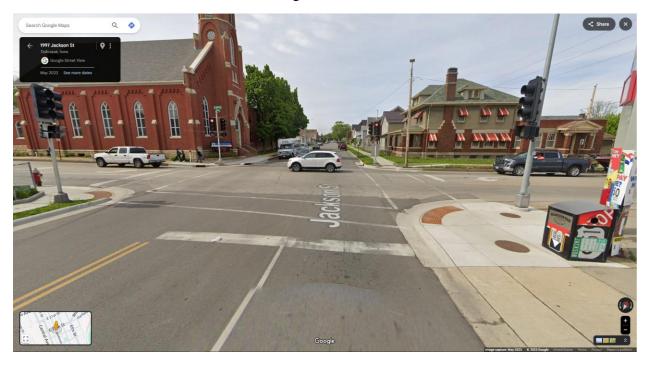
Figure 220. Intersection of Jackson Street and 20th Street (Image Source: Google)

This site is located in a low speed, residential/commercial area. Approach AADTs ranged from approximately 3,600 to 7,300 vpd. All approaches have dedicated left turn lanes. The 20th Street approaches are approximately 30 feet wide, while the Jackson Street width is approximately 40 feet. A convenience/liquor store is located on the southeast corner of the intersection, with wide driveways extending south and east. The intersection has pedestal mounted signalizes with pedestrian signals. The pedestal signals at this location can be somewhat difficult to see. No

pedestrian activation buttons appear present. Pavement markings indicate crosswalk locations. This location satisfied seven of the screening criteria.

Four crashes occurred at the intersection between 2021 and 2023 (one in 2021, two in 2022 and one in 2023). If the crash experience reflects traffic behavior, there appears to be a high level of bicyclist activity. Three of these crashes involved bicyclists.

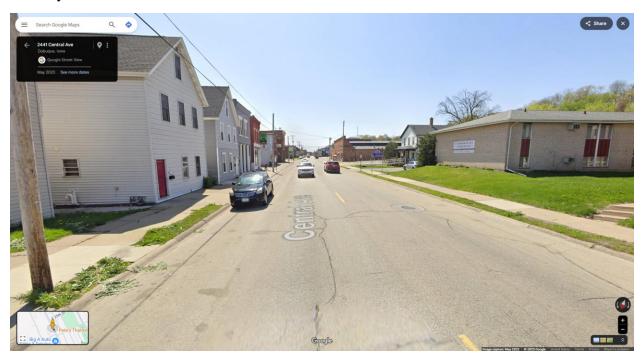
Figure 221. Central Avenue (Image Source: Google)

Central Avenue is a low speed, two-way, two lane road located in a mixed commercial and residential area. Traffic volumes are approximately 10,600 vpd. On street parking is allowed in the northbound direction. Sidewalks are located on both sides of the roadway, either immediately adjacent or with a narrow section of grass between the curb and sidewalk. In some locations, specifically the intersection(s) with 24th St, no curb is present to separate the sidewalk from the roadway.

The intersection(s) of 24th Street with Central Avenue are offset. There are no marked crosswalks at the offset intersections and no signing is present. The approaches from 24th Street are stop controlled, carrying 400 (west approach) and 3,000 vpd (east approach). There is no traffic control along Central Avenue. A bus stop is also located at the intersection. A gas station/convenience store is located at the southeast corner of the intersection. The convenience store certainly generates a large number of both vehicle and non-motorist trips. It also has wide driveways on three sides, increasing conflict points between vehicles and non-motorists.

A midblock crash occurred in between 24th Street and 25th Street during April, 2019. The pedestrian crossed improperly and was seriously injured. Three crashes (two in 2019, one in 2022) occurred at the offset intersections at 24th Street. Two involved bicyclists and one involved a pedestrian. All three were crossing are waiting to cross the road. All three crashes

involved turning vehicles – two southbound left turning vehicles and one westbound right turning vehicle. In one instance, a bicyclist improper crossed the road. Severities ranges from possible to minor injury.

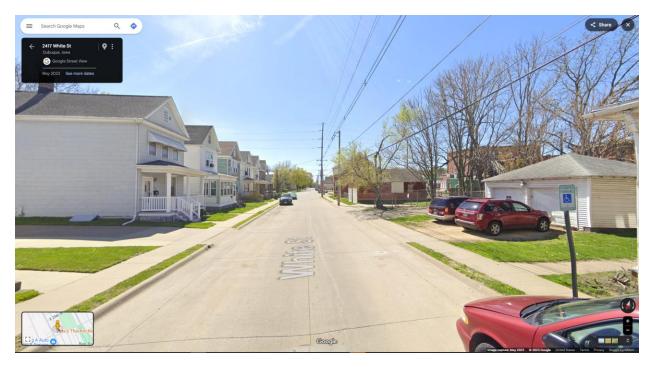
Figure 222: White Street (Image Source: Google)

White Street north of the E 24th Street intersection, is a low speed, two-way, two lane road located in a residential area. On street parking appears to be allowed along both sides of the road. Sidewalks are also located on both sides of the roadway, with a narrow section of grass between the curb and sidewalk.

The intersection of 24th Street with White Street is stop controlled along White Street. Pedestrian crossings are not marked on the pavement or with signage. Traffic volumes along White Street are 300 to 1,000, while traffic along 24th Street is approximately 3,000. Parking is allowed along the north side of 24th Street. A gas station/convenience store is located on the southwest corner of

the intersection. As noted in the previous section, the convenience store certainly generates a large number of both vehicle and non-motorist trips. It also has wide driveways on three sides, increasing conflict points between vehicles and non-motorists.

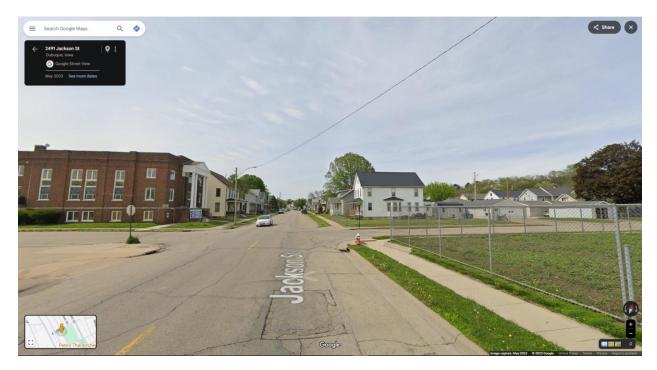
Figure 223: Jackson Road Near Comiskey Park (Image Source: Google)

Two non-motorist crashes occurred at this intersection in 2022 and 2019. One pedestrian was seriously injured, and a bicyclist suffered minor injuries. Both crashes occurred in dark conditions. The pedestrian crash involved a southbound vehicle moving straight. The pedestrian was "darting/dashing" and was intoxicated. The bicyclist failed to obey traffic control and was struck by a westbound, left turning vehicle.

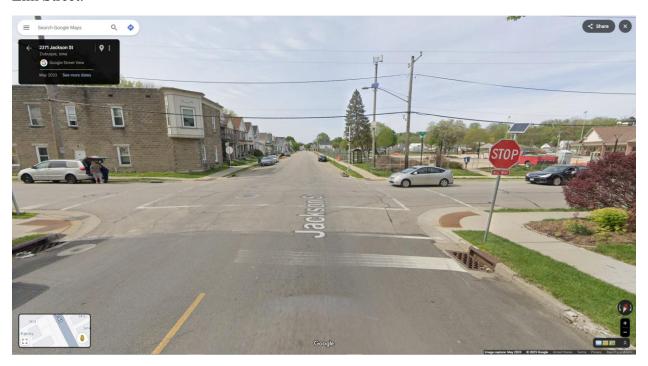
Figure 224: Intersection of Jackson Street and 24th Street (Image Source: Google)

Three non-motorist crashes occurred in this general vicinity between 2019 and 2023. A total of six non-motorist crashes have occurred since 2017. During the morning of August 11, 2023, a bicycle crash occurred along 24th Street, approximately 130 feet east of the intersection with Jackson Street. The bicyclist was nine-years-old and was struck by an eastbound vehicle. The bicyclist improperly exited/entered the road. Another nine-year-old bicyclist was struck in the area, at the intersection of Jackson Street and 24th Street, on September 2, 2019 at approximately 7:00 p.m. The bicyclist failed to obey the traffic sign and was struck by a northbound vehicle. During an afternoon in June 2019, a pedestrian was struck at the intersection as well. Two vehicles were involved, with one running the stop sign. Injuries in these crashes ranged from possible to minor.

Three of the six crashes at/near the intersection occurred in 2017 (two) and 2018. A three-year-old pedestrian was struck by an eastbound vehicle near the intersection during the morning of April 29, 2018. The pedestrian was darting/dashing in the roadway. In January 2017, a 14-year-old bicyclist was struck by a westbound, left turning vehicle. The bicyclist was reported as having no improper action. The crash happed at 5:17 p.m. The final 2017 crash involved a pedestrian who failed to yield right of way to a northbound vehicle. These three crashes all involved minor injuries.
