Appendix A: Dubuque MPO Sites

Intersections

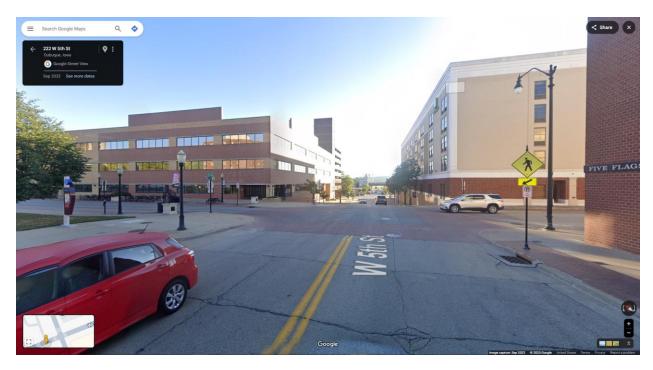
Figure 225: Intersection of Main Street and W 5th Street, Eastbound (Image Source: Google)

The proximity of buildings along the south approach along Main Street can the limit the sight lines of northbound vehicles to the W 5th Street approaches. More open sight lines are present along the other approaches with the exception of west approach of W 5th Street to the south approach of Main Street. Traffic volumes along W 5th Street are approximately 1,500 vpd, compared to approximately 3,500 along Main Street. However, traffic volumes may be impacted by events in the area.

This location satisfied seven of the screening criteria. Two pedestrian crashes occurred at this intersection during the five-year analysis period (in 2019, 2023). Both involved southbound vehicles (turning left and turning right), failing to yield to the pedestrians in the crosswalk. A third crash occurred along Main Street, approximately 160 feet north of the intersection. A vehicle lost control and struck pedestrians on the sidewalk. Crash severities for all three crashes ranged from minor injuries to possible injuries. All crashes occurred during daylight hours.

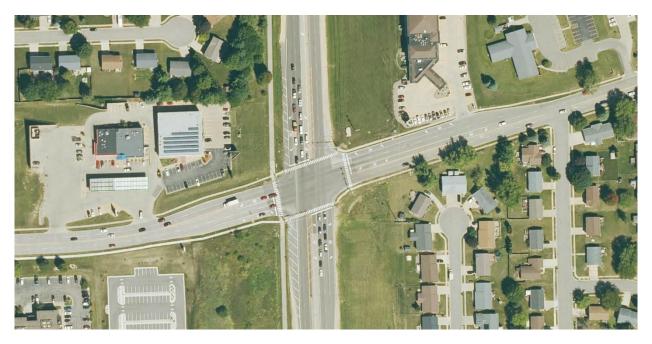
Figure 226: Intersection of NW Arterial and Pennsylvania Avenue (Image Source: Iowa Geographic Map Server)

There are six lanes across the Pennsylvania Avenue approaches. Both of the NW Arterial approaches have similar cross-sections with six lanes, median and cross-hatched shoulder. The southbound and northbound NW Arterial approaches and eastbound Pennsylvania approach are positive grades, which could impact site distance. Pedestrians may also become impatient at the crossings due to longer cycle lengths.

Two crashes, involving pedestrians, occurred at the intersection on March 18, 2021 (at 1:15 p.m.) and October 14 (at 9:12 p.m.). Both crashes involved southbound vehicles moving straight. One pedestrian failed to obey the traffic signal, while the other (an 18-year-old) was wearing dark clothing. A third crash occurred on January 23, 2018 at 9:09 p.m. involving a 14-year-old who crossed improperly.

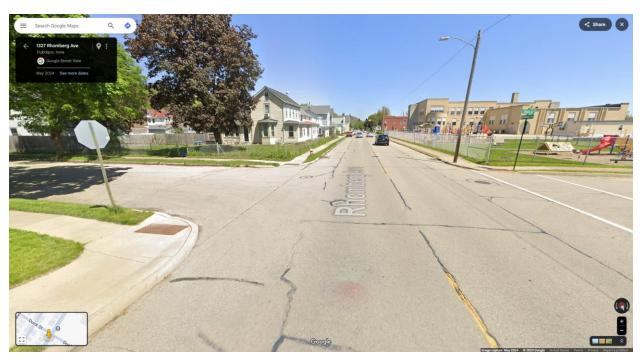
Figure 227: Intersection of Rhomberg Avenue and Dock Street (Image Source: Google)

This intersection is located in a predominantly residential area. Marshall Elementary School is located on the northeast corner of this intersection. The intersection is stop controlled along the Dock Street approaches. There are two through lanes in each direction of travel along each approach. On street parking is allowed the west side of Rhomberg Avenue (with a short no parking zone on the south leg) and on both sides of Dock Street. Sidewalks are present on both sides of all approaches. A pedestrian crossing ahead sign is located along the southwest approach, presumably for the midblock signalized intersection immediately adjacent to the school. Pavement markings indicate a crossing of the east Dock Street approach. Otherwise, there are no other crosswalks marked at the intersection. The school playground is located parallel to Rhomberg Avenue. Primary entrances to the playground are located near the signalized intersection on Rhomberg Avenue and on Dock Street near the Garfield Avenue intersection.

On July 3, 2021 at 10:48 p.m., a 12-year-old pedestrian was struck at this intersection by a northbound vehicle. The pedestrian was darting/dashing. In June 2014, a nine-year-old pedestrian was also struck at this intersection by a southbound vehicle.

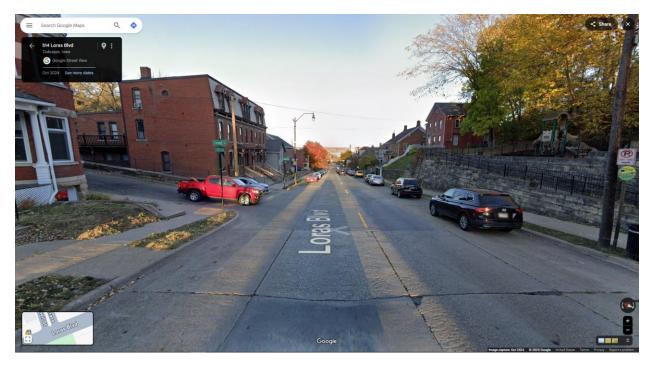
Figure 228: Loras Boulevard Near Cornell Street and Montrose Terrace (Image Source: Google)

Loras Boulevard is a two-way, two-lane road located on a notable grade. On-street parking is allowed, intermittently, on both sides. The general location of primary interest is the intersection of Loras Boulevard with Cornell Street and Montrose Terrace, which are parallel roads separated by a block wall. Both Cornell Street and Montrose are stop controlled. There is no traffic control along Loras Boulevard at this location. The major approach traffic volume at this intersection is approximately 9,500 AADT along Loras Boulevard. Bus stops are located on both sides of the street. Sidewalks are also present along each side of the road. The area is predominantly residential with some commercial. The Loras College campus begins approximately one block west of this intersection.

Two minor injury crashes occurred at/near the intersection of Loras Boulevard and Cornell Street in 2019 and 2020. A third possible injury crash occurred in 2018. All crashes involved pedestrians. Limited details were reported about the pedestrian action in the 2020 crash, which occurred at 7:35 a.m. The pedestrian was struck by an eastbound vehicle traveling straight. The other two crashes involved young non-motorists, a 17-year-old and a seven-year-old, who were improperly crossing or darting/dashing at midblock. Both crashes occurred at approximately 6:30 p.m. One involved a westbound vehicle moving straight, while the other involved an eastbound vehicle turning left.

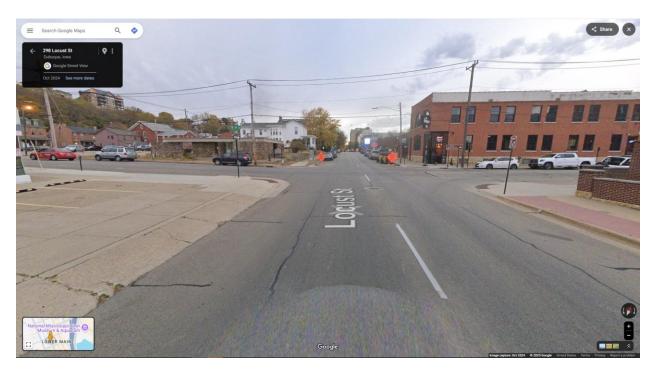
Figure 229. Locust Street and W 3rd Street (Image Source: Google)

The area is primarily commercial with some apartments in the general vicinity. A restaurant/bar is located at the northeast corner of the intersection. Sidewalks are located along both directions of travel. All crossings are unmarked.

Two possible injury, non-motorist crashes occurred at this intersection between 2019 and 2023 (2021 and 2023). The 2023 crash involved a bicyclist at 14:00. They were struck by an eastbound vehicle that failed to yield to the bicyclist in the crosswalk. The 2021 crash involved an impaired pedestrian at approximately 2:00, who was struck by a westbound vehicle.

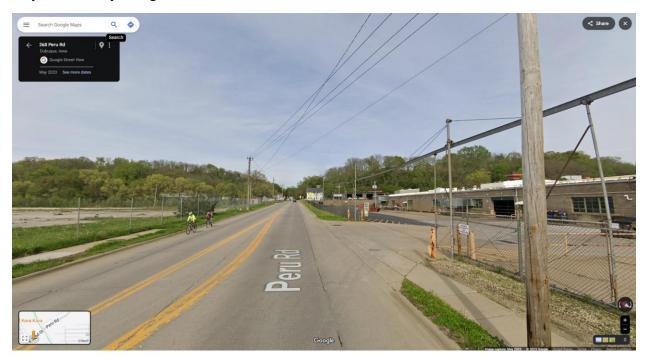
Figure 230: Bicyclist Activity Near Peru Road and Near Heritage Trail Crossing (Image Source: Google)

Near the Heritage Trail crossing, Peru Road carries approximately 5,400 vpd and has a speed limit of 30 mph. The following images, from different years, provide evidence of pedestrian and bicyclist activity along the road at this location.

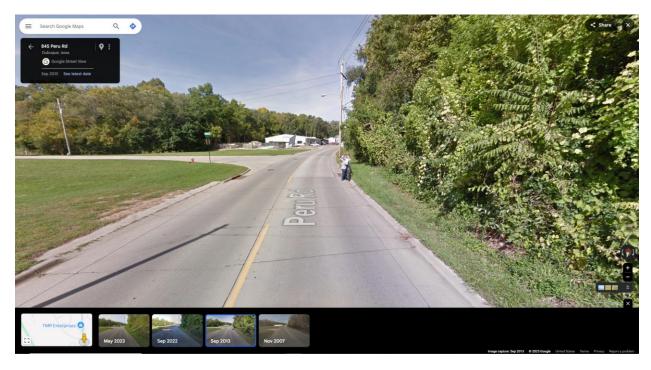
Figure 231: Pedestrian Activity Near Peru Road and Aerostar Drive Intersection (Image Source: <u>Google</u>)

W-beam guardrail is located along the west side of Peru Road from approximately Louella Lane to Sheridan Road. The traffic volume is approximately 8,200 at the intersection with Sheridan, which is stop controlled from Sheridan Road. Sheridan Road has an AADT of approximately 3,500. The speed limit along Peru Road increases to 35 mph after the intersection. There is also evidence of pedestrian activity on the road near the Aerostar Drive intersection. There are also curb cuts on both sides of Aerostar Drive.
