# Appendix B: RPA Region Sites

This section provides a review of sites identified as candidates for safety improvements in the overall RPA region. These sites were identified as having High ( $\geq 0.25$ ) KAB or KABCO ( $\geq 1.0$ ) PCR values. [Note: KABCO is defined as K = fatal, A = Incapacitating injury, B = minor injury, C = possible injury, O = property damage only.] Based on the crash trends and existing features of these sites, potential safety countermeasures have been identified that can serve as a starting point for pursuing improvements.

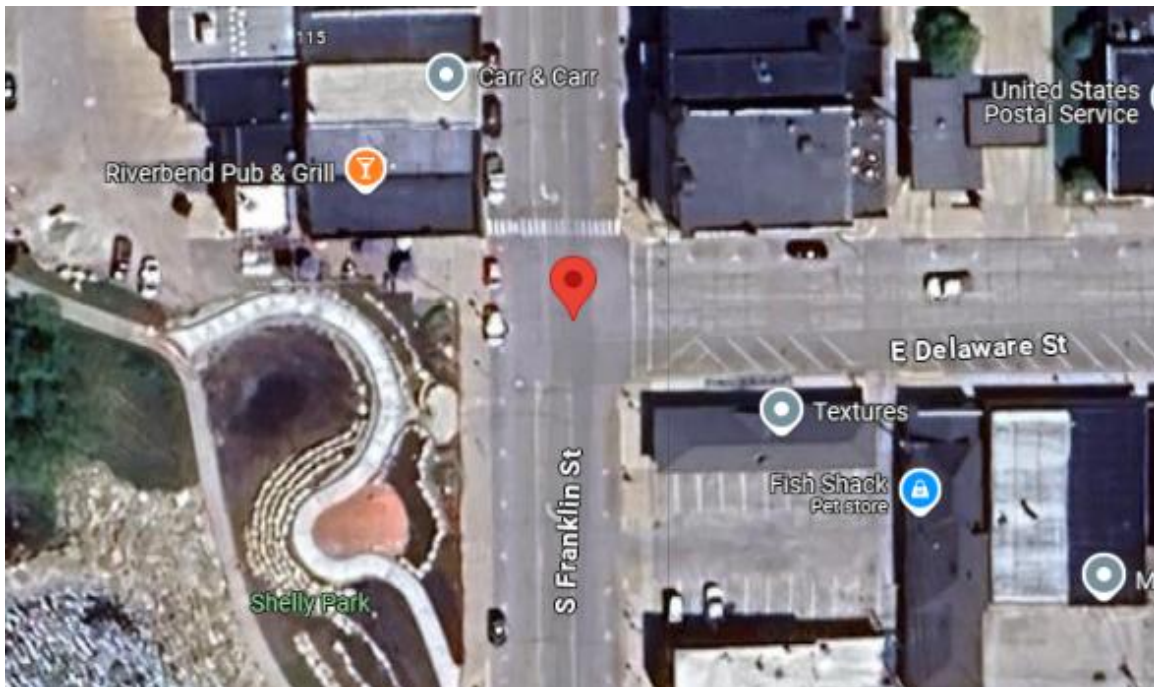
Figure 27: Intersection of East Delaware Street and South Franklin Street

This site is a Three-legged, Undivided, Low Speed, Partial Stop Controlled intersection ([Google Map Link](#)). It has a medium PCR level for KABCO crashes, indicating the need for potential countermeasures. The area surrounding the intersection is predominantly a commercial area. The intersection has well-defined curbs, curb ramps, and sidewalks. Overhead lighting is present at the intersection, improving nighttime visibility. The pavement appears to be in good condition, and marked crosswalks are available to enhance pedestrian safety.

Crash reports indicate that a total of eight crashes have occurred at this intersection over a five-year period (2018-2022), including one KAB crash related to pedestrian and seven CO crashes. The predominant manner of collision is sideswipe (same direction), accounting for 50% of crashes, followed by broadside (front-to-side), non-collision (single vehicle), and rear-end (front-to-rear) crashes. The primary contributing factors to KABCO crashes include failure to yield right-of-way (FTYROW) from parking, improper turns, and unknown causes. The KAB Annual PCR for the intersection is 0.007087, indicating a low severity level, while the KABCO Annual PCR is 0.64835, which is considered medium. Based on statewide rankings, this intersection is ranked 6,618th for KAB crashes and 1,855th for KABCO crashes out of 115,274 intersections.

Based on the crash history, contributing factors, and performance data, the following safety improvements are recommended along with their associated cost levels:

- Install pedestrian crossing signs (Low)
- Add missing crosswalk to south approach (Low)
- Convert all crosswalks to enhanced to increase visibility (Low)
- Restrict or eliminate parking on intersection approaches (Low)

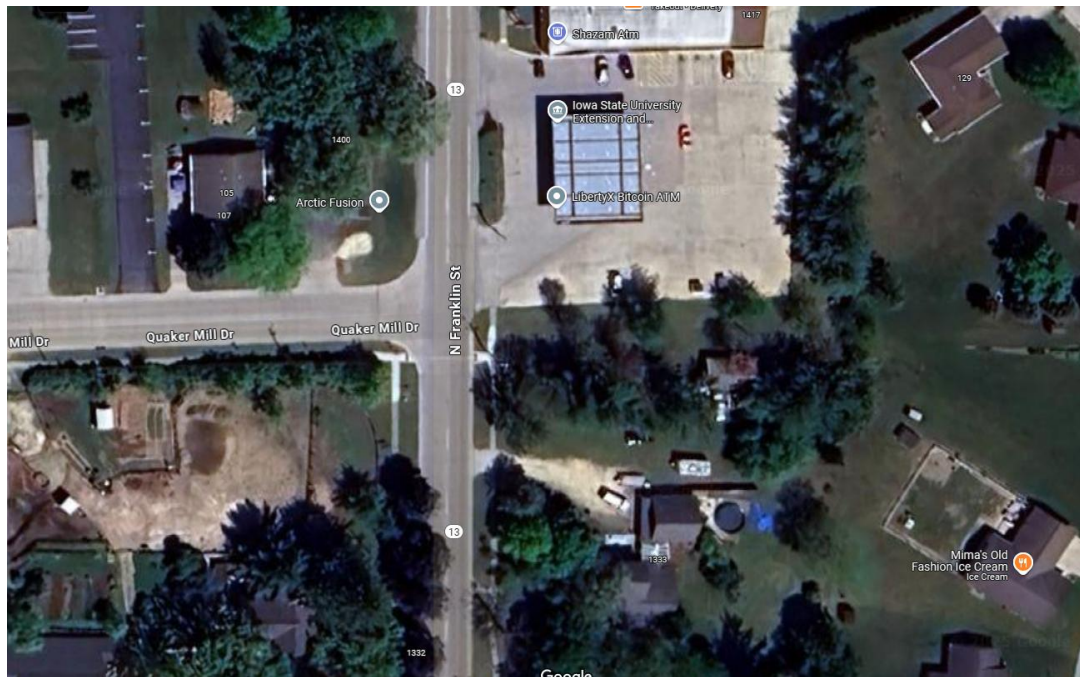
Figure 28: Intersection of Quaker Mill Drive and IA 13/North Franklin Street, Manchester, IA  
(Image: Google Maps)

This site is a three-leg, undivided, low-speed, partial stop intersection ([Google Map Link](#)). North Franklin Street serves as the primary roadway, while Quaker Mill Drive is a stop-controlled minor street. Curb and gutter are present, and some pedestrian infrastructure (sidewalks and curb ramps) is present, although it is incomplete. Quaker Mill Drive does not have a stop bar present, and overhead lighting is not provided.

This intersection has experienced multiple crashes, including two KAB crashes and four CO crashes in recent years. The primary manners of collision include rear-end, angle, and broadside crashes. Rear-end collisions were reported on the northbound (NB) and southbound (SB) approaches, primarily due to drivers following too closely, with one incident occurring under wet roadway conditions. Angle crashes occurred between northbound (NB) and southbound (SB) vehicles, attributed to failure to yield right-of-way (FTYROW) while making a left turn, with additional factors including driver distraction from exterior sources, occurring under wet and dark-lighted conditions. Additionally, a broadside crash involving westbound (WB) and southbound (SB) vehicles was recorded, also due to failure to yield while making a left turn. The KABCO PCR value for this intersection is 0.418088, indicating a moderate severity level. Speed data shows that 33.3% of vehicles on the northbound (NB) and southbound (SB) approaches exceed the speed limit by 5 mph+ while approaching the intersection. Similarly, 48.2% on the westbound (WB) approach exceed the speed limit by at least 5 mph+ when approaching the intersection to stop, suggesting a significant speeding issue.

Based on the crash history and existing roadway conditions, potential safety improvements that have been identified include:

- Install dynamic speed feedback signs on west approach (Low)
- Install pavement markings for left-turn paths (Low)
- Install stop bar pavement marking on west approach (Low)
- Install street lighting at the intersection (Medium)
- Complete missing pedestrian infrastructure, mainly additional sidewalks and crosswalk markings (Medium)
- Check pavement surface friction and use friction enhancing treatments if needed (Medium)

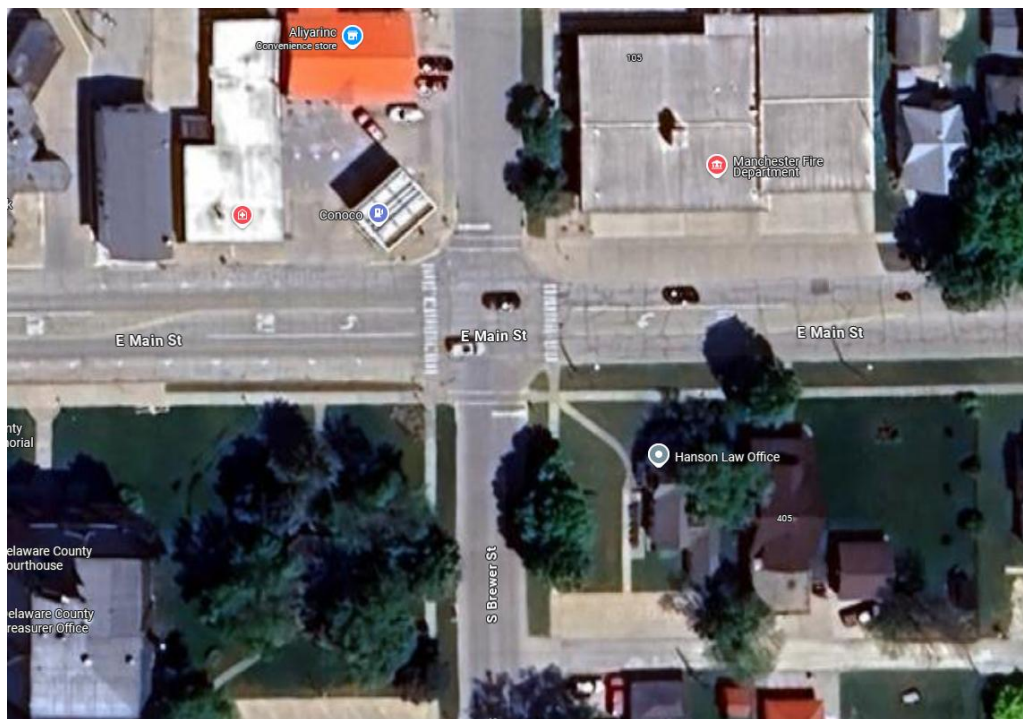
Figure 29: Intersection of East Main Street and North/South Brewer Street (Image: Google Maps)

This site is classified as a four-leg, undivided, low-speed, partial stop intersection ([Google Map Link](#)). East Main Street serves as the primary roadway, while North Brewer Street and South Brewer Street are stop-controlled minor streets. Extensive pedestrian infrastructure is present, including sidewalks, curb ramps, and marked crosswalks on all approaches. On-street lighting is also present.

This intersection has experienced six crashes, all classified as CO crashes in recent years. The primary manners of collision include broadside, rear-to-side, and sideswipe crashes. Broadside crashes occurred at three locations: between southbound (SB) and eastbound (EB) vehicles, eastbound (EB) and northbound (NB) vehicles, and westbound (WB) and northbound (NB) vehicles, primarily due to failure to yield right-of-way (FTYROW) from the stop sign, particularly from the southbound approach. One of these crashes occurred under wet roadway conditions. Rear-to-side crashes were reported on the eastbound (EB) and westbound (WB) approaches, with contributing factors including failure to keep in the proper lane and interior driver distraction. Additionally, a sideswipe crash occurred on the westbound (WB) approach, attributed to FTYROW from a parked position. The KABCO PCR value for this intersection is 0.352933, indicating a moderate severity level. Speed data shows that 10.2% of vehicles on the eastbound (EB) and westbound (WB) approaches, and 14.1% on the southbound (SB) approach, exceed the speed limit by at least 10 mph+, suggesting a moderate speeding concern, particularly for southbound traffic.

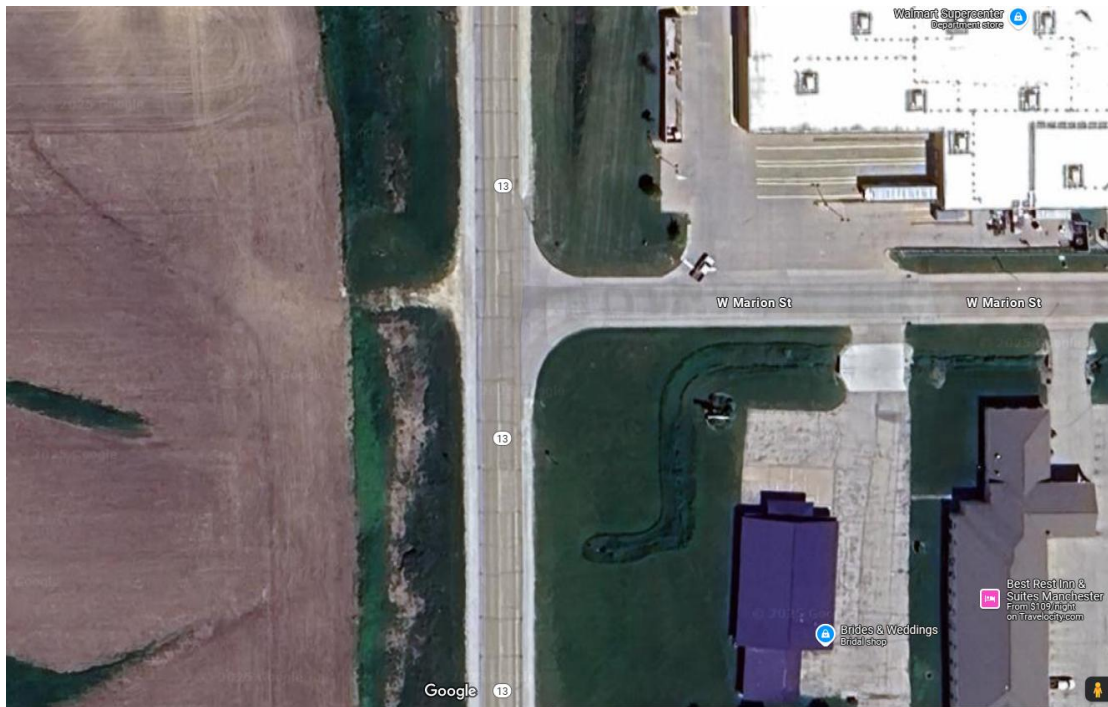
Figure 30: Intersection of West Marion Street and IA 13 (Image: Google Maps)

This site is classified as a three-leg, undivided, low-speed, partial stop intersection ([Google Map Link](#)). IA 13 serves as the primary roadway, while West Marion Street is a stop-controlled minor street. The intersection lacks dedicated turn lanes, and pavement markings and signage are in poor condition based on photographic data. Overhead lighting is not present. The placement of the stop sign on Marion Street appears to be set back a good deal from the curb, which may affect detection by approaching drivers.

This intersection has experienced multiple crashes, including two KAB crashes and three CO crashes in recent years. The primary manner of collision included rear-end, broadside, angle, and non-collision incidents. Rear-end crashes were reported on the southbound (SB) and northbound (NB) approaches, caused by drivers following too closely, with one occurring under dark-lighted conditions. A broadside crash between southbound (SB) and eastbound (EB) vehicles was due to failure to yield right-of-way (FTYROW). An angle crash was also reported on the southbound (SB) approach, attributed to following too closely. Additionally, a non-collision incident involving a northbound (NB) vehicle was caused by reckless or negligent driving behavior. The KABCO PCR value for this intersection is 0.352858, indicating a moderate severity level. Speed data shows that only 3.6% of eastbound (EB) vehicles exceed the speed limit by at least 10 mph+, suggesting that speeding is not a major issue at this location.

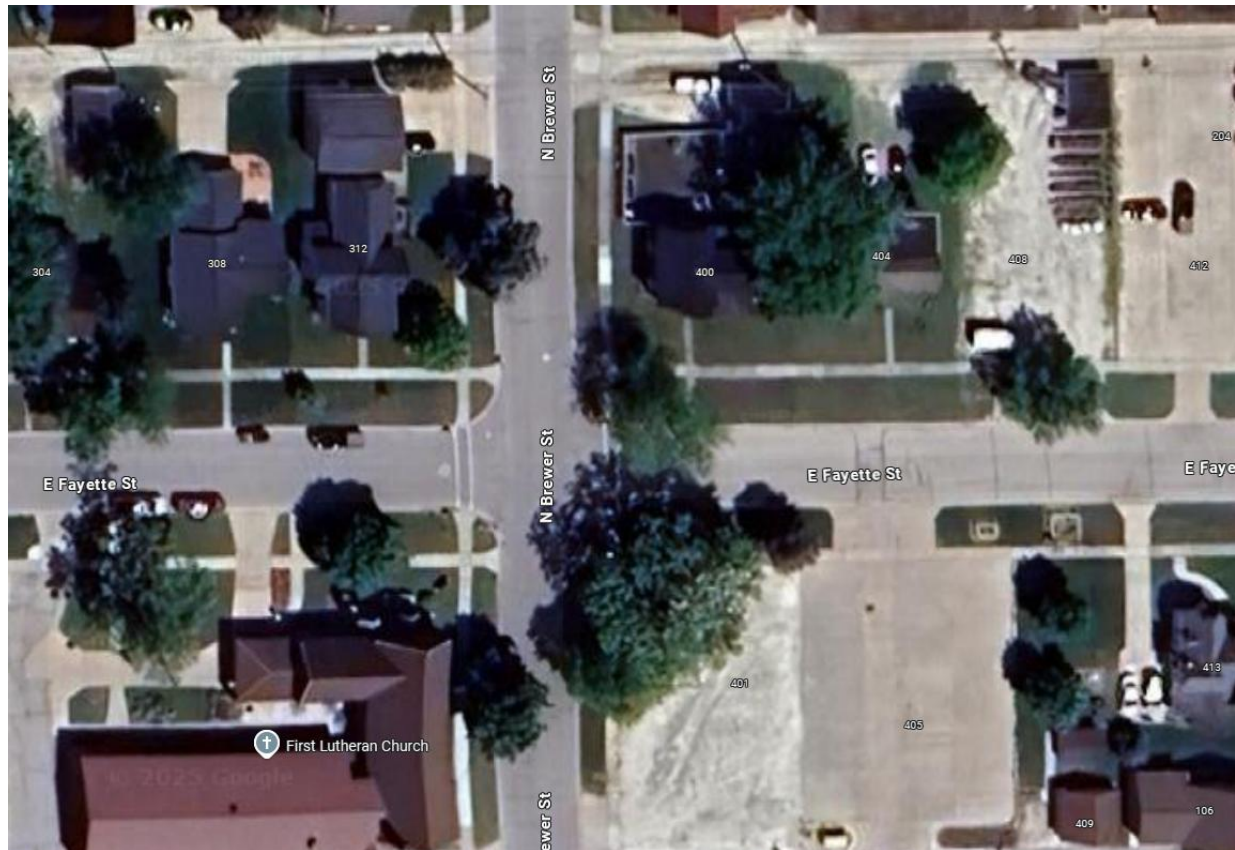
Figure 31: Intersection of East Fayette Street and North Brewer Street (Image: Google Maps)

This site is classified as a four-leg, undivided, low-speed, partial stop intersection ([Google Map Link](#)). North Brewer Street serves as the primary roadway, while East Fayette Street is stop-controlled on both approaches. Pedestrian infrastructure is present, specifically sidewalks, curb ramps, and marked crosswalks on the east and west approaches. The intersection is located in a residential area or the city.

This intersection has experienced multiple crashes, including one KAB crash and four CO crashes in recent years. The primary manners of collision include broadside and non-collision incidents. Broadside crashes were recorded in two directions: two between southbound (SB) and eastbound (EB) vehicles, and two between northbound (NB) and eastbound (EB) vehicles. Contributing factors included failure to yield right-of-way (FTYROW) from the eastbound approach and running a stop sign, with incidents occurring under wet and snowy conditions. Additionally, two non-collision incidents were recorded on the northbound (NB) and eastbound (EB) approaches, caused by driver distraction due to passengers. Sight distance limitations were noted on the eastbound (EB) approach, potentially contributing to some of the stop-sign

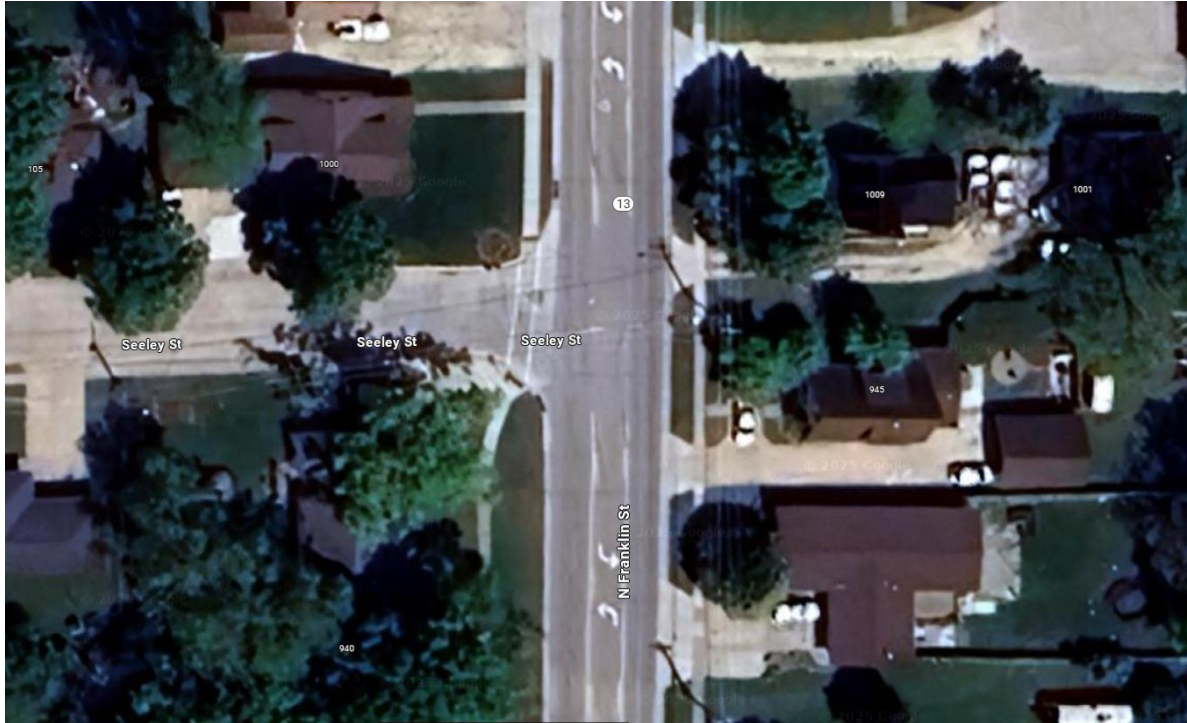
Figure 32: Intersection of Seely Street and IA 13/North Franklin Street (Image: Google Maps)

This site is classified as a three-leg, undivided, low-speed, partial stop intersection ([Google Map Link](#)). North Franklin Street serves as the primary roadway, while Seely Street is a stop-controlled minor street. Pedestrian infrastructure is present, specifically sidewalks, curb ramps, and crosswalks. The area is residential in nature. An overhead street light is present.

This intersection has experienced multiple crashes, including one KAB crash and three CO crashes in recent years. The primary manners of collision include sideswipe and rear-end crashes. Sideswipe crashes occurred between southbound (SB) and northbound (NB) vehicles, as well as between westbound (WB) vehicles and a parked vehicle. This crash was attributed to failure to yield right-of-way (FTYROW) while making a left turn, with one incident occurring under snowy conditions. Rear-end crashes were reported on the northbound (NB) approach, caused by drivers following too closely. The KABCO PCR value for this intersection is 0.223923, indicating a moderate severity level. Speed data shows that 7.9% of eastbound (EB) vehicles and 4.9% of northbound (NB) and southbound (SB) vehicles exceed the speed limit by at least 10 mph+, indicating that speeding is not a major concern at this location.

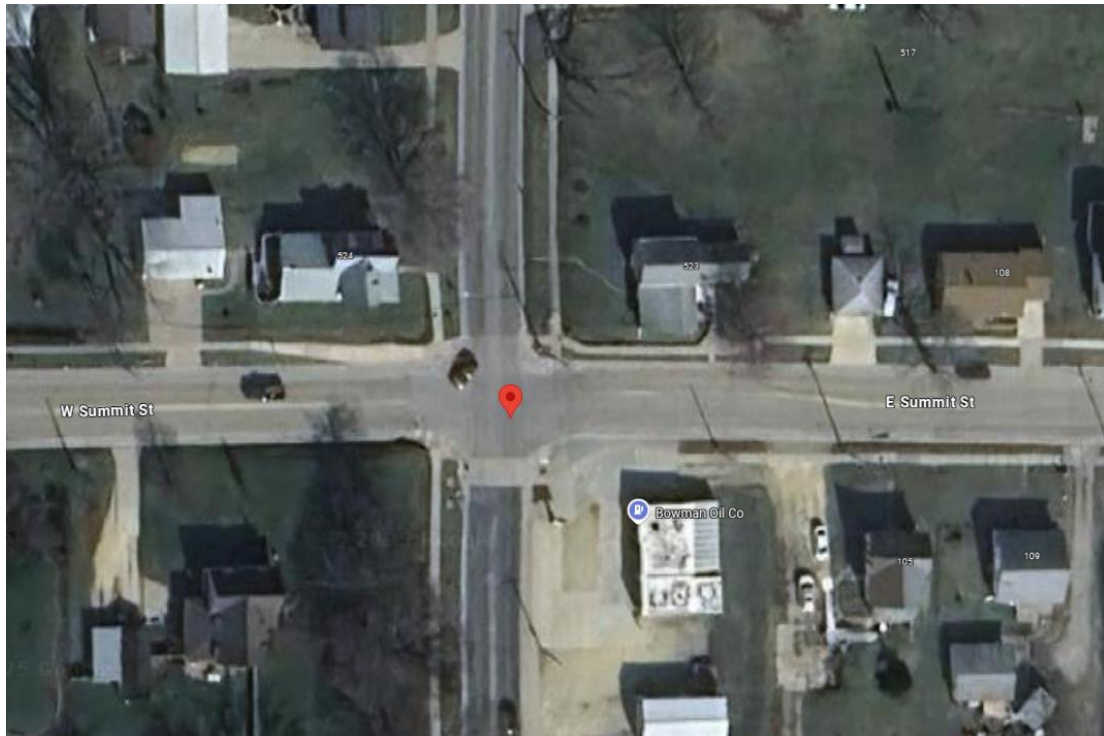
Figure 33: Intersection of Summit Street and South Main Street

This site is a Four-legged, Undivided, Low Speed, All-Way Stop Controlled intersection ([Google Map Link](#)). It has a high PCR level for KABCO crashes, indicating the need for immediate attention and potential countermeasures. The area surrounding the intersection is predominantly residential, with well-defined curbs, curb ramps, and sidewalks. There are some obstructions within the sight triangles around the intersection, creating visibility issues. Overhead lighting is present at the intersection, improving nighttime visibility. The road pavement appears to be in good condition based on photographic data, and there are marked crosswalks providing facilities for pedestrian safety.

The primary contributing factors to crashes at this intersection include running a stop sign, failure to yield right-of-way from a stop sign, following too closely and failure to yield right-of-way while making left turn. The KAB Annual PCR for the intersection is -0.057158, indicating no KAB severity level, while the KABCO Annual PCR is 1.084819, which is considered high. Based on statewide rankings, this intersection is ranked 113,549th for KAB crashes and 1,076th for KABCO crashes out of 115,274 intersections statewide. While no severe crashes have been recorded, the high frequency of CO crashes suggests a recurring traffic safety issue.

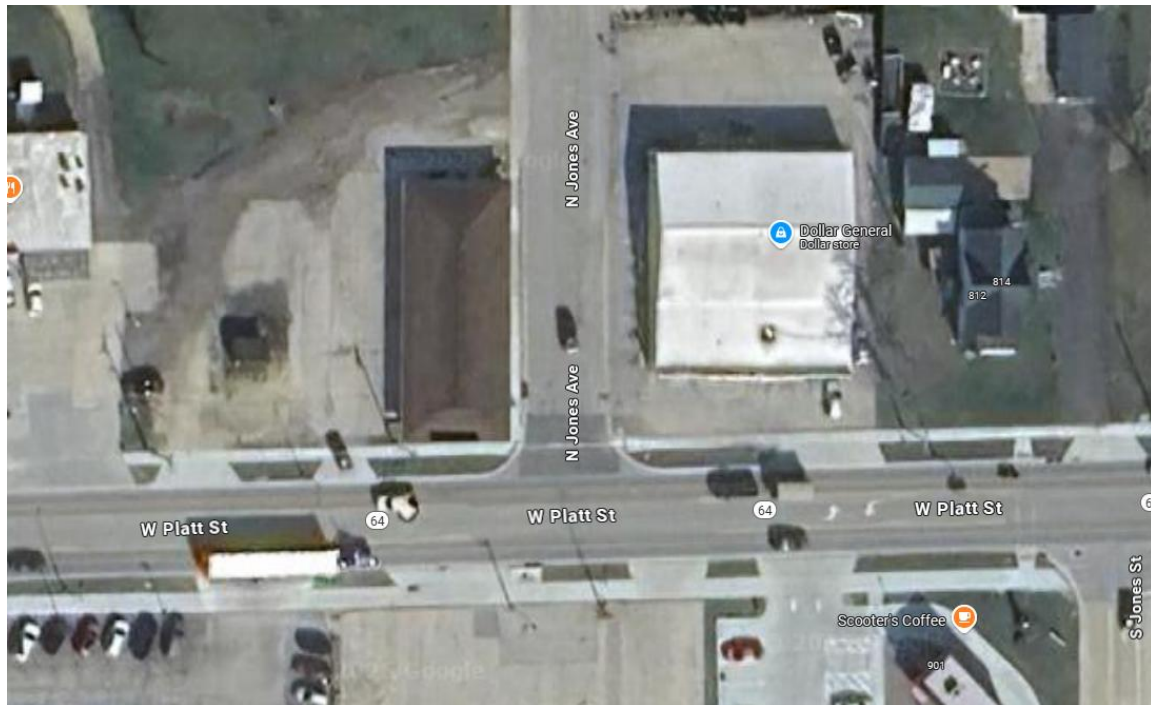
Figure 34: Intersection of North Jones Avenue and West Platt Street (Image: Google Maps)

This is a three-leg, undivided, low-speed, partial stop intersection ([Google Maps Link](#)). West Platt Street serves as the primary roadway, while North Jones Avenue is a stop-controlled minor street. The intersection features dedicated turning lanes on the eastbound (EB) and westbound (WB) approaches, but there are concerns regarding sight distance, espRPally on the southbound (SB) approach, where visibility appears to be insufficient.

This intersection has experienced two broadside collisions resulting in a non-injury crash (CO). The primary contributing factor in each was running the stop sign/failure to yield right-of-way (FTYROW) at the southbound (SB) approach, and wet roadway conditions may have played a role in at least one crash. The KABCO PCR value for this intersection is 0.460706, indicating a moderate severity level. Speed data shows that 19.6% of vehicles on the EB and WB approaches exceed the speed limit by at least 10 mph+, while only 0.8% of vehicles on the SB approach exceed the speed limit, highlighting speeding as a concern on the through roadway.

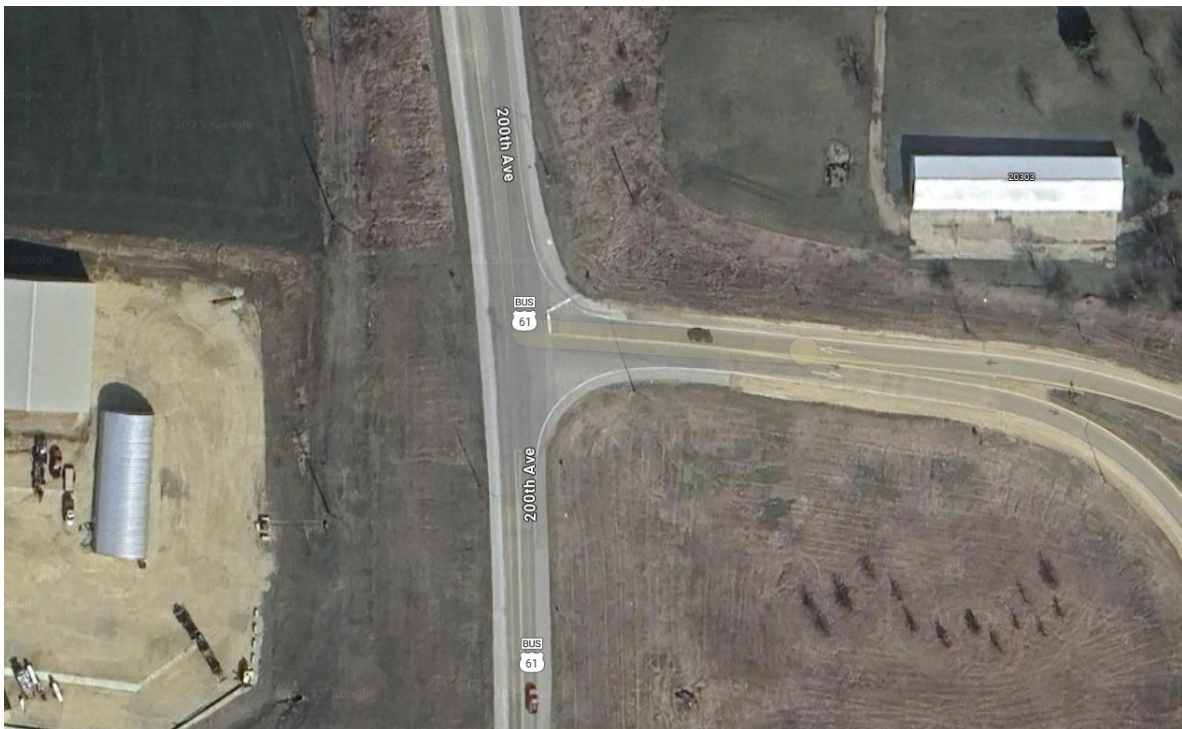
Figure 35: Intersection of US 61 Ramps and 200<sup>th</sup> Avenue (Google Maps Image)

This site is a three-leg, undivided, low-speed, partial stop intersection ([Google Map Link](#)). 200<sup>th</sup> Avenue is the through route, while the northbound exit ramp from US 61 is stop controlled. No pedestrian infrastructure is present at the intersection. Overhead lighting is present in the northeast, southeast and southwest quadrants of the intersection.

This intersection has experienced a series of crashes over time, including one KAB crash and five CO crashes. The primary manner of collision included rear-end, angle, and non-collision incidents. A rear-end crash occurred on the westbound (WB) and southbound (SB) approaches, caused by driving too fast for conditions and loss of control due to icy roads. An angle crash occurred between the southbound (SB) and northbound (NB) vehicles, attributed to failure to

yield right-of-way (FTYROW) when making a left turn from the SB approach. There was also a non-collision incident on the WB approach where the driver ran off the road and lost control, as well as an FTYROW-related incident between the WB and NB vehicles, stemming from the stop sign at the intersection. The crash history highlights issues with speed, road conditions, and compliance with stop sign rules, although the specific speed data for this site is not available. The KABCO PCR value for this intersection is 0.448894, indicating a moderate severity level.

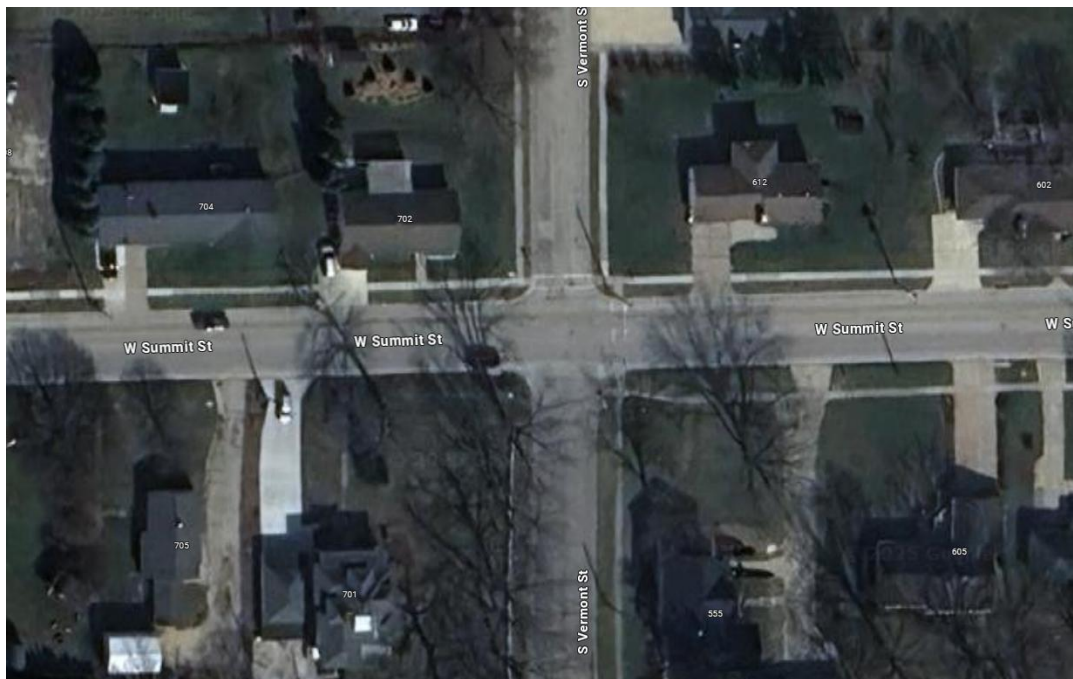
Figure 36: Intersection of South Vermont Street and West Summit Street (Image: Google Maps)

This site is a four-leg, undivided, low-speed, All-Way stop control intersection ([Google Maps Link](#)). The stop signs along Summit Street have flashing LED borders. Pedestrian crossing signage is also present at the intersection along Summit Street. There appear to be poor pavement markings based on photographic data and may be potentially limited sight distance on the south approach due to a house in the southeast quadrant. The site is located in a residential area, and both roadways are presumed to be low speed (i.e. 25 mph).

This intersection has experienced five crashes, all resulting in non-injury incidents (CO). The primary manner of collision includes broadside, head-on, and rear-end collisions. A broadside collision occurred between the northbound (NB) and eastbound (EB) vehicles, caused by failure to yield right-of-way (FTYROW) at the stop sign on the NB approach. A head-on collision was recorded between the eastbound (EB) and westbound (WB) vehicles, also due to FTYROW at the stop sign on the WB approach. Additionally, a rear-end crash occurred between the northbound (NB) and eastbound (EB) vehicles, stemming from failure to yield right-of-way (FTYROW) on the NB approach. The crash history suggests that visibility issues and failure to yield are significant factors contributing to the crashes. Speed data reveals that 2.8% of vehicles on the EB and WB approaches exceed the speed limit by at least 10 mph+, so speeding does not appear to be a concern at this location. The KABCO PCR value for this intersection is 0.390991, indicating a moderate severity level.

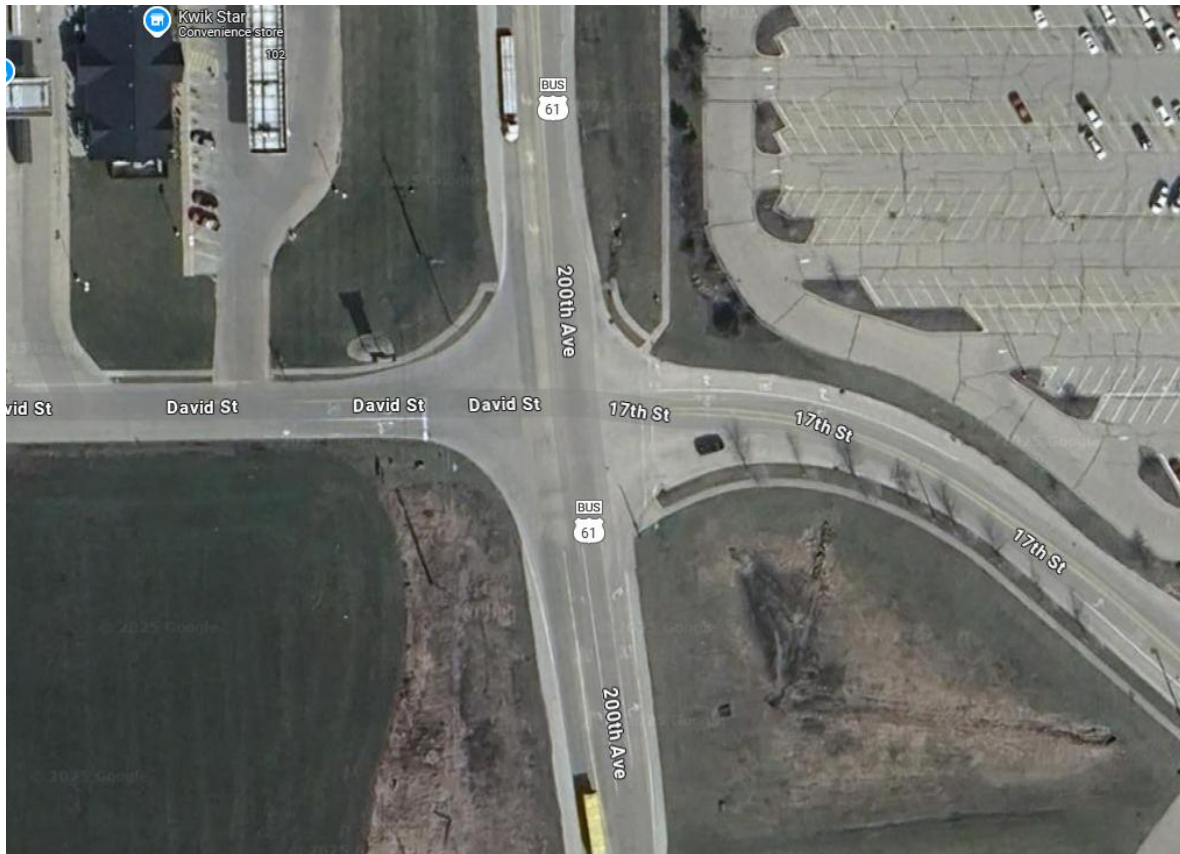
Figure 37: Intersection of 17th Street, David Street, and South Main Street (Image: Google Maps)

This site is a four-leg, undivided, low-speed, partial stop intersection ([Google Map Link](#)). South Main Street serves as the primary through roadway, while David Street and 17th Street are stop-controlled minor roadways. The intersection appears to have a stop compliance issue, as several collisions have been attributed to running stop signs and failure to yield right-of-way (FTYROW) at the stop-controlled approaches. Dedicated left turn lanes are provided on the west, north and south approaches, while the east and south approaches have dedicated right turn lanes. Pedestrian facilities are present on the east and north sides of the intersection, including sidewalks and crosswalks. Overhead lighting is present in the southeast and northwest quadrants.

This intersection has experienced a range of crashes, including one KAB crash and four CO crashes. The primary manner of collision includes broadside and angle crashes. Broadside crashes were recorded between the eastbound (EB) and westbound (WB) vehicles, as well as between the northbound (NB) and southbound (SB) vehicles, all due to failure to yield right-of-way (FTYROW) from the stop sign. Additionally, an angle crash occurred between the NB and SB vehicles, attributed to driver distraction. The KABCO PCR value for this intersection is 0.328009, indicating a moderate severity level. Speed data shows that 4.7% of vehicles on the NB and SB approaches, and 4.2% on the EB and WB approaches exceed the speed limit by at least 10 mph+. This suggests that speeding could also contribute to crash risk at this location.

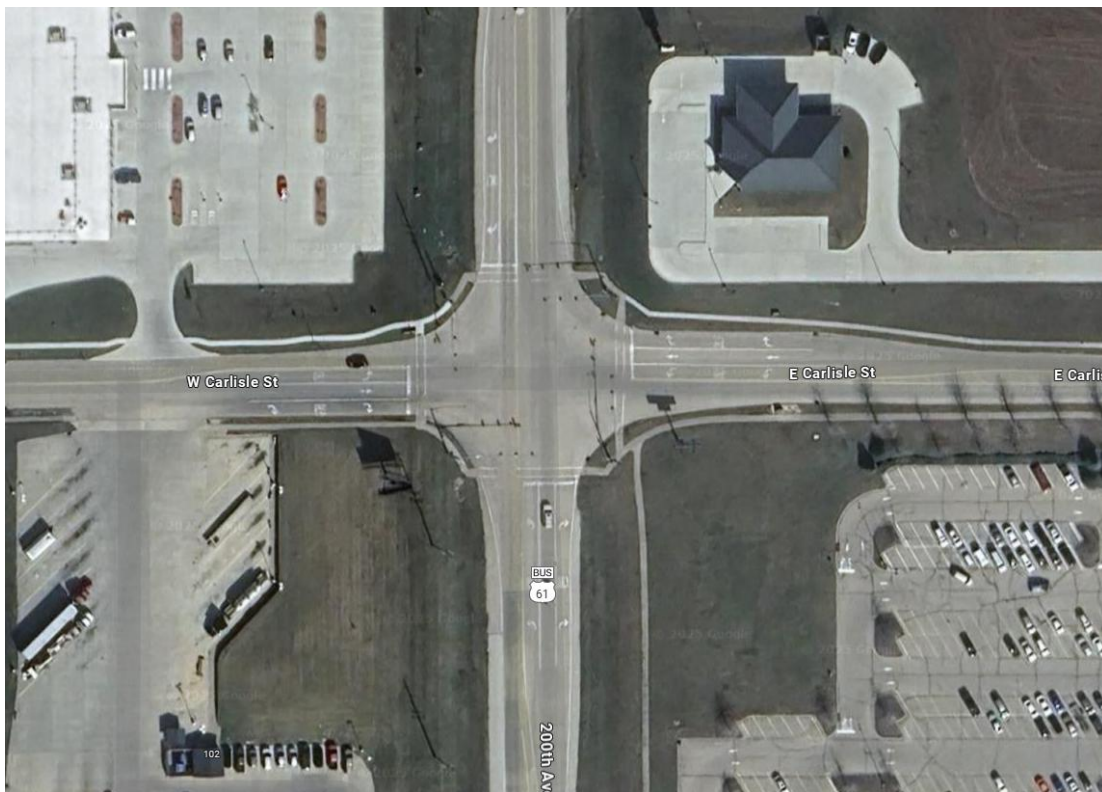
Figure 38: Intersection of Carlisle Street and South Main Street (Image: Google Maps)

This site is a four-leg, undivided, low-speed, signalized intersection ([Google Map Link](#)). The intersection is signal-controlled, and pedestrian facilities are located to an extent along all approaches. Notably, the westbound (WB) approach is adjacent to a Walmart parking lot, which could contribute to traffic conflicts and disruptions. Overhead lighting is present in all four quadrants.

This intersection has experienced several crashes, including one KAB crash and three CO crashes. The primary manner of collision includes rear-end and broadside crashes. A rear-end crash occurred on the westbound (WB) and southbound (SB) approaches, caused by driving too fast and following too closely. A broadside crash occurred between the northbound (NB) and eastbound (EB) vehicles, attributed to running a traffic signal. The KABCO PCR value for this intersection is 0.305375, indicating a moderate severity level. Speed data shows that 4.4% of vehicles on the NB and SB approaches exceed the speed limit by at least 5 mph+, though speeding does not appear to be a significant issue at this location.

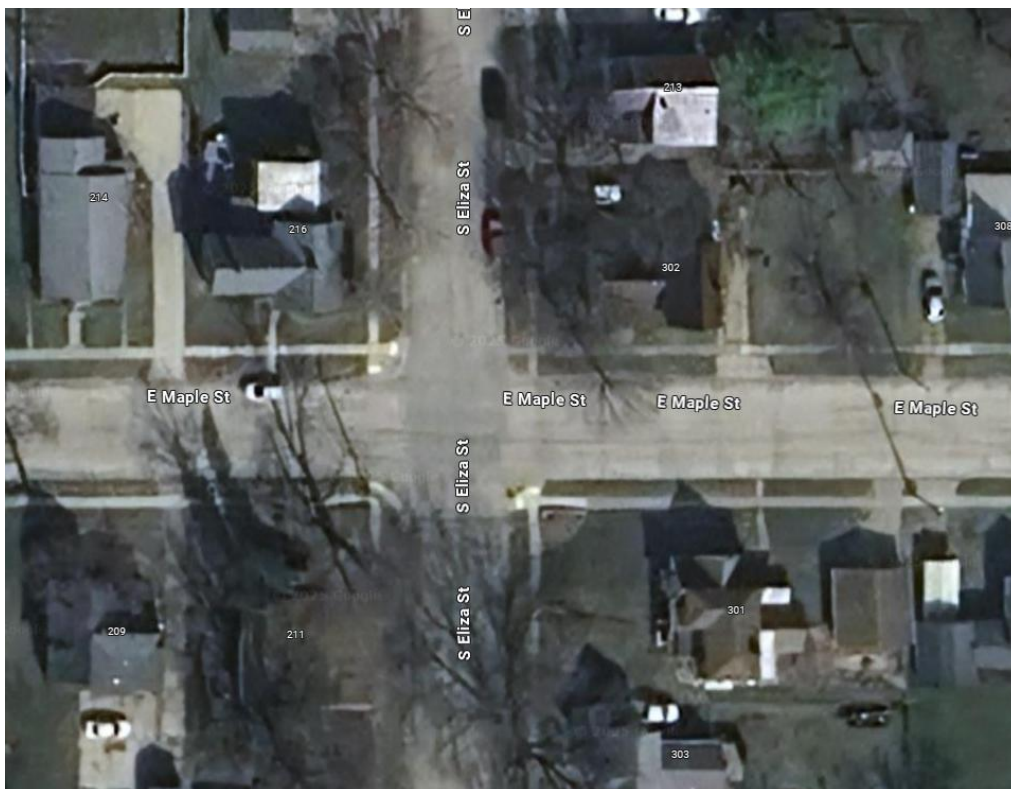
Figure 39: Intersection of East Maple Street and South Eliza Street (Image: Google Maps)

This site is a four-leg, undivided, low-speed, partial stop intersection ([Google Map Link](#)). East Maple Street serves as the primary roadway, while South Eliza Street is a stop-controlled minor roadway. There is on-street parking near the intersection, which could contribute sight distance impacts. There are also potentially poor markings based on photographic data. Pedestrian infrastructure at the site consists of sidewalks and curb ramps. Overhead lighting is present. The site is presumed to be low speed on all approaches given the residential character of the area.

This intersection has experienced one non-injury (CO) crash. The primary manner of collision was sideswipe. This crash was caused by failure to yield right-of-way (FTYROW) at the stop

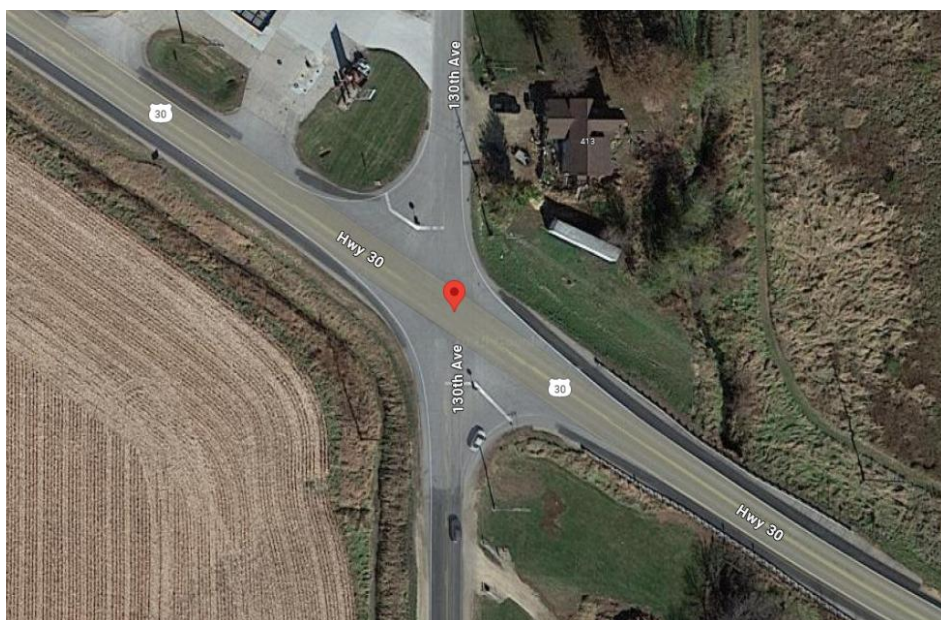
Figure 40: Intersection of 130th Avenue and US 30 (Google Maps)

This site is a Four-legged, Undivided, High Speed, Partial Stop Controlled intersection ([Google Map Link](#)). It has a medium PCR level for KAB crashes, indicating the need for immediate attention and potential countermeasures. There are no curbs or sidewalks in this intersection. The road delineation and pavement are in good condition based on photographic data. However, the lighting appears to be insufficient to adequately illuminate the entire intersection, which may contribute to visibility concerns during nighttime conditions.

The primary contributing factors to KAB crashes at this intersection include failing to yield the right-of-way at a stop sign, making improper turns, and running a stop sign. Other contributing factors including CO crashes are followed too close and operator inexperience.

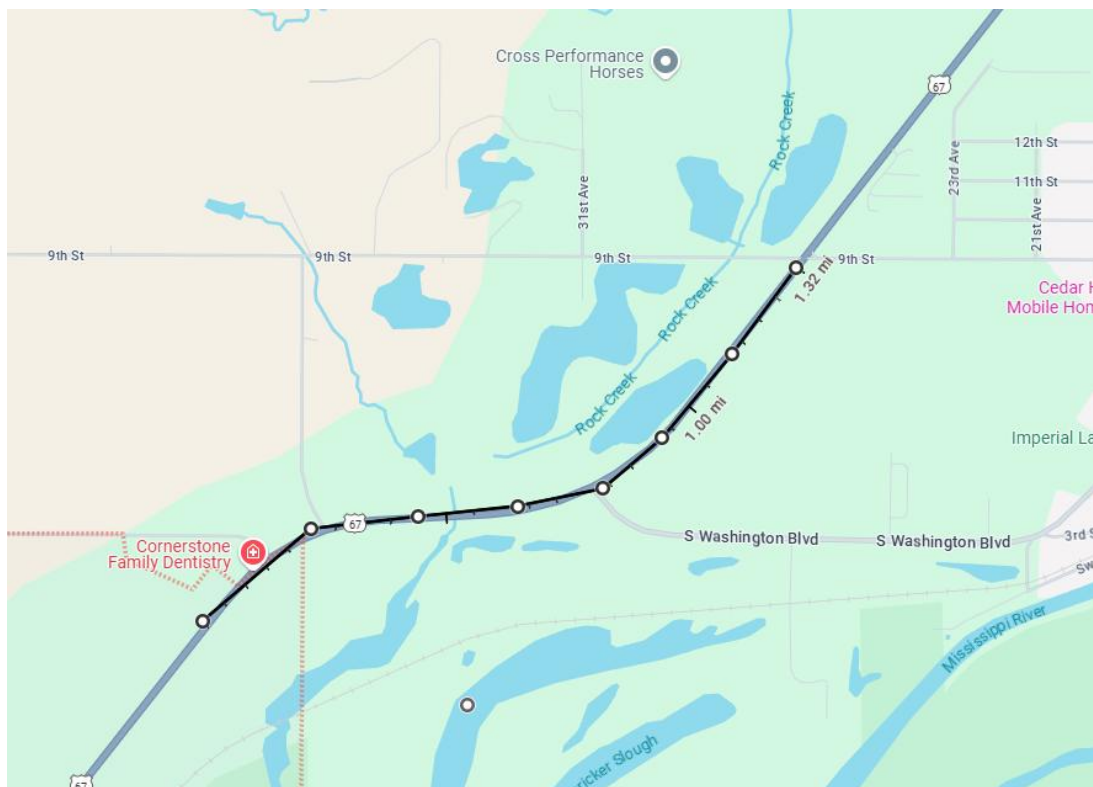
Figure 41: Highway 67 ([Google Map Link](#))

This segment of Highway 67 was identified as a safety candidate for review based on its segment-level PCR values. The roadway consists of 1.32 mile, two-lane rural highway with shoulders travelling north- south through the city. The speed limit along the segment is 55 mph, and the surrounding land use includes the area rural farmlands and open spaces. This segment includes occasional stop-controlled intersections and has a history of non-collision crashes.

A total of 27 crashes were recorded along the Highway 67 corridor in Camanche from 2018 to 2024. Crash severities included one suspected serious injury, 3 possible injuries, and 24 property damage only crashes. The corridor experiences a mix of crash types, with 14 non-collision (single-vehicle) incidents, 9 crashes where the manner of collision was not reported, and 4 broadside (front-to-side) collisions. The segment identified ranks 141 out of 5,032 similar segments based on the KABCO Annual PCR of 1.920685.

Key contributing factors to crashes along this segment include 19 animal-related incidents, highlighting the presence of wildlife given the close proximity to the Mississippi River. Additional contributing factors include 2 instances of failure to stop at stop-controlled intersections, 1 loss of control resulting in a single-vehicle crash, and 1 incident involving exceeding the authorized speed. A review of available speed data indicated that 9.3 percent of vehicles exceeded the speed limit by 10 mph+.

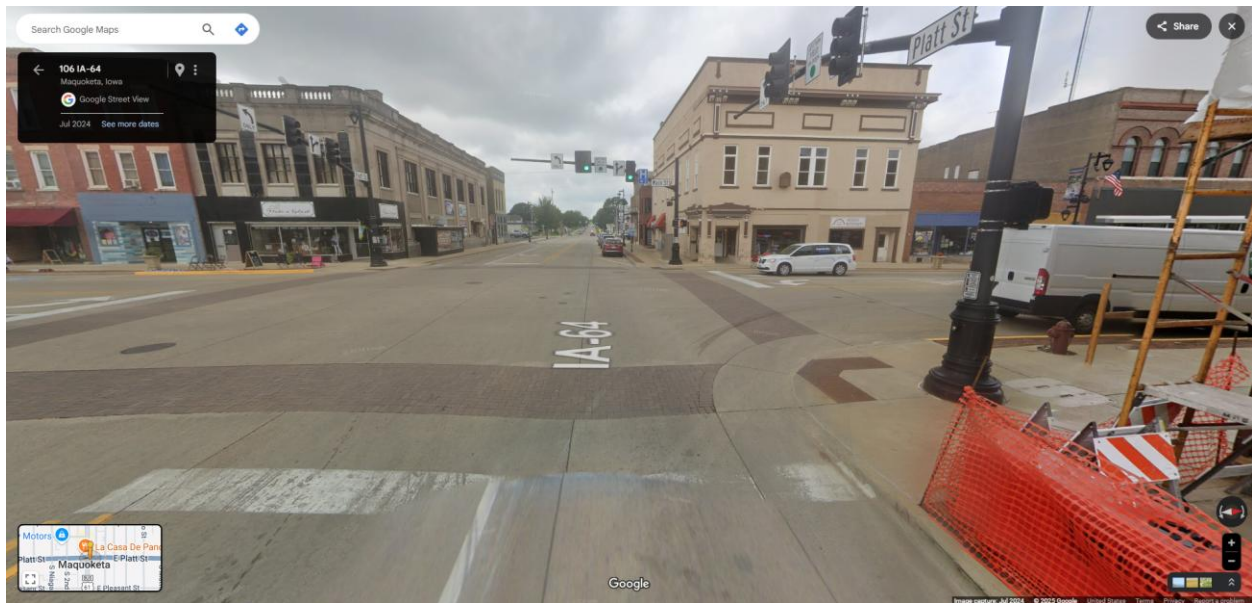
Figure 46: Intersection of North Main Street and Iowa 64 (Platt Street), Westbound (Image Source: [Google Maps](#))

This signalized intersection is located in a low speed, commercial area. Platt Street is a state route, Iowa 64, and Main Street is a municipal road. Each approach has one through/right turn lane and a dedicated left turn lane. On-street parking is allowed downstream from the intersection approaches, longitudinally offset from the intersection with crosshatch pavement markings. On-street is also allowed upstream of the intersection but at a greater distance. Traffic volumes are approximately 6,900 along Platt Street and 3,700 to 5,000 along Main Street.

Pedestrian signal heads and activation buttons are present at the intersection. The north approach along Main Street approach has sharrows on the pavement. Pedestrian crossings are brick – a contrast in material and color from the adjacent PCC pavement.

This location both had a fatal crash and satisfied the general screening criteria. The fatal crash occurred on June 23, 2020 at 9:01 involving a pedestrian and a westbound left turning vehicle that did not yield. Two other crashes occurred at this intersection, one of which involved a westbound, right turning vehicle. This location also satisfied eight of the ten evaluation criteria. Distance to private schools was not met.

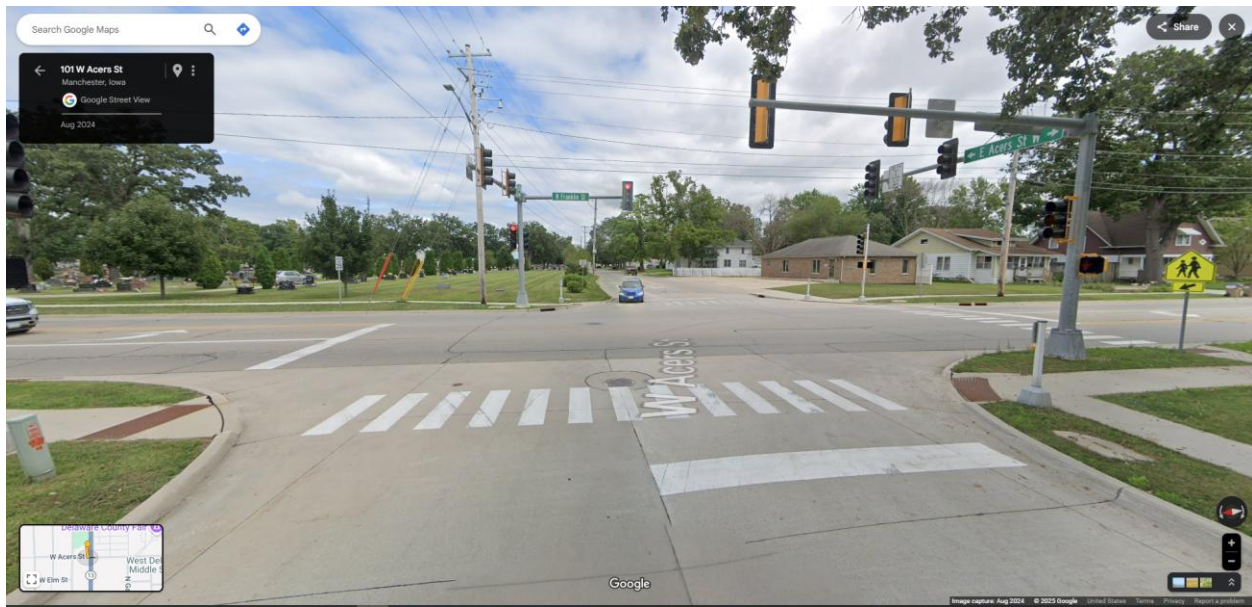
Figure 47: Intersection of N Franklin Street (Iowa 13) and W Acres Street (Image Source: [Google](#))

The intersection is four-leg with two approaches offset. Three of the approaches have a dedicated left turn lane. Major approach AADT is approximately 8,300, with minor approach volumes of approximately 400 to 2,200 vpd. All approaches are low speed, 25 to 35 mph. The intersection is signalized with three marked crossings with pedestrian signal heads and activation buttons. Pedestrian signing is also present.

Five screening criteria, four of which were related to higher risk facilities, were satisfied at this location. However, a fatal crash also occurred. The fatal crash occurred September 6, 2015 at 21:56 and involved a pedestrian under the influence. This is the only crash at this intersection. Given the circumstances, and existing safety features at the intersection, no treatment strategies are recommended.

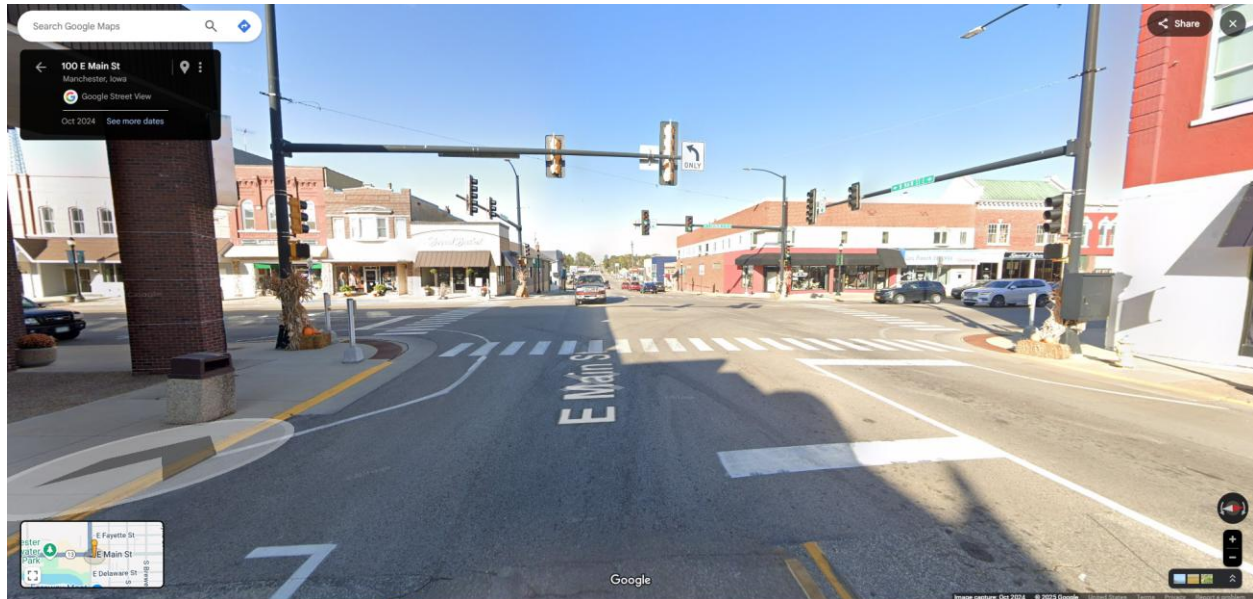
Figure 48: Intersection of Franklin Street and Main Street (Image Source: [Google](#))

On-street parking is allowed on all approaches, both upstream and downstream of the intersection. The parking is longitudinally offset from the intersection. The intersection currently has many pedestrian safety features, including sidewalks, lighting, pedestrian signals, activation buttons, marked crosswalks and painted bulb-outs.

Between 2019 and 2023, two crashes occurred at the intersection of Franklin Street (Iowa 13) and Main Street. One crash involved an eight-year-old bicyclist crossing Main Street. The bicyclist was crossing the road at the crosswalk when they were struck by a westbound vehicle moving straight. Limited details regarding bicyclist and vehicle contributing circumstances were provided in the coded crash data. The other crash involved a southbound, right turning vehicle striking two elderly non-motorists reported as having no contributing circumstances.
